FSM Department of Environment, Climate Change and Emergency Management (FSM DECEM)

Mission Report

Subject: Assessment of Pohnpei Southern Islands region Public Infrastructures (PIs) and Adaptation Fund (AF) project sites on Nukuoro and Kapingamarangi with FSM DECEM in Collaboration with Pohnpei State EPA and T & I offices

Duration of Mission: April 26 to May 3, 2020

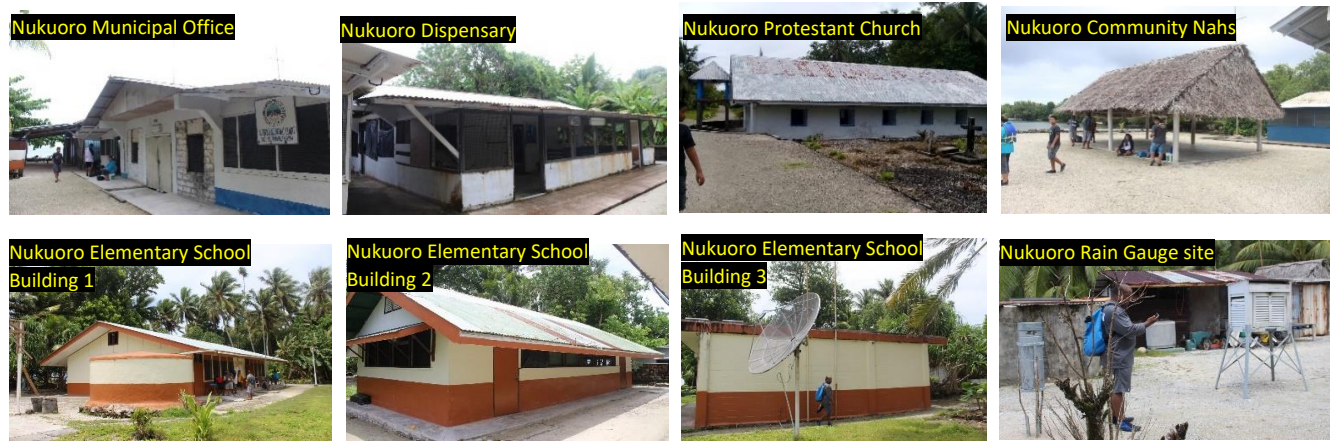
The PI assessment on Nukuoro includes the municipal office, dispensary, community nahs, protestant church, elementary school buildings, and the weather station rain gauge. All these PIs on Nukuoro were assessed and documented with pictures taken for each of the PIs. The assessment activities include GPS location and altitude, buildings measurements, number of floors and rooms, building structure and roofing conditions, water storage availability and condition, toilet facility availability and condition, and communication system availability. Shown below are the PIs assessed on Nukuoro.

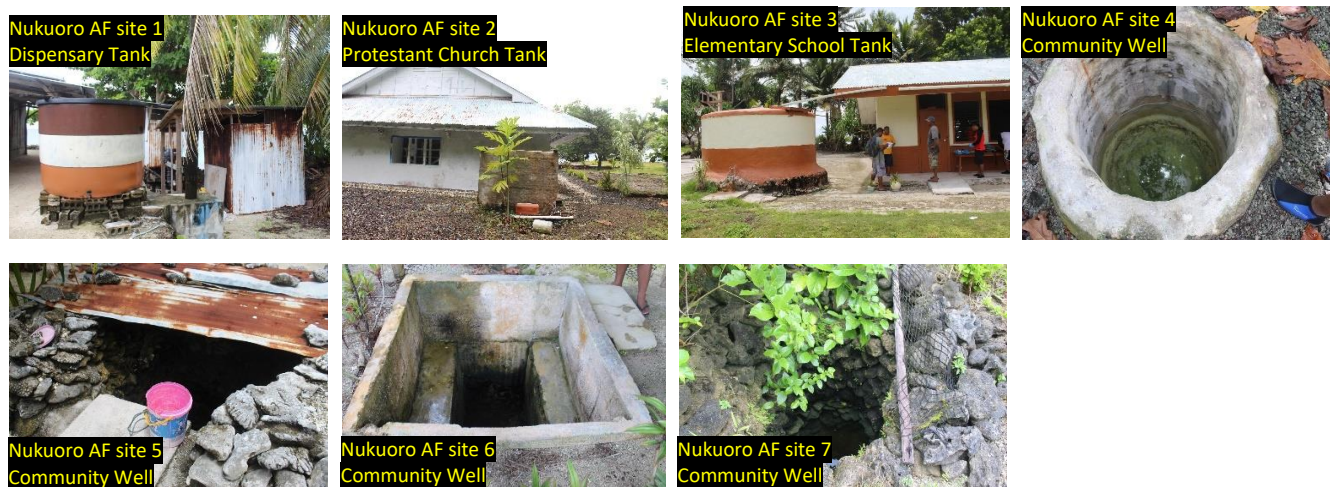
The AF project sites assessment on Nukuoro include the dispensary & municipal water tank, protestant church water tank, elementary school water tank, Adelaide Henry water well, Senard Leopold water well, Richard Fred water well, and Jano Rudolph water well. Total of seven (7) AF sites on Nukuoro, which include 3 tanks and 4 wells, and all sites were assessed and documented with pictures taken for each site. The assessment activities include GPS location and altitude, tank/well measurements, water storage structure and roofing conditions, water storage usage, and most importantly the water quality testing for each of the water storage/site. The water quality test includes e-coli, total coliform bacteria, chlorine residual, temperature, turbidity unit and the pH reading. Shown below are the 7 AF sites assessed on Nukuoro.

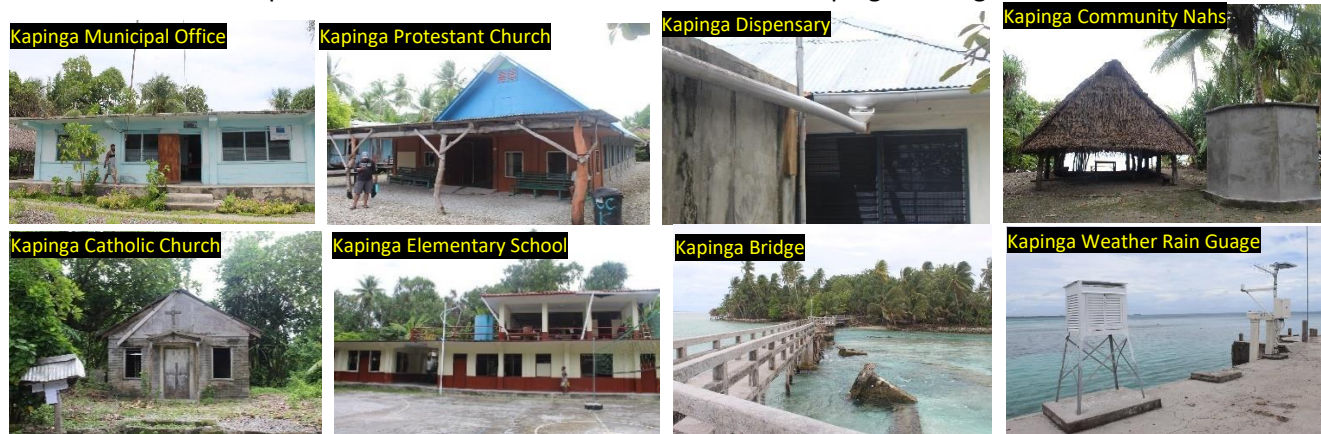
The PI assessment on Kapingamarangi includes the municipal office, dispensary, community nahs, protestant church, catholic church, elementary school buildings, bridge, and the weather station rain gauge. All these PIs on Kapingamarangi were assessed and documented with pictures taken for each PI. The assessment activities also include GPS location and altitude, buildings measurements, number of floors and rooms, building structure and roofing conditions, water storage availability and condition, toilet facility availability and condition, and communication system availability.

Shown below are the public infrastructures that were assessed on Kapingamarangi:

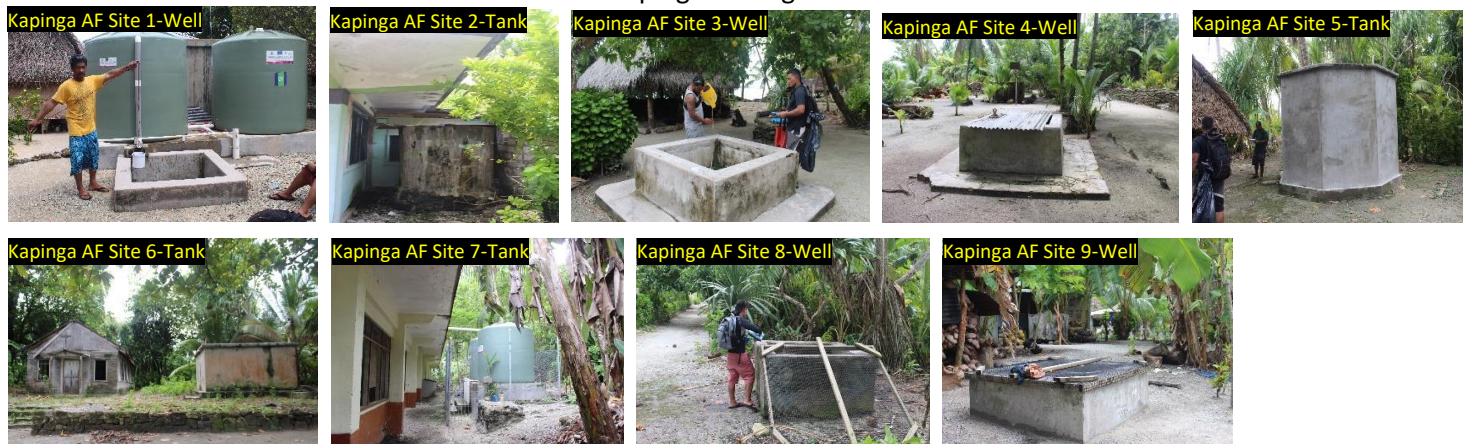
The AF project sites assessment on Kapingamarangi includes the municipal water tank, protestant church water well, elementary school water tank, community nahs water tank, catholic church water tank, and four (4) community and public water wells. Total of nine (9) AF sites and five (5) repaired water tanks were assessed and documented on Kapingamarangi with pictures taken for each site. The assessment activities also include GPS location and altitude, tank/well measurements, water storage structure and roofing conditions, water storage usage, and the water quality testing for each of the water storage/site.

Below are the 9 AF sites that were assessed on Kapingamarangi:

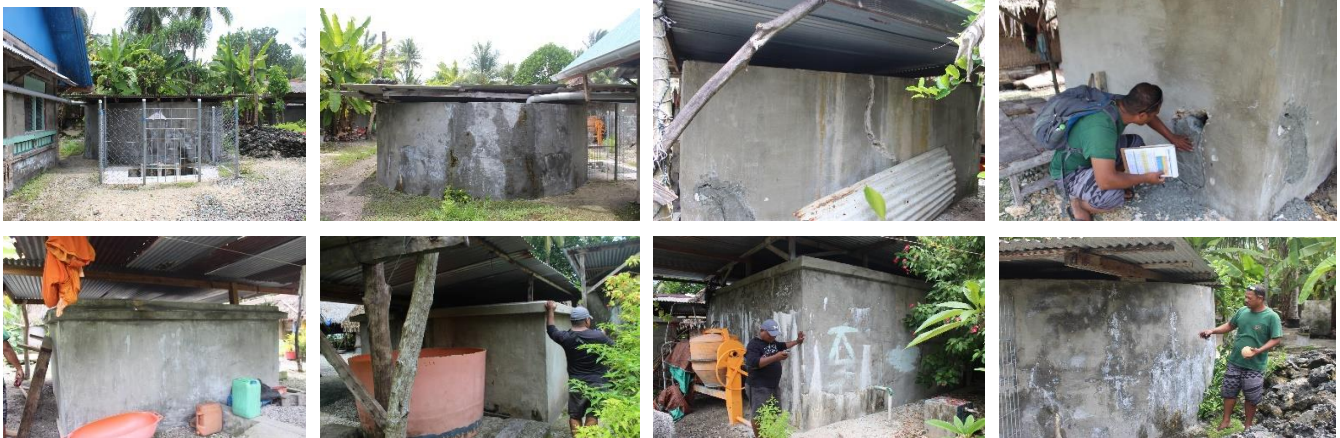
Shown below are some of the water tanks that the AF project repaired for community use on Kapingamarangi:
