Town Electrification Investment Program – Tranche 1

TOWN ELECTRIFICATION INVESTMENT PROGRAMME TRANCHE 1

4th Semi Annual Environmental Monitoring Report

Reporting Period: January to June 2018

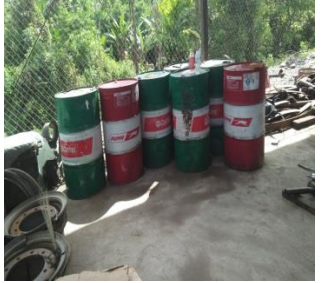
2	No proper storage and designated area for fuel drums, fuel drums laying around	<ul style="list-style-type: none"> • Provide proper storage for fuel drums and oil in one designated area away from water sources • Empties must be disposed of properly or recycled. 	30/11/17	Implemented	Contractor	Fuel Handling Management	Yes

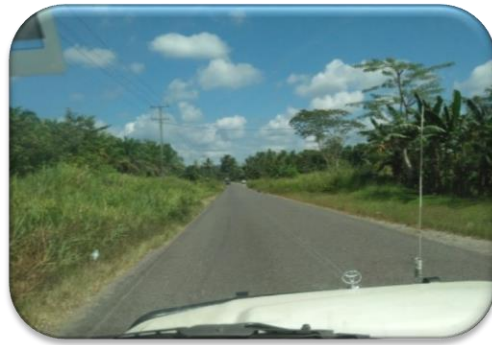
TRANSMISSION LINE SAGGED ALONG ROAD

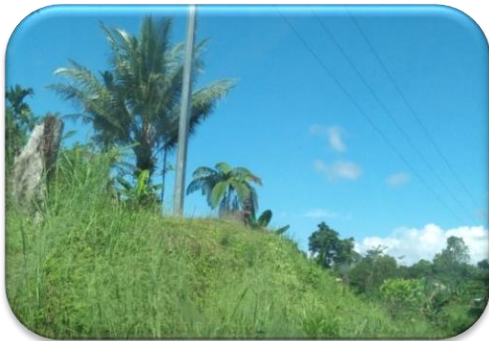
SAGGING TL
