*Archaeological Survey and Inventory of  
Submerged Cultural Resources in the Lagoon  
of Kwajalein Atoll:*

SITES ON THE SOUTH AND EASTERN SIDES OF KWAJALEIN ATOLL

Matthew B. Holly

HPO Report 2000/02

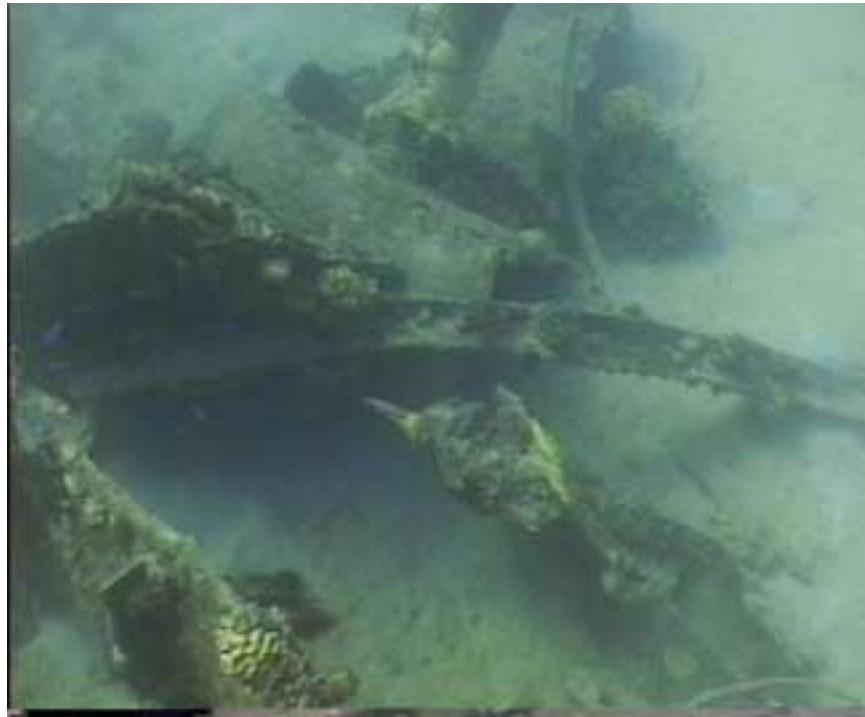
Photo KS1-2 Large Metal debris of unknown type in the west side of the debris field. Rivets and curved sections may represent boilerplate metal.

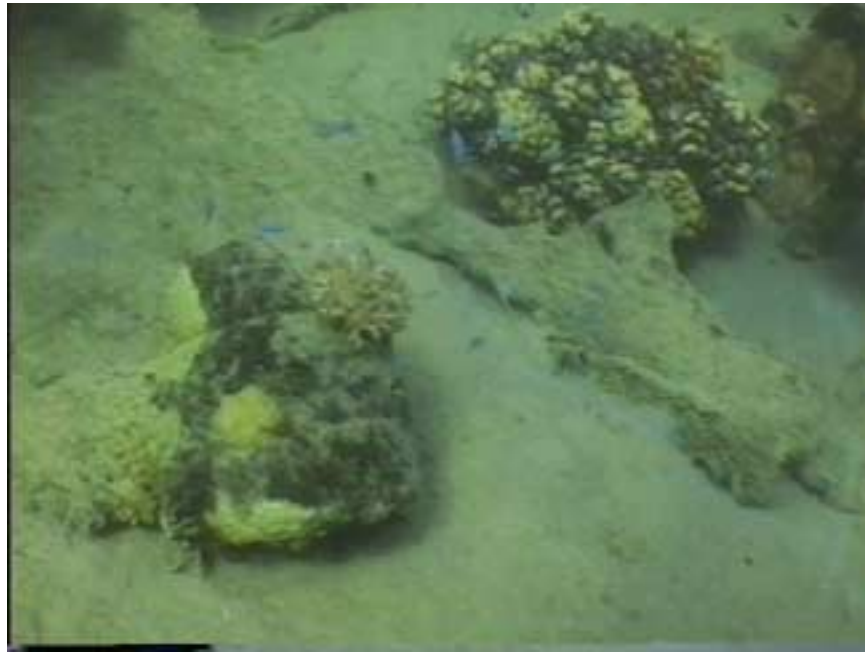
Photo KS1-4 Large anchor shaft end with shackle in debris field. This is probably an USN anchor and weights over 3000 pounds, and is well buried in the sand.

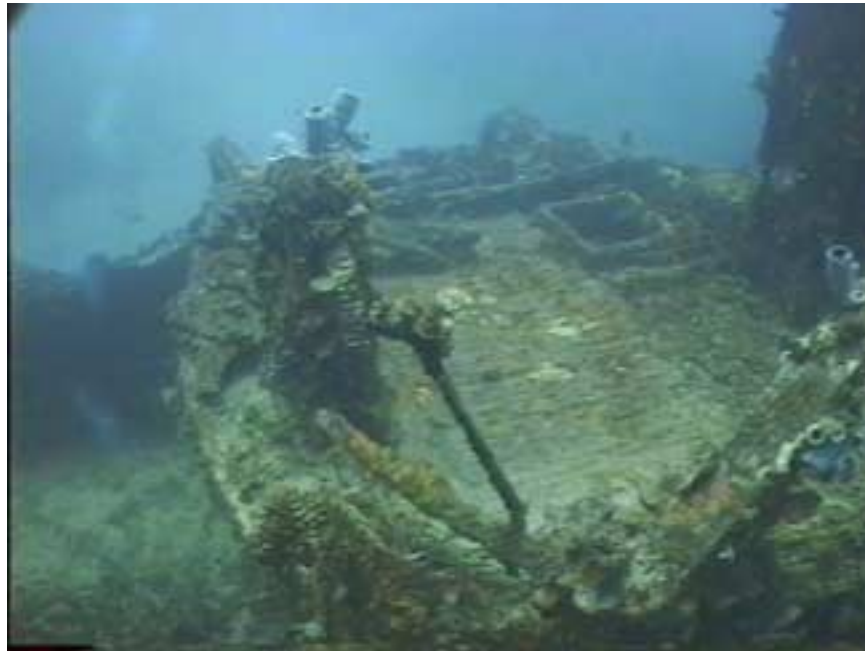
The vessel did not burn, or at least seriously burn, as the pilothouse wood floor is intact (Photo KS4-4), as is the bow and overhanging wood stern (Photo KS4-5). Most of the vessels deterioration is from the marine environment, time, and from divers.

Photo KS4-4 Pilothouse area of North Loi wreck. Notice wood flooring is still intact, and drive gear for ships steering forward of the missing wheel position.

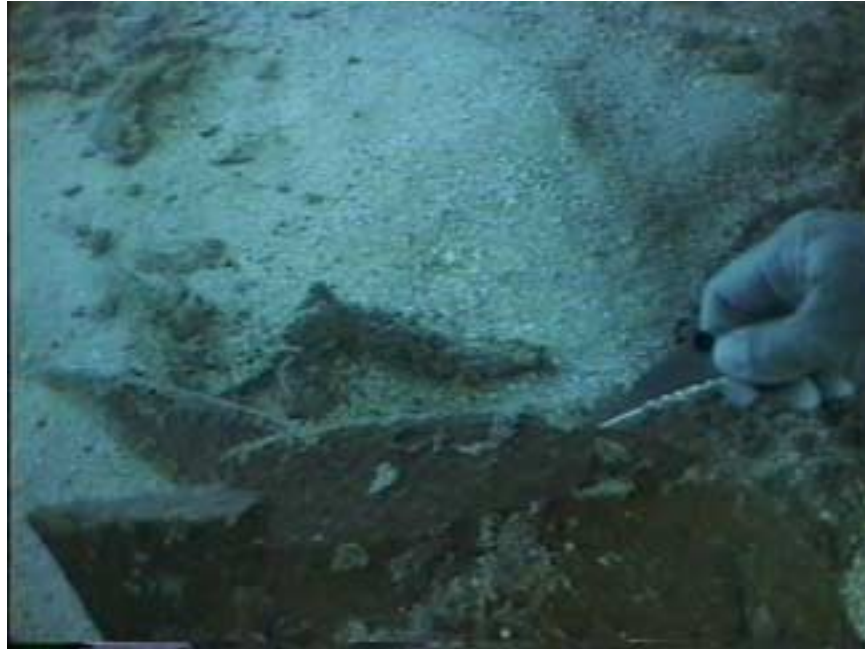
Divers hacksawed off one blade of the vessels 3 bladed propeller for whatever reason (Photo KS4-6). The steel hull sheeting (Photo KS4-7) has deteriorated but some sections on the port side were probably torn away upward by divers (Photo

Photo KS4-6 Propeller with missing blade. Note hacksaw cuts.

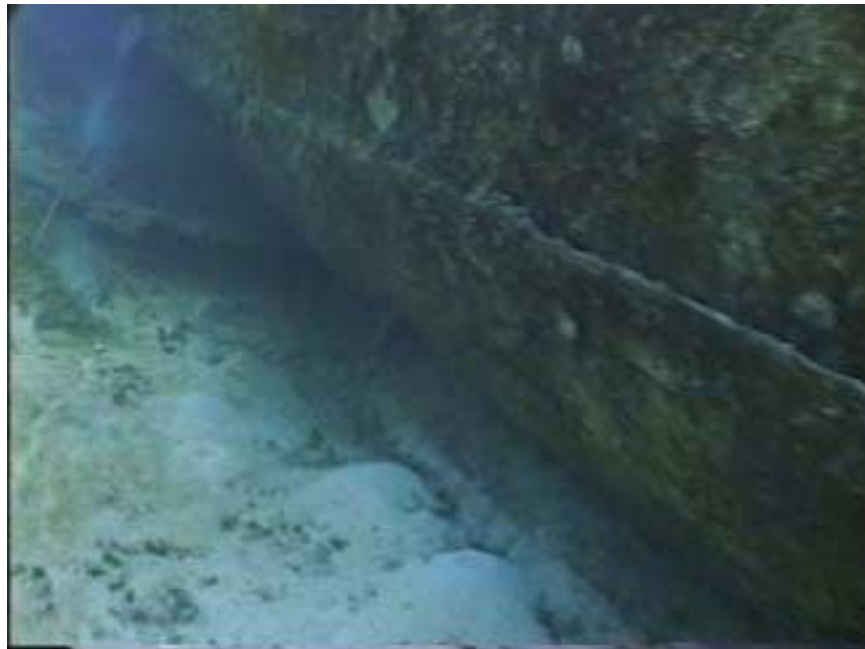
Photo KS4-7 Steel sheeting added to below the waterline. Note section fallen away at top left of photo which is next to the engine room.

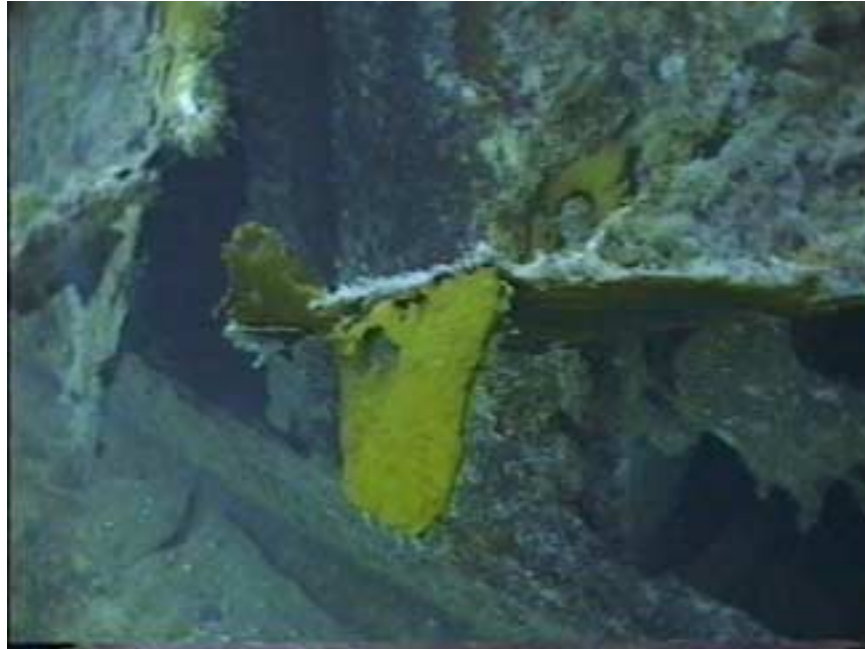
KS4-8) to look for additional artifacts. Holes in the starboard sheeting allowed me to photograph the main engine and engine room (Photo KS4-9). No personal artifacts were found, all that remains is machinery and some spare parts such as cables and hoses in the forward compartment (Photo KS4-10).

Photo KS4-8 Starboard side metal sheeting at engine room with sections pulled upwards. Rust on edges indicates recent movement

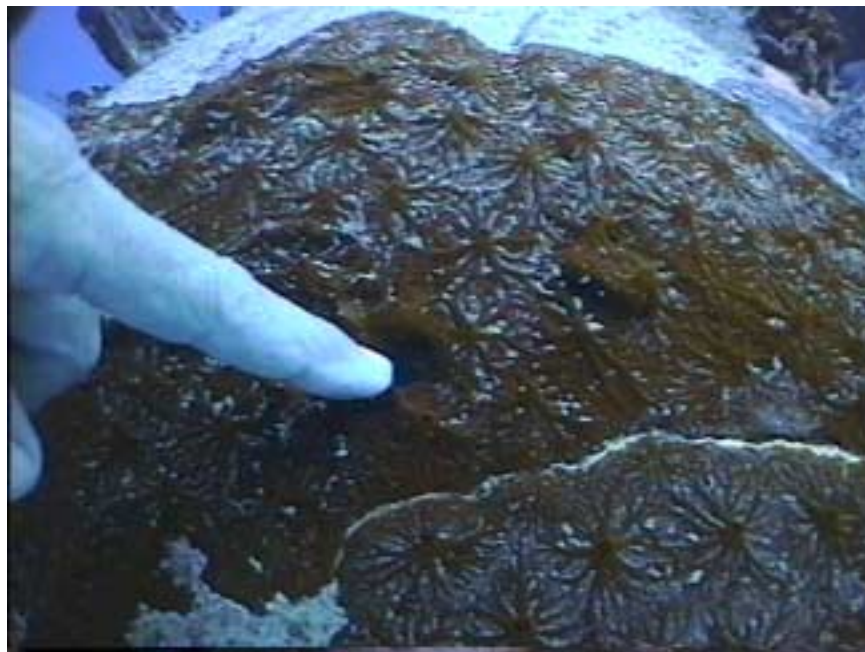
Photo KS7-3 Bullet hole in nose of "Mavis" H6K4 Flying-Boat.

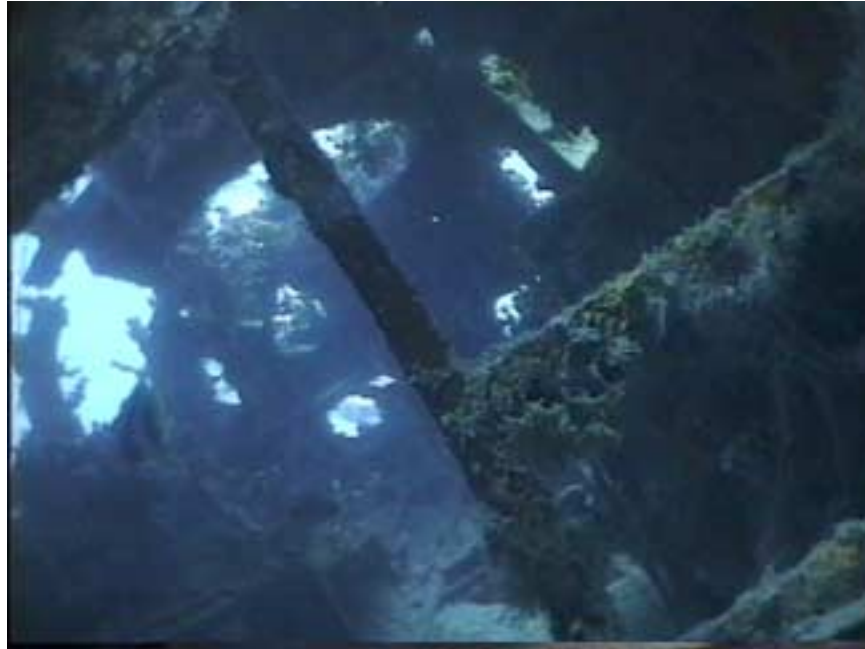
Photo KS7-4 Inside the nose of the Central Mavis Flying-Boat. Left side is partially burned away, but forward gun position remains and is open.

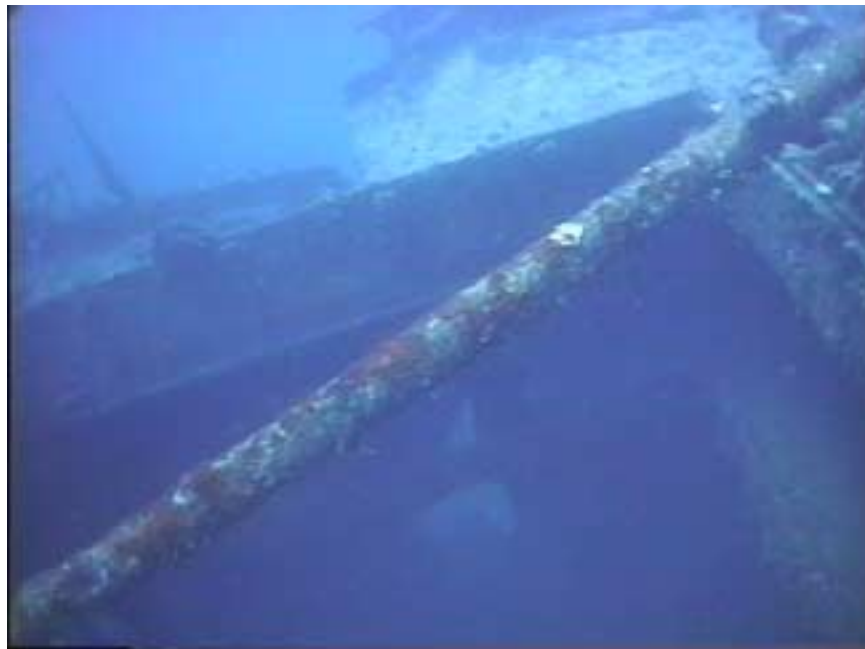
Photo KS10-10 Number 4 hold with damage through hull and at deck level. This damage is what sunk the vessel.

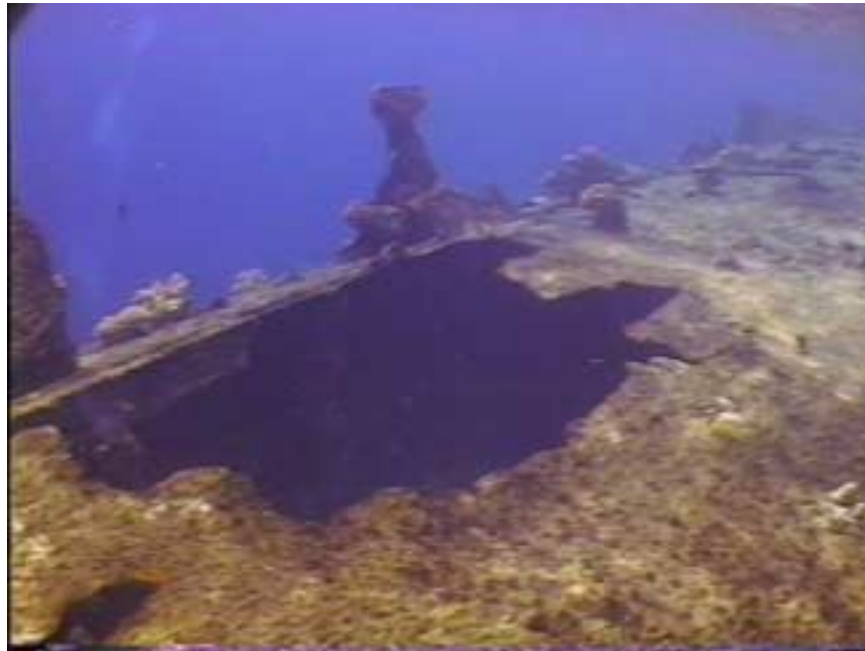
Photo KS13-3 Hole in hull bottom on port side near the end of the bilge keel. Divers can drop straight down through this hole into the shadows of the ship for excellent photos of marine life in open water below.

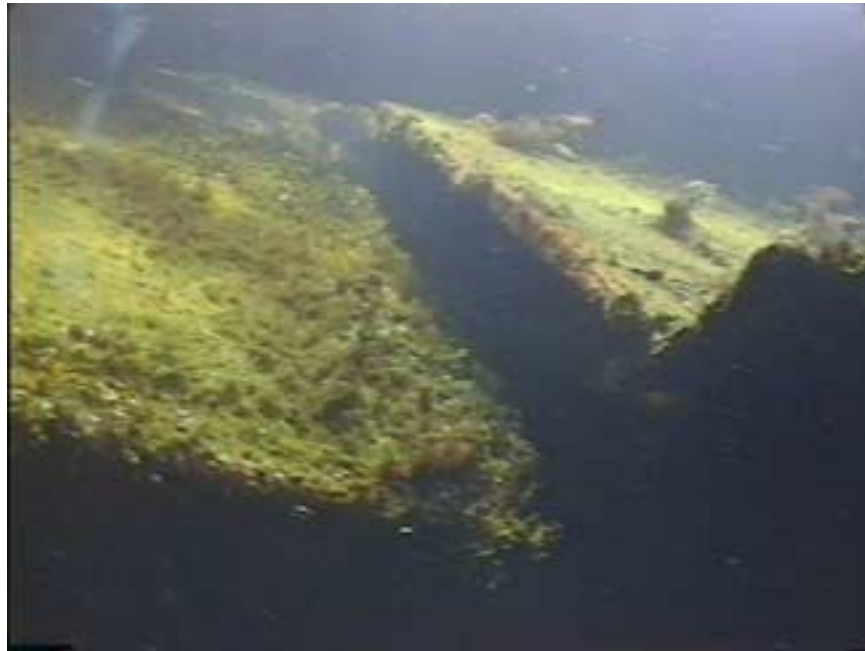
Photo KS13-5 Damaged 80mm armor plate, torn apart from explosion.

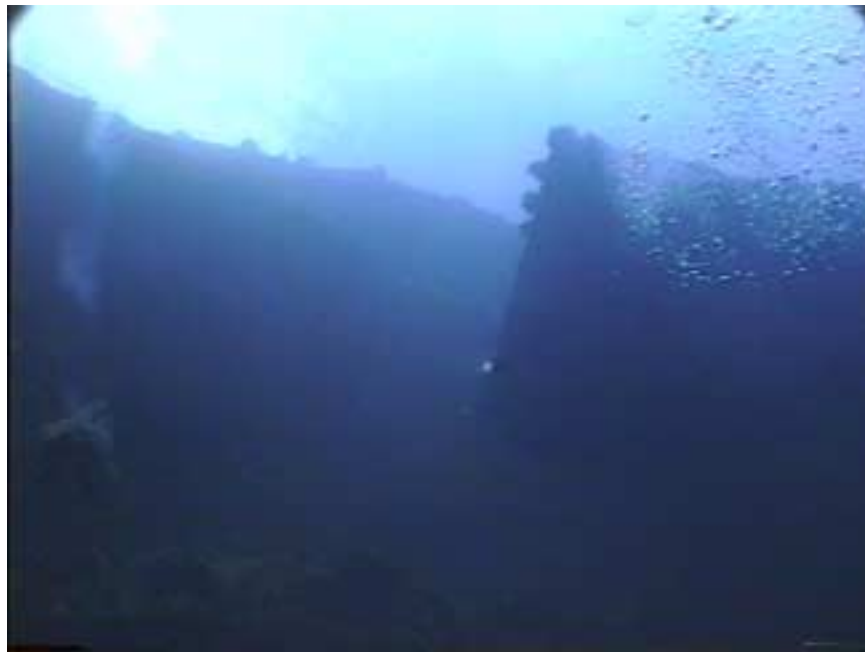
Photo KS13-6 Hull damage from explosion, main deck on right of photo, keel at edge of light at top of photo, with a missing or collapsed sections in between.

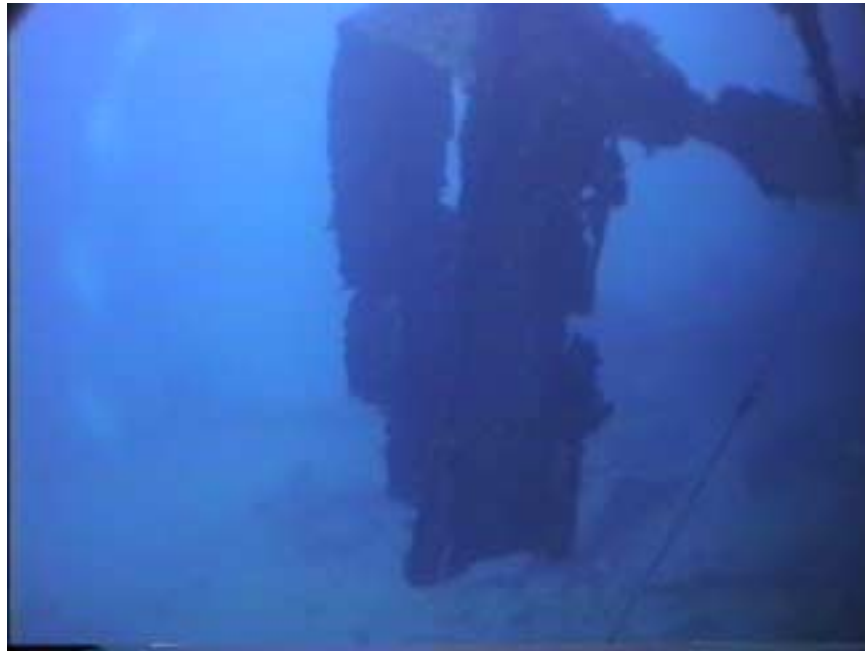
Photo KS13-7 Hanging hull section from damage site. Section is attached to anti-submarine cable and extends almost to the sand.

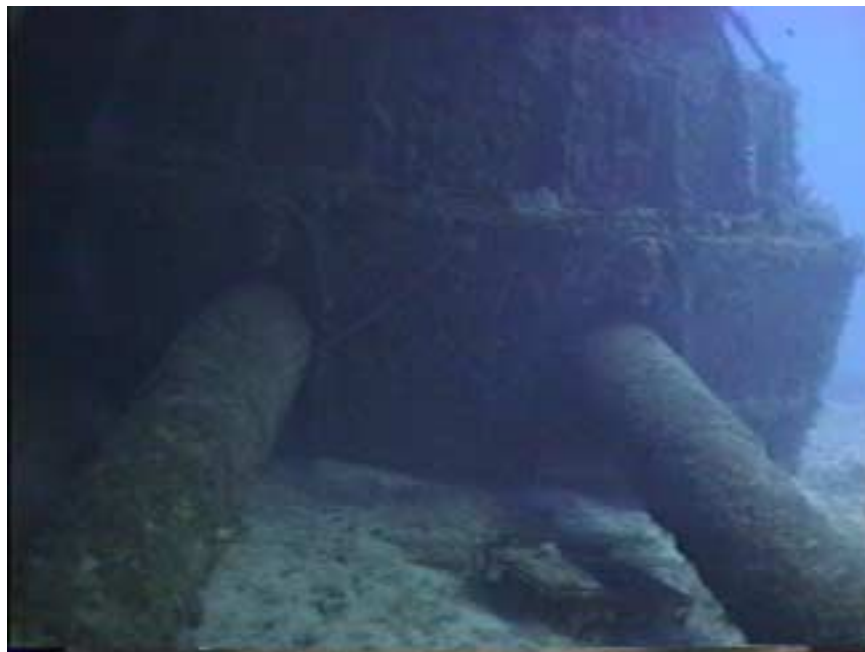
Photo KS13-12 Number 4 turret lying on the bottom.
