*Archaeological Survey and Inventory of Submerged
Cultural Resources in the Lagoon of Wotje Atoll*

Matthew B. Holly

HPO Report 2000/03

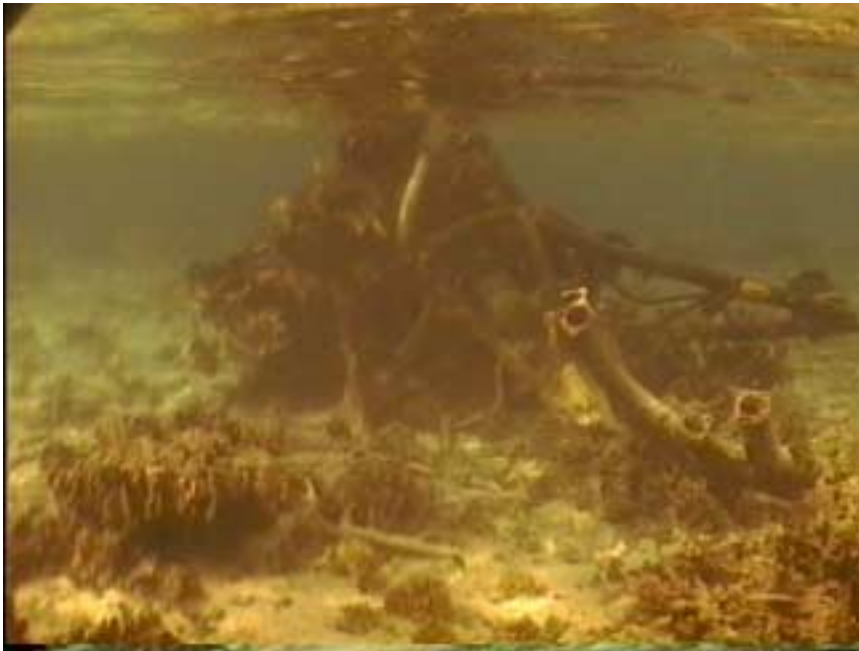
The aircraft engine is the farthest major piece from shore, and is barely exposed at low water (Photo WT1-4). The engine, Photo WT1-5, is basically intact, missing a few cylinders and the propeller. Conspicuous were the stainless steel exhaust manifolds, still shining, and significantly different than the Japanese versions that turn black with age and exposure to the elements. A close-up of the engine (Photo-WT1-6) shows the double row of cylinders which totaled 14, the correct amount for a SD2C engine (which was a Wright Cyclone model R2600).

Photo WT1-5. View of entire engine remains of SB2C aircraft. Note bright stainless steel exhaust manifolds in right side of photo.

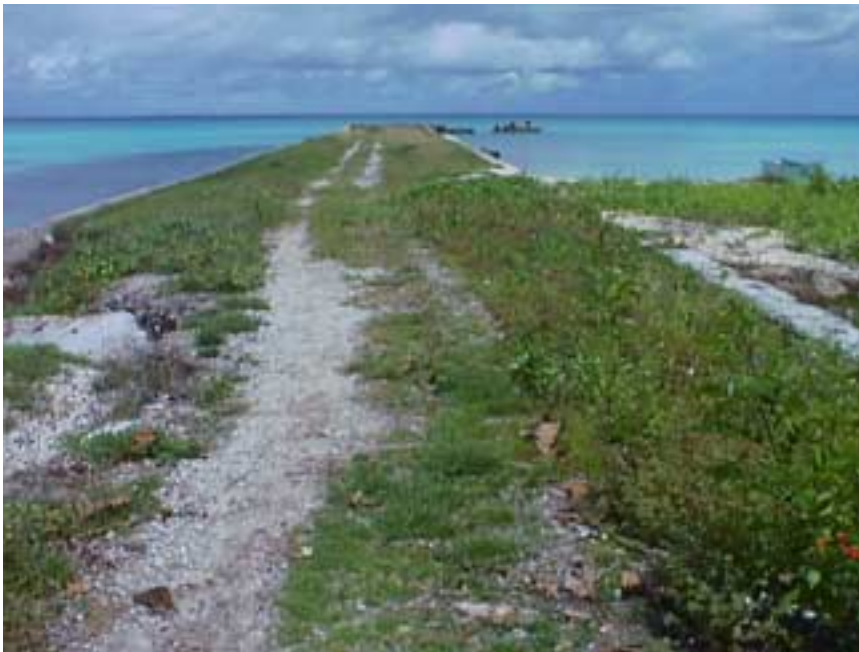
Photo WT6-1. Japanese built Wotje Main Service Dock. Only the far end destroyed by bombing.

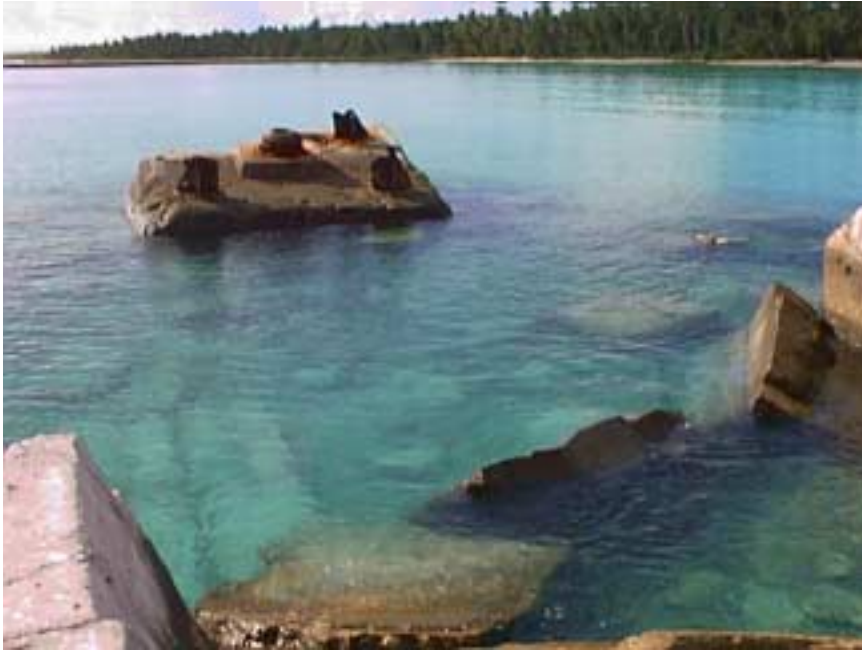
Photo WT6-2. Deep end of Main Service Dock, heavily damaged by bombing and time, with crane base exposed on original end of dock.

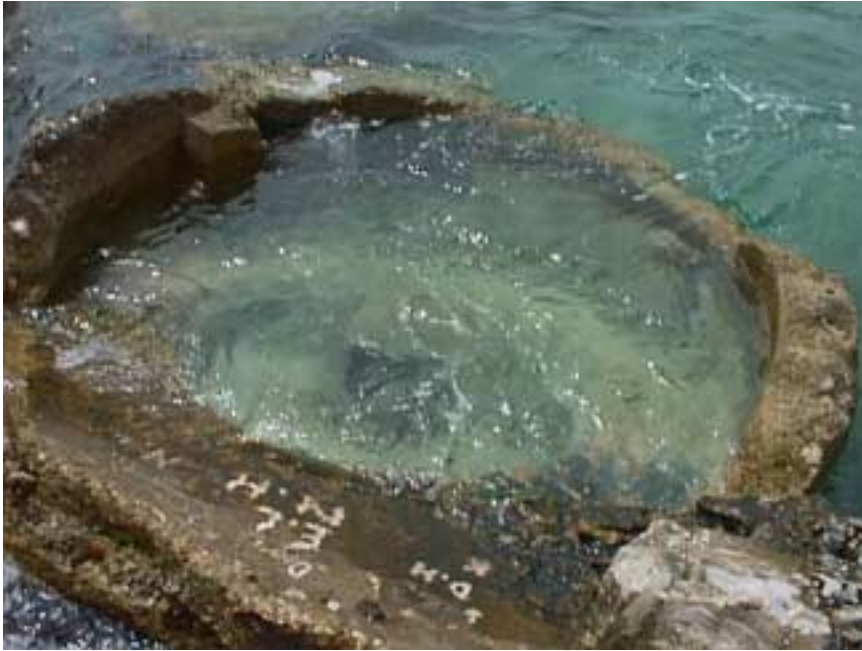
Photo WT6-4. Anti-Aircraft Site blown into water from bomb damage at the end of the Main Service Dock.

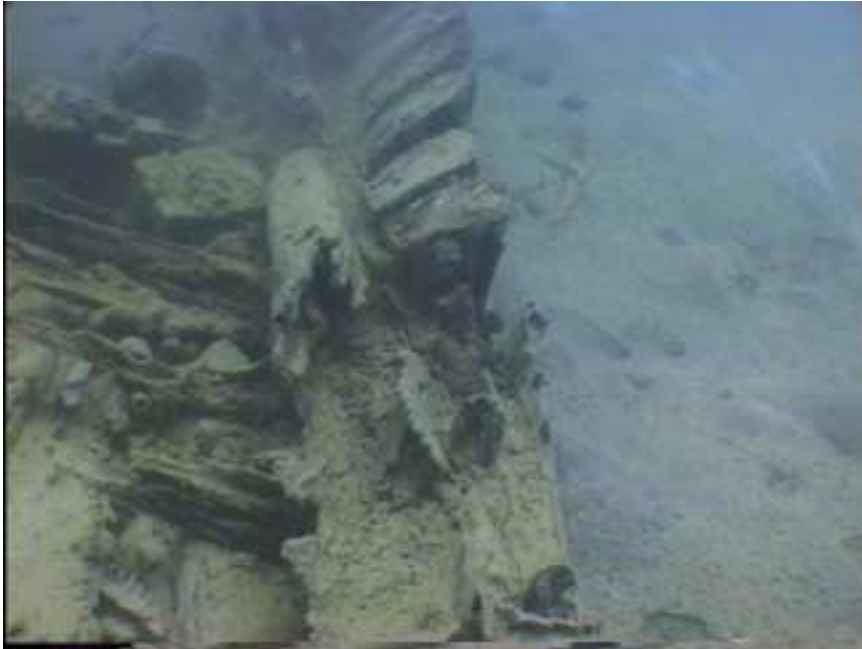
Photo WT7-2. The bow of the Central Vessel, with decayed bow spirit and residual concrete repairs between the frames on the port side obviously evident.

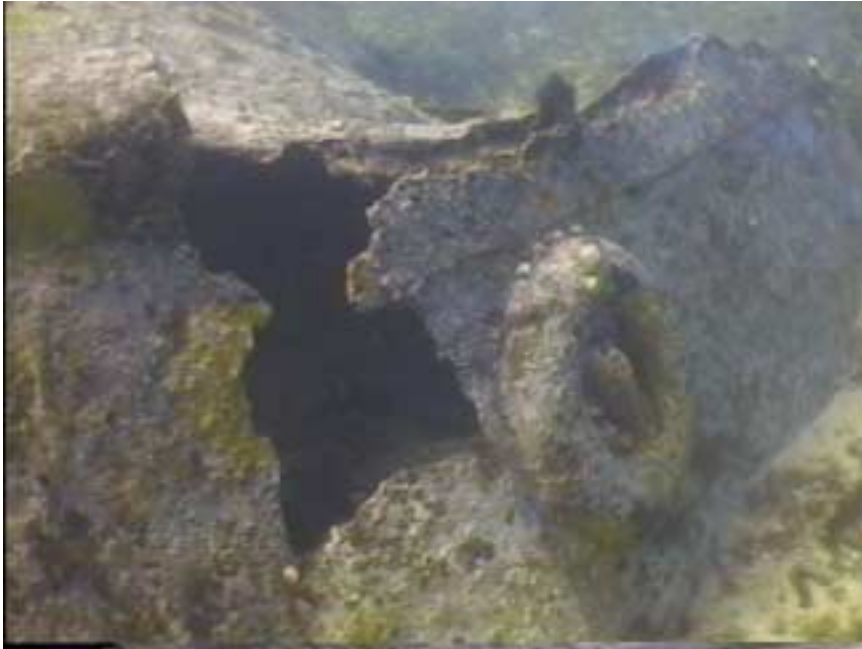
Photo WT9-2. Bow of steel vessel with chain tube opening. Note rust mark at false waterline, indicating vessel rotted for along time before being demolished.

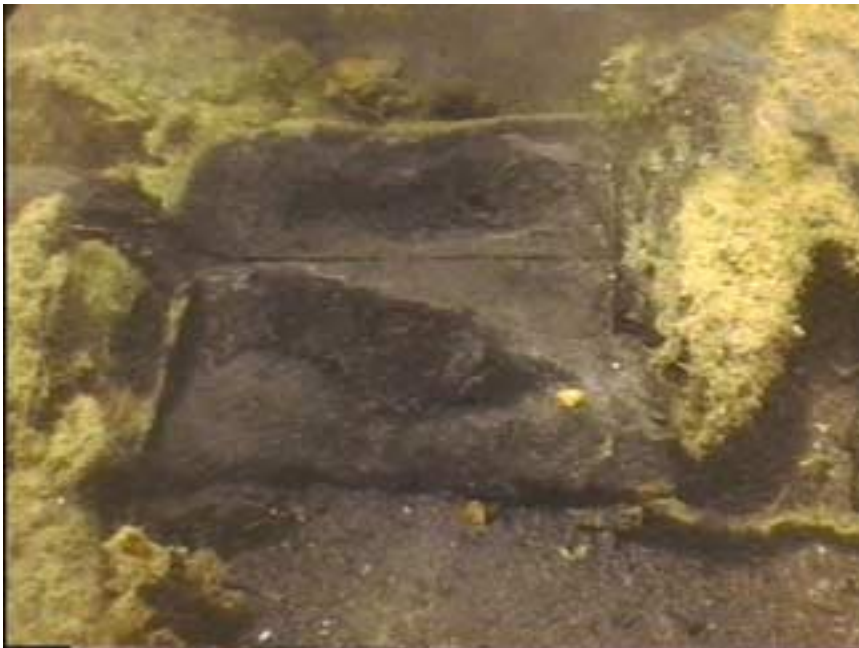
Photo WT11-9. Hull lumber with possible fire damage.

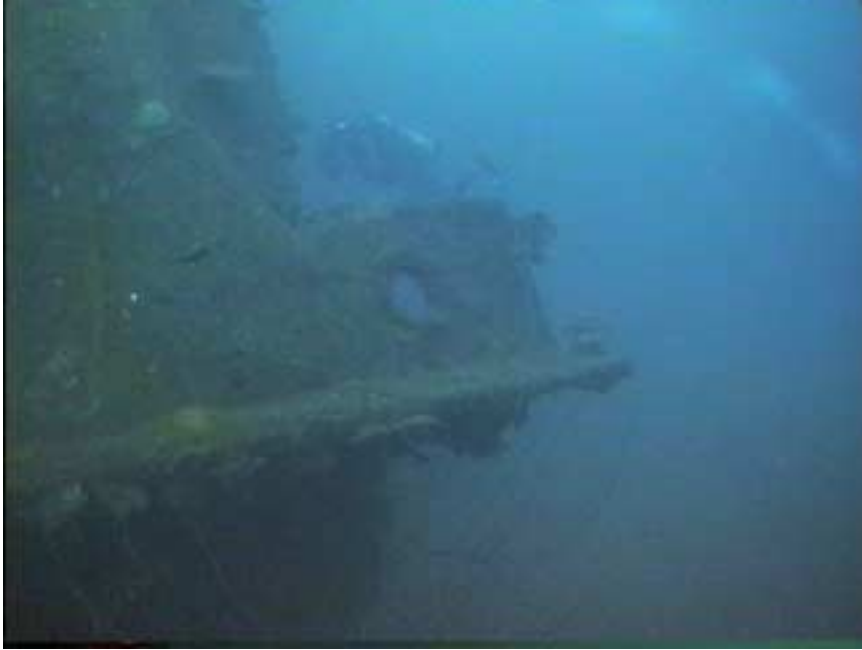
Photo WT12-2. Bow of the Borudou Maru. Notice the straight lines of the bow, and the diver highlighting the damaged starboard bow area.

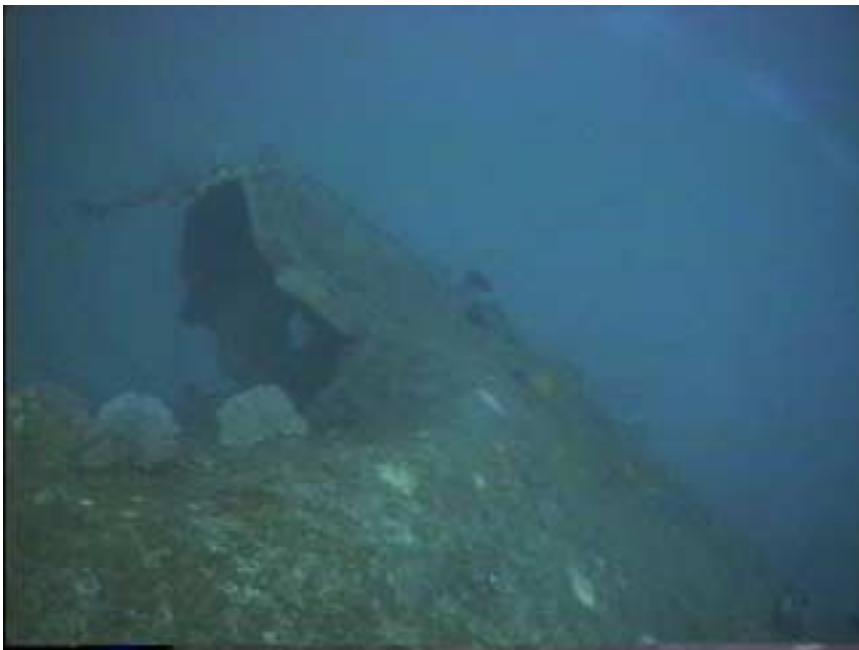
Photo WT12-5. Starboard bow damage. Note un-damaged front of vessel.

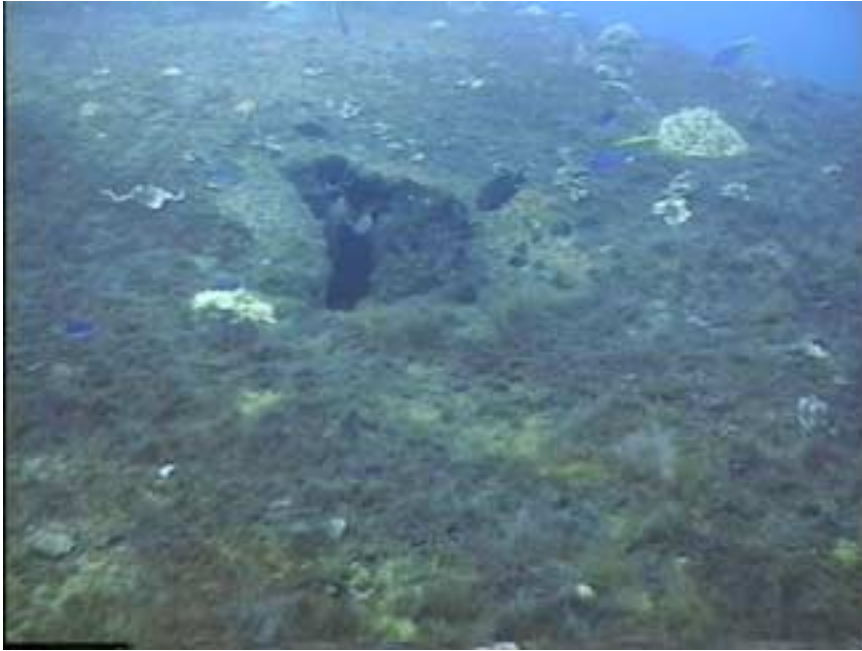
Photo WT12-12. Bomb damage or artillery round hole in the starboard side, just forward of or just in the engine room spaces. Hole measured apx. 3 square feet of area.

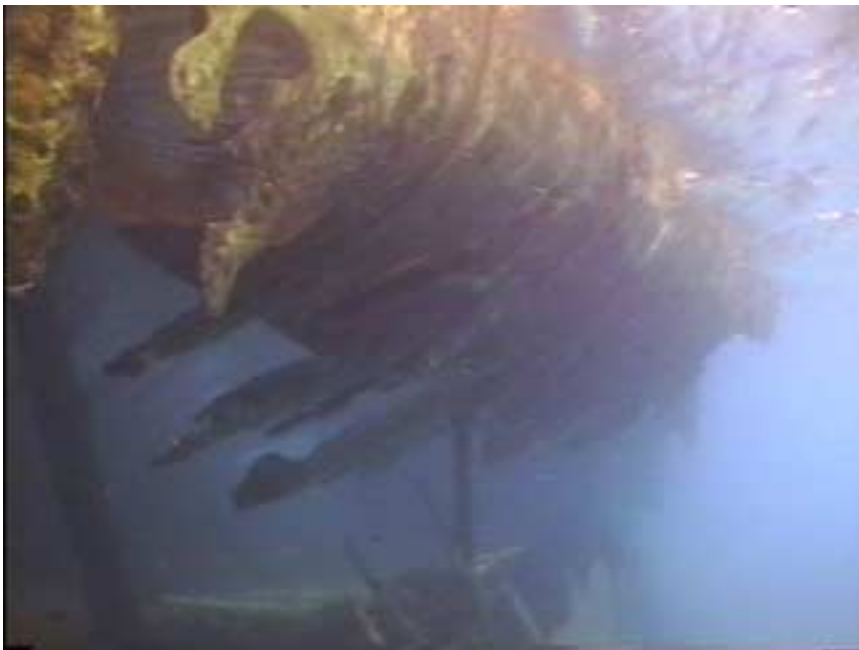
Photo WT13-6. Inside bow looking to starboard damage. This damage is probably from the weight of the bow crushing the underwater structure, but could also be from near bomb misses.

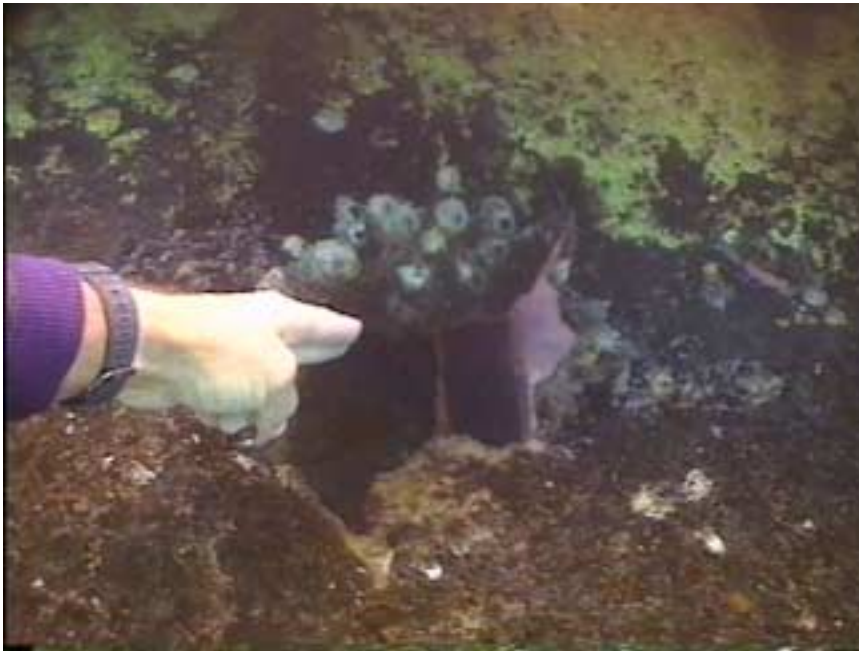
Photo WT13-7. Hole likely from artillery shell, but also possible damage from a near bomb explosion.
