The Impact of a Ship Grounding and Associated Fuel Spill at Rose Atoll National Wildlife Refuge, American Samoa

U.S. Fish and Wildlife Service Pacific Islands Ecoregion Honolulu, Hawaii

September 1997

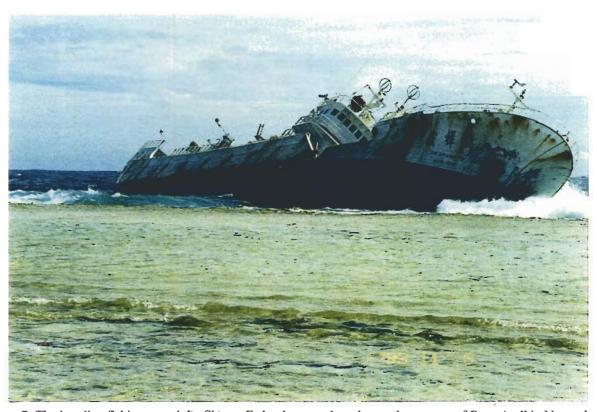
Figure 7 The longline fishing vessel Jin Shiang Fa hard aground on the southwest arm of Rose Atoll in November 1993.

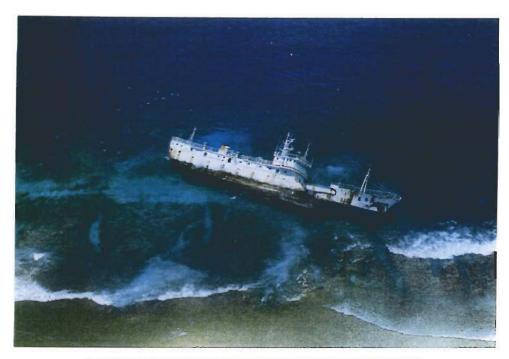
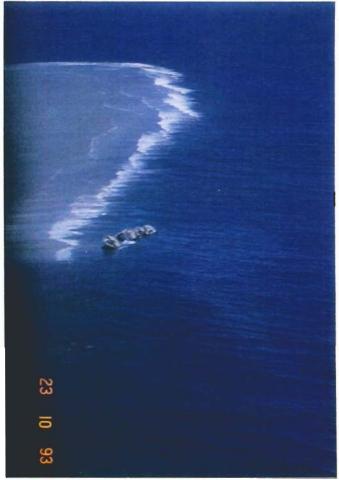
Figure 8 The Jin Shiang Fa hard aground across spurs on the reef slope at Rose Atoll in October 1993 (top) and the contaminant spill north of the vessel on October 23, 1993 (bottom).

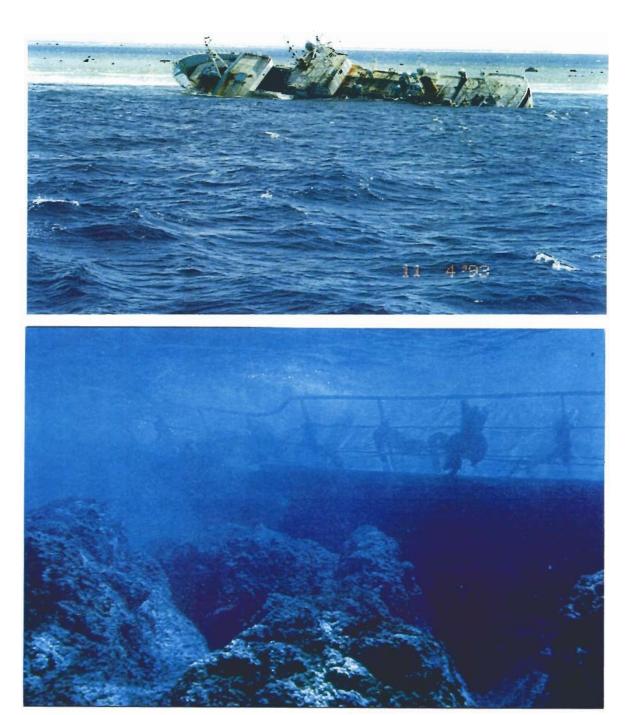
Figure 9 The outer reef slope at Rose Atoll in November 1993 showing the *Jin Shiang Fa* keeled over on its port side (top) with the port side railing under water (bottom).

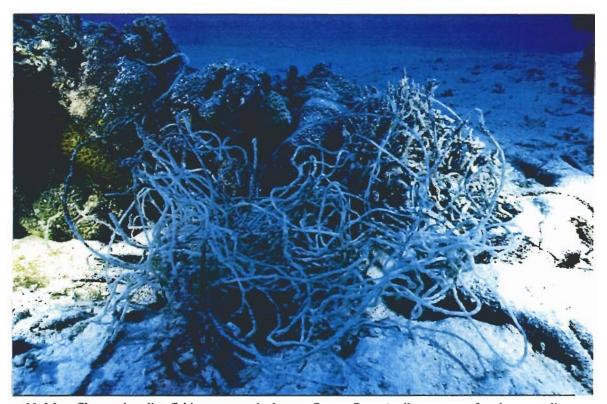
Figure 10 Monofilament longline fishing gear on the lagoon floor at Rose Atoll two years after the grounding.

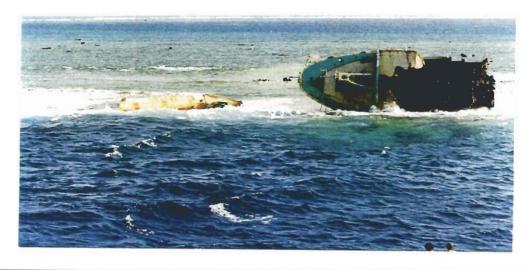
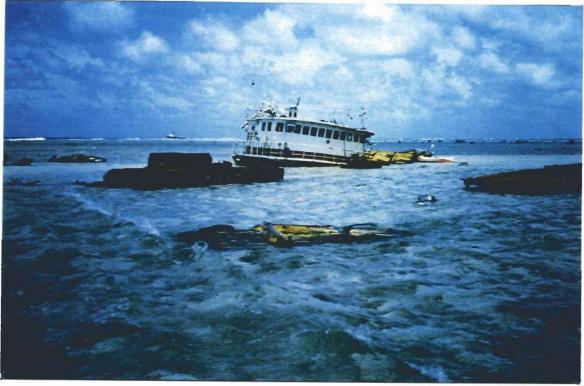
Figure 11 The bow section (top), wheelhouse and other pieces of wreckage (bottom) on the reef flat at Rose Atoll six weeks after the grounding.

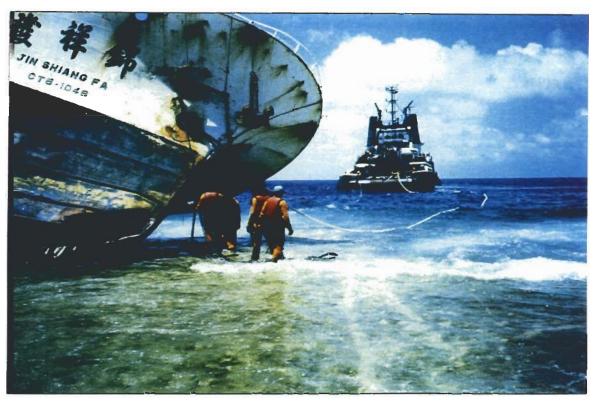
Figure 12 Salvage operation to remove the wreckage from the reef flat six weeks after the grounding.

Salvage operations (Fig. 12) were successful in removing most of the larger pieces of wreckage and debris from the reef flat (Barclay 1993). This included pulling the bow, wheelhouse, shelter deck, and miscellaneous pieces of ship wreckage off the reef flat into deeper water (600-1,000 m). However, the salvage crew did not attempt to move the stern and its associated debris from the shallow reef slope because the sheer mass of the stern made it impossible to move (Barclay 1993). In the months following the salvage operation, the stern was broken up into smaller pieces by high wave energy.

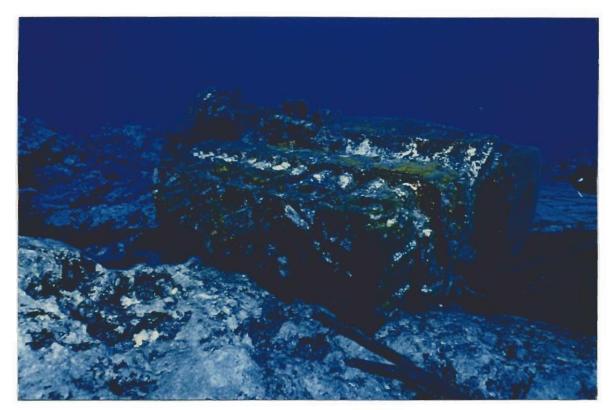
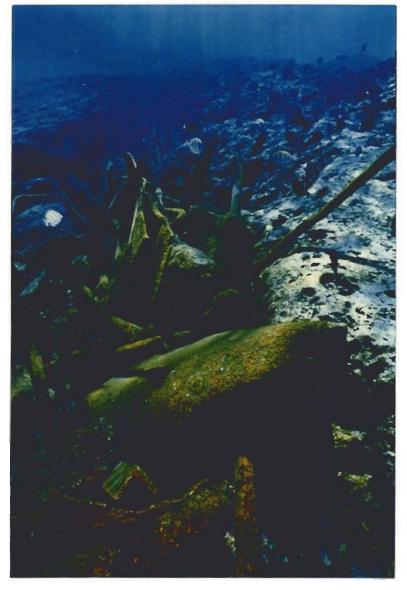
Four months after the grounding, a large amount of wreckage and debris was still present on the reef slope, covering an area of approximately 3,500 m² (Molina 1995). The engine block was on the reef slope just below the surf zone (Fig. 13), and numerous other pieces of wreckage and debris were distributed in the area, mostly within the natural reef groove where the vessel came to rest (Fig. 13, Molina 1995). The remaining wreckage included coils of longline fishing gear, large metal plates, twisted engine conduit, pieces of super structure, and many other miscellaneous items (Molina 1995). Molina (1995) also noted that much of the debris appeared to be very unstable, although some had been imbedded in a large rubble pile below the main area of the wreckage (see *Generation of Berms*).

Figure 13 Wreckage on the outer reef slope two years after the grounding, including the engine block (top) and other metal sections of the stern and ship debris (below).

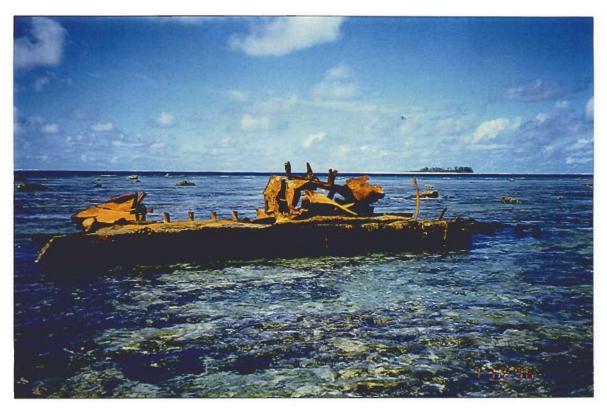
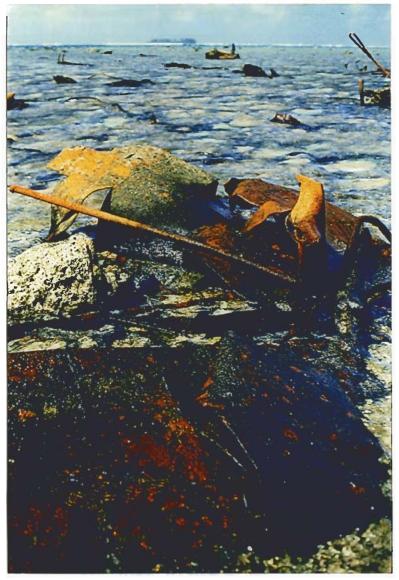
Figure 14 Wreckage from the Jin Shiang Fa on the reef flat two years after the grounding.

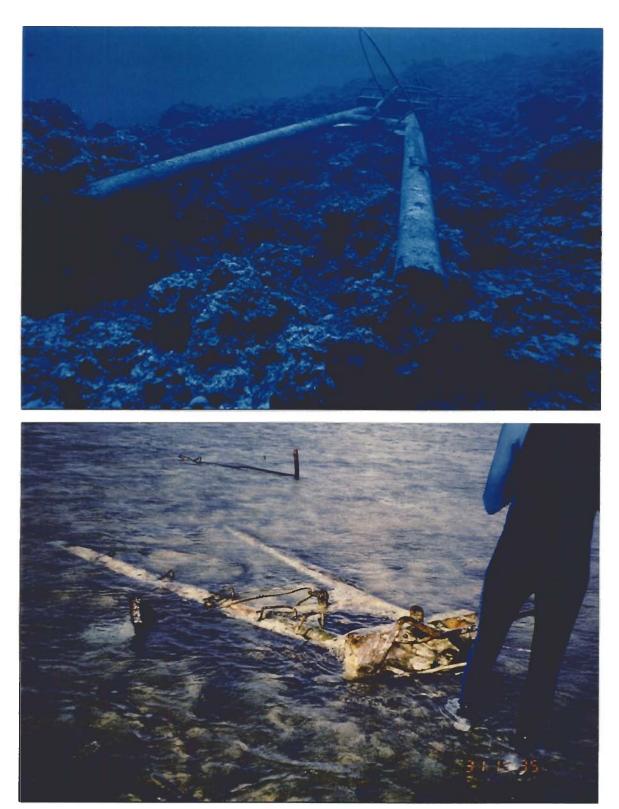
Figure 15 Foremast on the outer reef slope five months after the grounding (top) and the same piece of wreckage on the reef flat $1\frac{1}{2}$ years later (bottom).

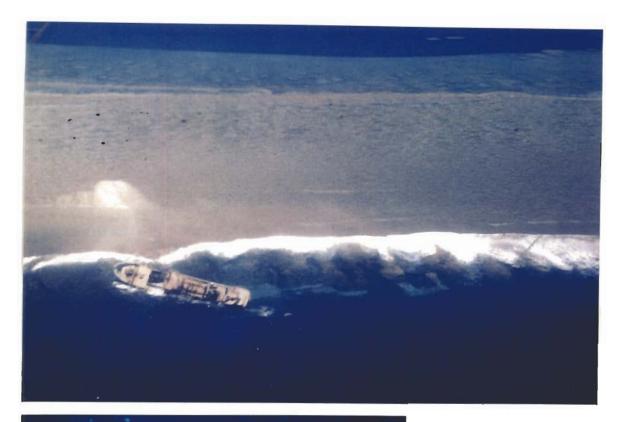
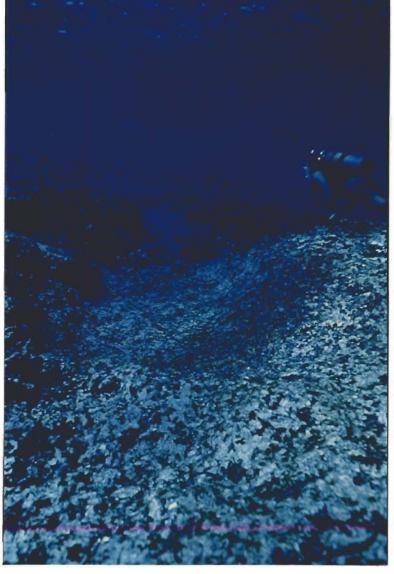
Figure 17 Scarring on the outer reef slope caused by the passage of the vessel as seen from the air (top) and underwater (bottom).

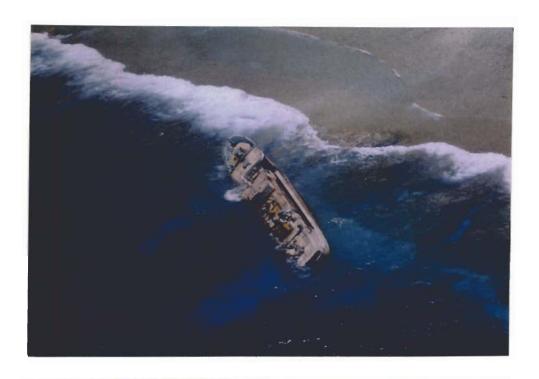
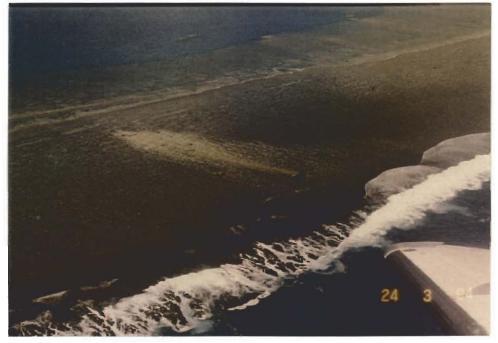
In the weeks following the grounding, the rocking of the vessel by waves and surge caused additional injury to the outer reef slope, by enlarging the groove in which the ship's keel and hull were lodged. Calcareous sediments (i.e. pulverized reef) generated by the movement of the hull formed two large piles which extended down the reef slope below the vessel (Fig. 18: Molina 1994). Both of these berms were large enough to be clearly visible from the air (Fig. 18). The largest of the berms spread down the slope from just below the surf zone to a depth of 46 m (Molina 1995). Two weeks after the grounding, this berm was 78 m long, and ranged in width from 21 to 42 m at depths of 14 m and 9 m respectively (Molina 1995). These berms are believed to have buried benthic marine organisms and a large amount of ship debris, as evidenced by the pieces of fishing line and other items protruding from within the sediments (Molina 1994). Subsequently, this berm has migrated down the outer reef slope to the seaward terrace in deeper water below the wreck (J. Burgett pers. obs.).

Over time, the sediments from the reef flat berm have spread laterally and moved towards the lagoon, scouring and filling in numerous cracks and depressions in the reef flat, and burying and abrading reef organisms (Molina 1994, 1995, see *Corals* and *Echinoderms*). Three years after the grounding, these sediments remain prominent in depressions in the reef flat near the wreck (J. Burgett pers. obs.).

Figure 18 Sand-rubble berms on the outer reef slope below the vessel two weeks after the grounding (top) and the berm on the reef flat adjacent to the wreck site five months after the grounding (bottom).

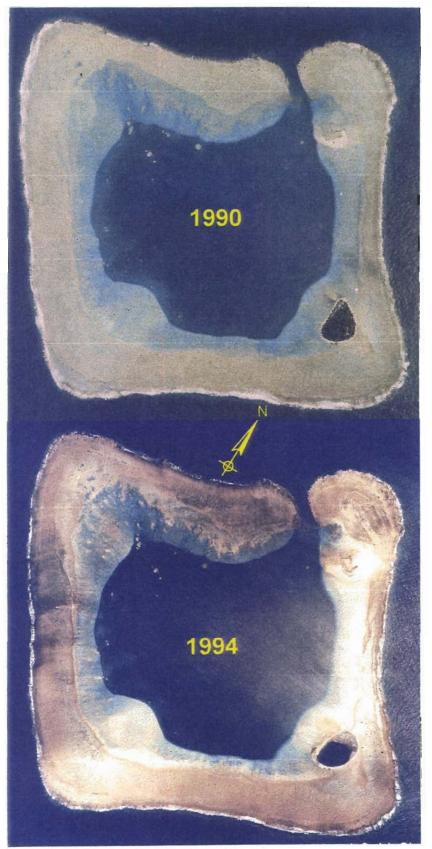
Scientists visiting the atoll two to three weeks after the grounding noticed two obvious changes in the algal communities at the wreck site. First, a large area of bleached coralline algae was observed over a distance of 650 m along the outer reef flat and reef margin on the southwest arm, suggesting that there had been a massive die-off of crustose coralline algae over a large area at the wreck site (Molina 1994). Six weeks after the grounding, it was noticed that this zone of bleached

Fig. 19 Aerial photographs of Rose Atoll prior to and one year after the ship grounding in 1993. Note uniform coloration of the reef flat in 1990 (green color due to high tide) contrasted with large patches of dark algae on the reef margin and reef flat in 1994.

Second, the scientists noticed that filamentous cyanobacteria⁵ (blue-green algae), usually uncommon on the atoll, had become established in reef depressions along 700 m of the reef flat on the southwest arm (from 200 m southeast to 500 m northwest of the wreck) in the weeks following the grounding (Molina 1994). At that time the densest patches of cyanobacteria were observed closer to the wreck site (from 190 m southeast to 500 m northwest of the wreck: Molina 1994). Several months to a year later (March 1994 and April 1995), the cyanobacteria bloom had spread along the entire southwest arm of the atoll, although it was most concentrated within a 150 m wide band across the reef flat and adjacent lagoonal habitats at the wreck site (Fig. 19: Flint and Craig 1995, Molina 1995). The cyanobacteria were also present on the northwest arm, but tended to be less dense and more restricted in distribution (Flint and Craig 1995, Molina 1995, Fig. 19).

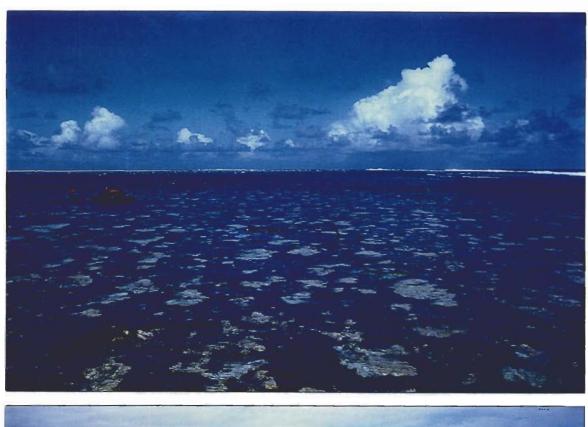
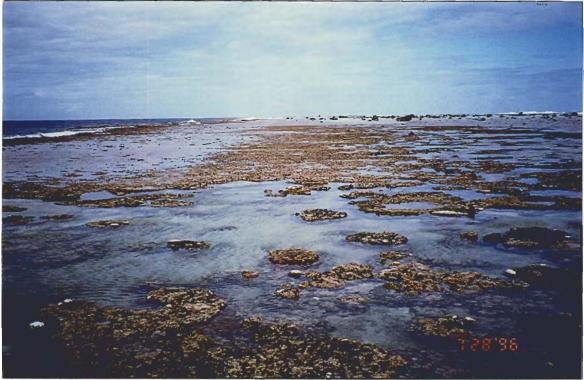
The algal communities on the southwest arm have changed dramatically as a result of the grounding. By 1995, it was apparent that the previously dominant crustose coralline algae were no longer abundant on this arm (0-35% cover: Fig. 21), and that they had been replaced by opportunistic species. At that time, the dominant algae on the southwest arm were a mixed community of cyanobacteria species and a finely branched, turf-forming coralline alga, *Jania adherens*, which together accounted for up to 90% of the cover (Fig. 21). The *Jania*, like cyanobacteria, is usually rare on the atoll, and became abundant on the southwest arm sometime between March 1994 and August 1995. As a result of this change in the algal communities the reef flat on the southwest arm had changed from pink, the color of healthy crustose coralline algae, to black, the color of the mixed cyanobacteria community (Figs. 19 & 22). This pattern was most pronounced on the outer reef flat (Figs. 22).

Figure 22 Reef flat adjacent to wreck site showing dominance of dark opportunistic algae (cyanobacteria and *Jania adherens*) six months after the grounding (top) and healthy reef flat on southeast arm of the atoll showing typical dominance of pink crustose coralline algae (bottom).

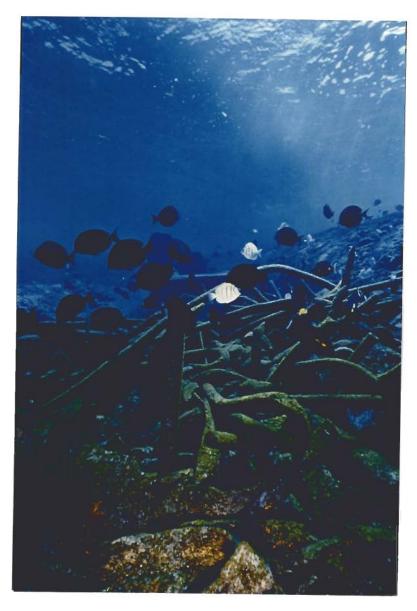
Figure 32 Herbivorous surgeonfishes (*Ctenochaetus striatus*, *Acanthurus triostegus*, and *Acanthurus olivaceus*) around the wreckage on the outer reef slope.
