**Phase Two Survey and Inventory of Submerged Cultural
Resources in Portions of Maloelap Lagoon, Republic of the
Marshall Islands**

July 6-13-2003

**Final Report
March 2007**

**Submitted by
Suzanne S. Finney
Supervising Archeologist**

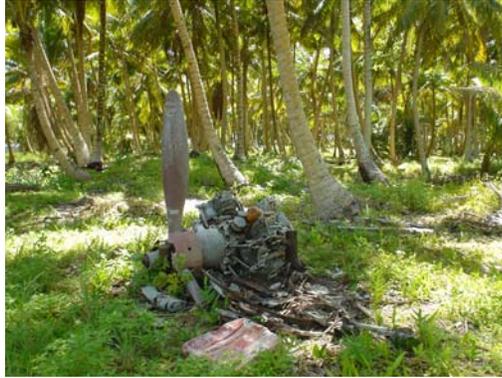
Figure 3. Aircraft debris from Japanese airbase, Taroa

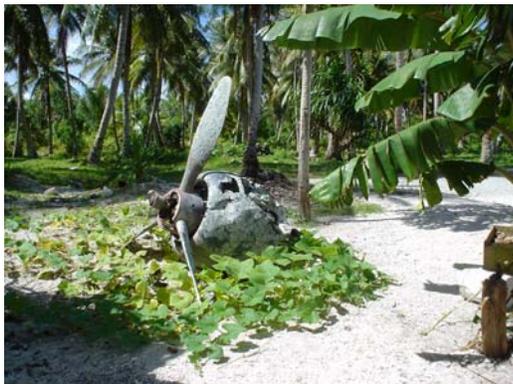
Figure 4. Aircraft debris on Taroa

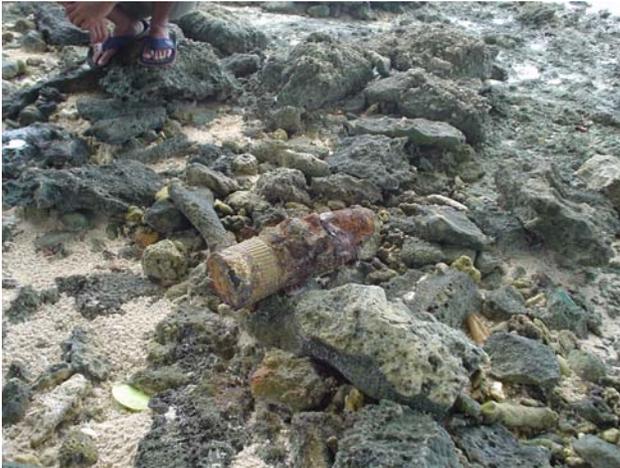
Figure 5. Example of unexploded ordnance at Taroa, photographed in July 2003

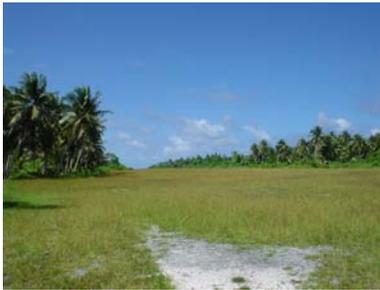
Figure 7. Japanese airstrip, now used as modern runway

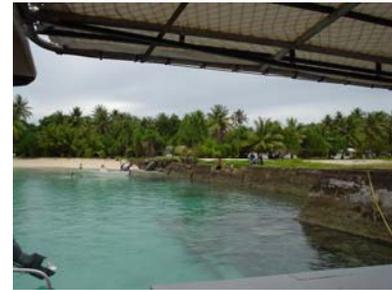
Figure 9. Section of Japanese era pier, deteriorating but still in use today

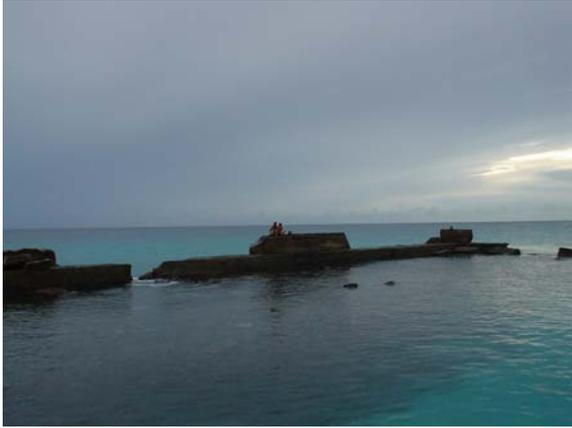
The pier is in a state of disrepair, dating all the way back to World War II when it was bombed by the U.S. over the course of several months. Bomb damage and the resulting erosion have resulted in deterioration. There have been attempts to refill the pier but without repair of the supporting wall the interior continues to erode.

Figure 11. Outer wall of pier, Taroa. Note the extensive deterioration of sections

features and artifacts that are unique to a significant event or period of time. Caution should be noted, however, as it is important to gain the support of the local population prior to the nomination of any significant portion of the island or surrounding shoreline or near shore sites. Many people equate historic properties with an uncompromising series of regulations prohibiting the improvement or renovation of such sites. In the case of Taroa Island plans were underway for the rebuilding of the pier during the period of the survey in 2003, although it is not known at the time of this writing whether any repairs had been completed. This was not the first time the pier had been filled in according to local sources. However, erosion caused by the deterioration of the external wall eventually leads to the weakening of the interior repairs and the pier begins to fall apart again. If the pier were to be nominated to the NRHP, funds may then be available for a more complete reconstruction of the pier, maintaining its historic integrity while giving the people a fully operational pier.

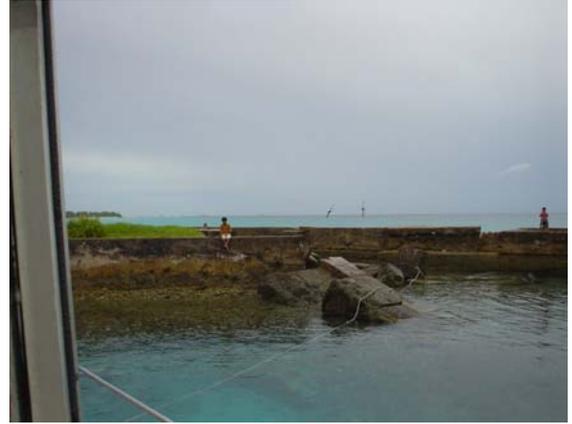
There is a possible anti-aircraft gun in pieces embedded in a damaged section near shore. There is so much damage to this area that it was not possible to clearly determine exactly what was there. The lagoon side wall is completed with concrete blocks of a style one local informant indicated was common Japanese construction. Small concrete blocks were put in place to form the base, then larger blocks put on top and filled in to form the pier. The blocks were formed so that two men could carry them slung between them and easily manipulate them into place. Further investigation into this type of engineering construction is warranted. This pier is known locally at the “Japanese pier,” and is generally estimated to have been built by the Japanese prior to World War II. (Figure 11) (Figure 12)

Figure 12. Pier section at Taroa

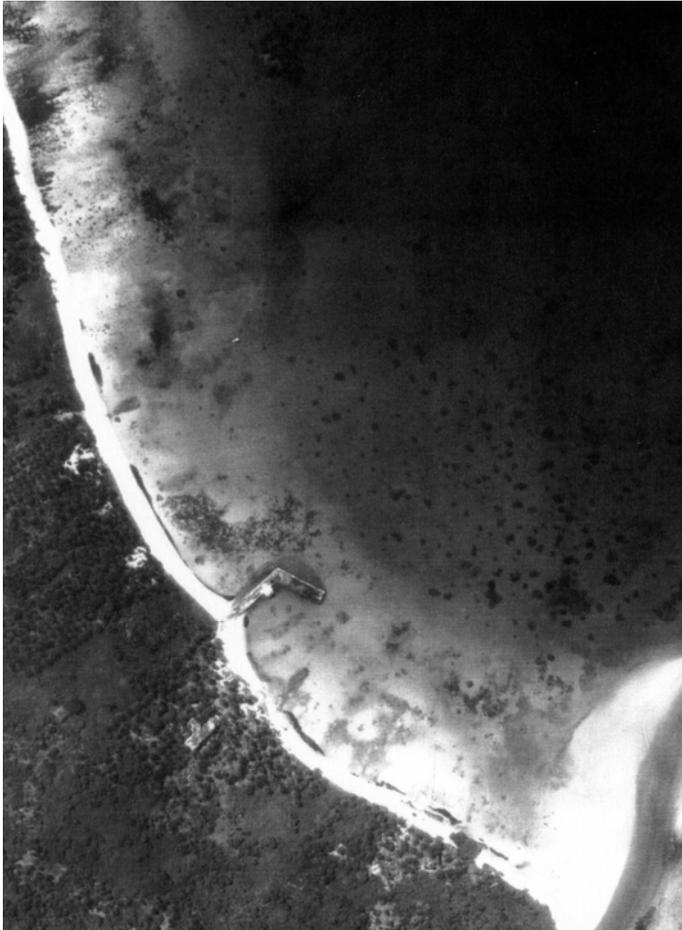
Figure 15. Section of an aerial photograph of Taroa taken in 1976. Although difficult to see, the LCU appears to be along the beach below the pier. [Marshall Islands District, Taroa Flight Line No. 2, Photo 193. From the Trust Territory Archives]

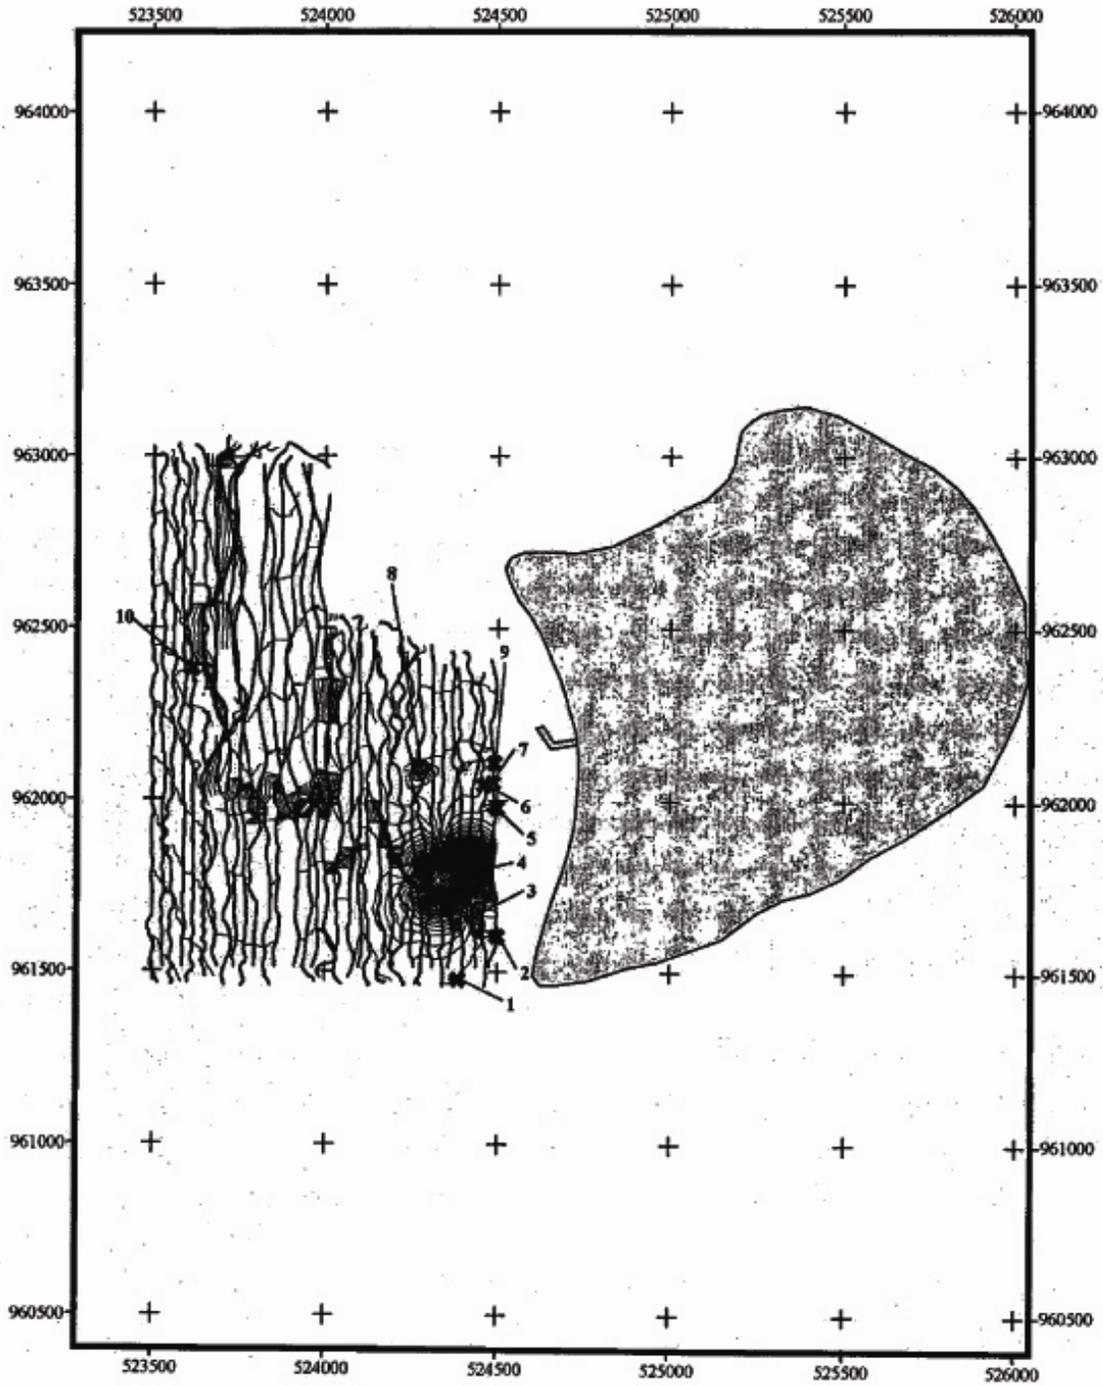
Taroa Survey

Most of the anomalies are in close proximity to MI-MI-004 and are probably associated with that shipwreck. With the exception of the shipwreck the anomalies are not visible on the surface. Because of their size, more intensive searching for these small objects was not recommended due to the strong possibility that these are unexploded ordnance buried under the sandy bottom. Poyer notes that the clean up of Wotje atoll involved 32 tons of mines and 4200 pounds of other ordnance (Poyer 1997:82). Maloelap has not been subject to a comprehensive clean up of ordnance and unexploded ordnance is still visible throughout Maloelap atoll, making the search for small anomalies under the surface potentially hazardous.

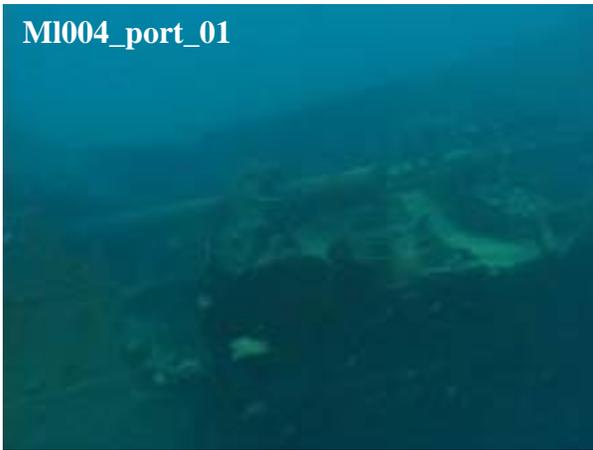
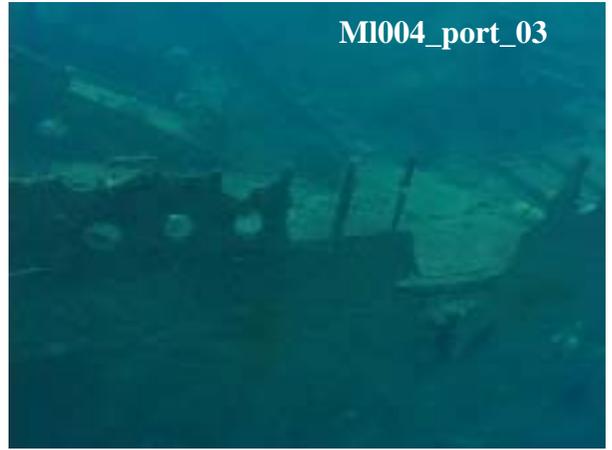
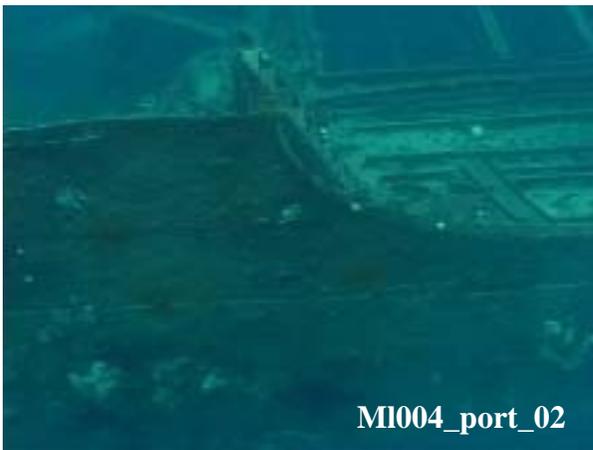
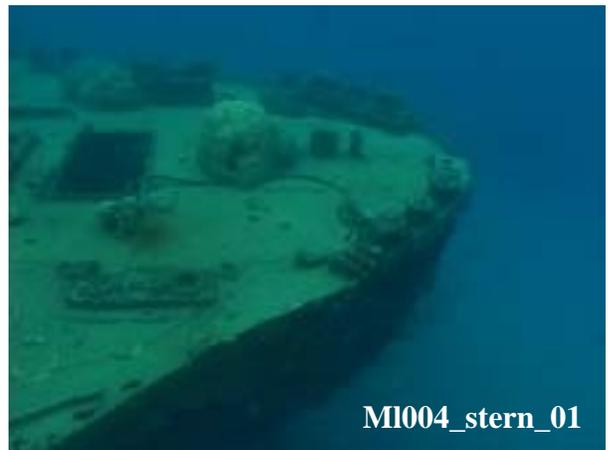
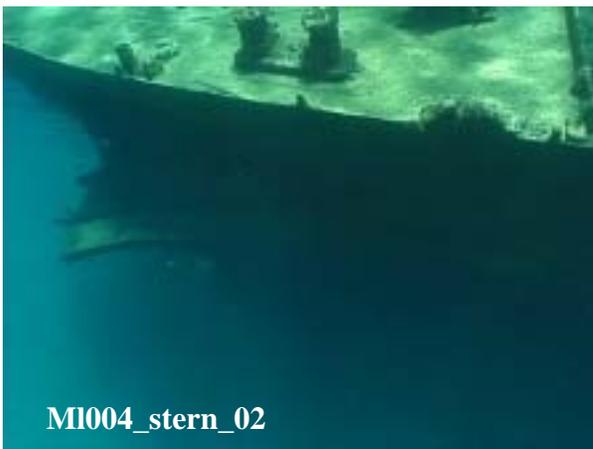
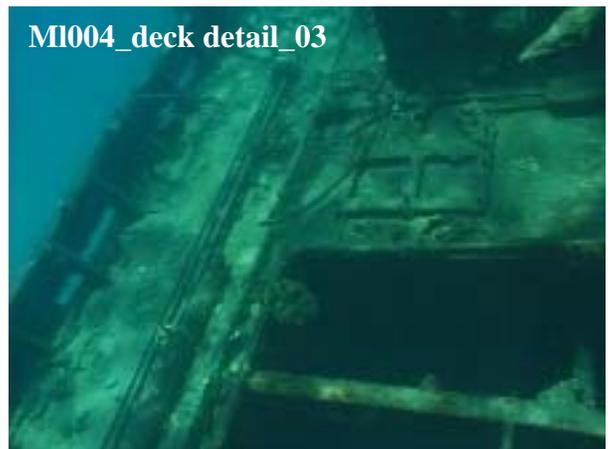
RMIHPO #MI-MI-004

This site is located directly off the beach at Taroa Island, parallel to the pier, and is a steel hulled ship lying upright in shallow water with a maximum depth of 45 feet (14 meters) at the stern and a minimum depth of 20 feet (plus surface protrusions) (6 meters) at the bow. Dimensions are 61 meters (200 feet) in length, 9 meters (30 feet) beam. The ship leans slightly to the port and the hull is largely intact except at the bow, which is torn almost completely away from the rest of the ship. Damage here is evident and likely caused from an explosion. The propeller (possibly brass) is intact with rudder. Two large holes at the stern also indicate explosions. The ship is visible from shore due to two masts still attached to the ship that rise above the water.

Information from Bartsch (1986) and Adams et al (1997) indicate that the damage to the hull is from the 1970s demolition of the ship, resulting in the removal of much of the superstructure. It is hard to tell if this was indeed the case. Adams et al (1997:48) explains the demolition as necessary to remove old explosives in the cargo holds, yet the visual evidence from 2003 does not appear to support this. The cargo interiors appeared relatively intact.

meters (322 square feet). The survey team identified an iron mast, windlass, rudder, anchor chain still in the anchor locker, hawse pipe, a section of the bow and a section of the stern. No anchor was found. The hull is riveted and a nameplate on one beam reads “Danver.” The chain is stud linked, a design manufactured beginning in the 19th century. There is no evidence of a propeller or engine.

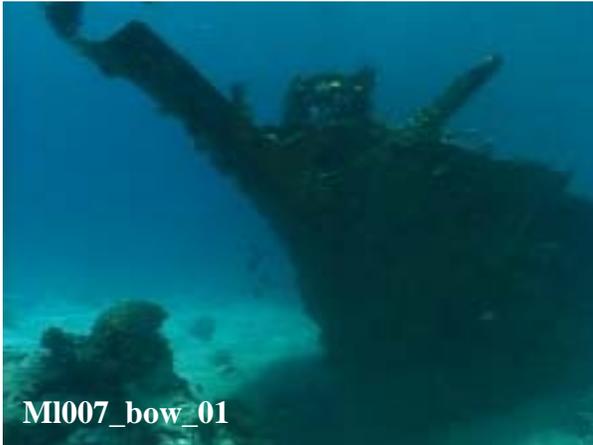
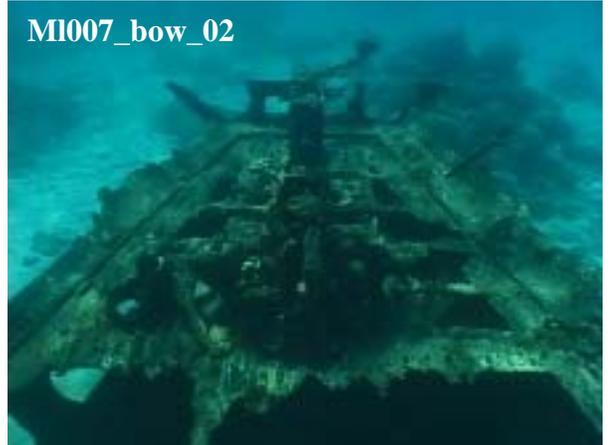
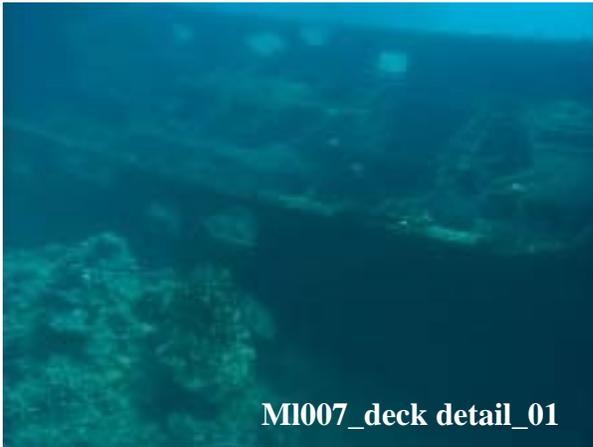
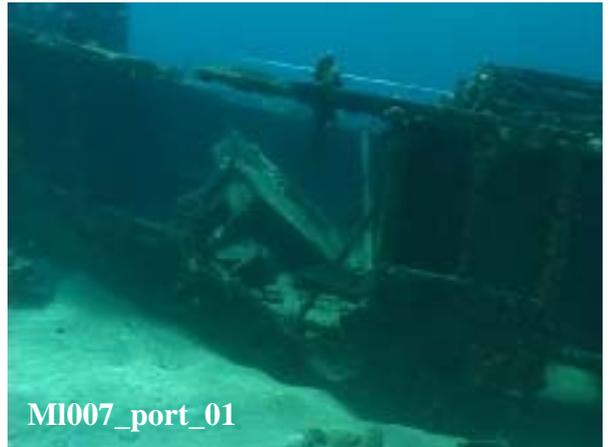
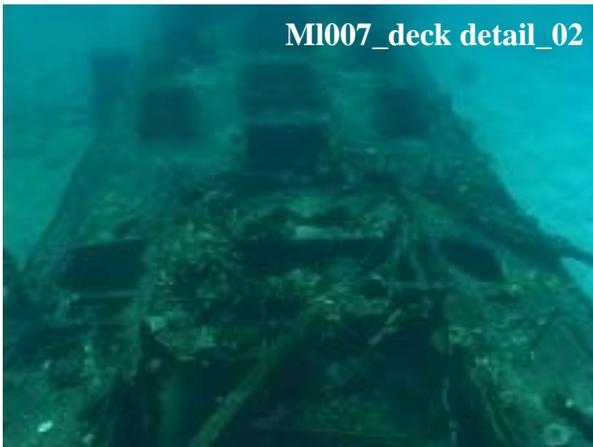
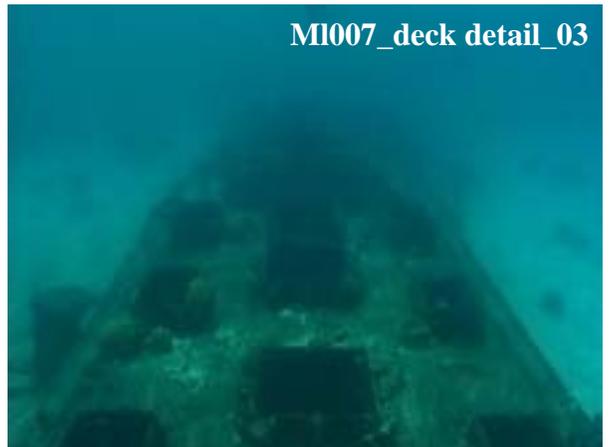
RMIHPO #MI-MI-007

MI-MI-007 is a steel hulled ship 29.5 meters (96 feet) in length (31 meters to bowsprit) and 5.8 meters (19 feet) in beam. It lies upright on a sandy bottom on a slight slope with the bow facing the shore. Maximum depth is 17 feet (5.1 meters) at stern; minimum is 13 feet (4 meters) at the bow. The wreck is in good condition with some coral encrustation, loose debris on deck and in holds. There is no local name for this wreck. It appears to be another merchant/cargo ship circa World War II. Based on historical information we suspect this is a Japanese merchant ship that was sunk either by the regular American bombardment in 1944-1945 or possibly scuttled by the Japanese. There does not appear to be much damage to the hull, as one would expect from a bombardment.
