SUAVA ECONOMIC GROWTH CENTRE GEOTECHNICAL REPORT

SEPTEMBER 12th 2021

**Ministry of Commerce, Industry, Labor and
Immigration (MCILI)**

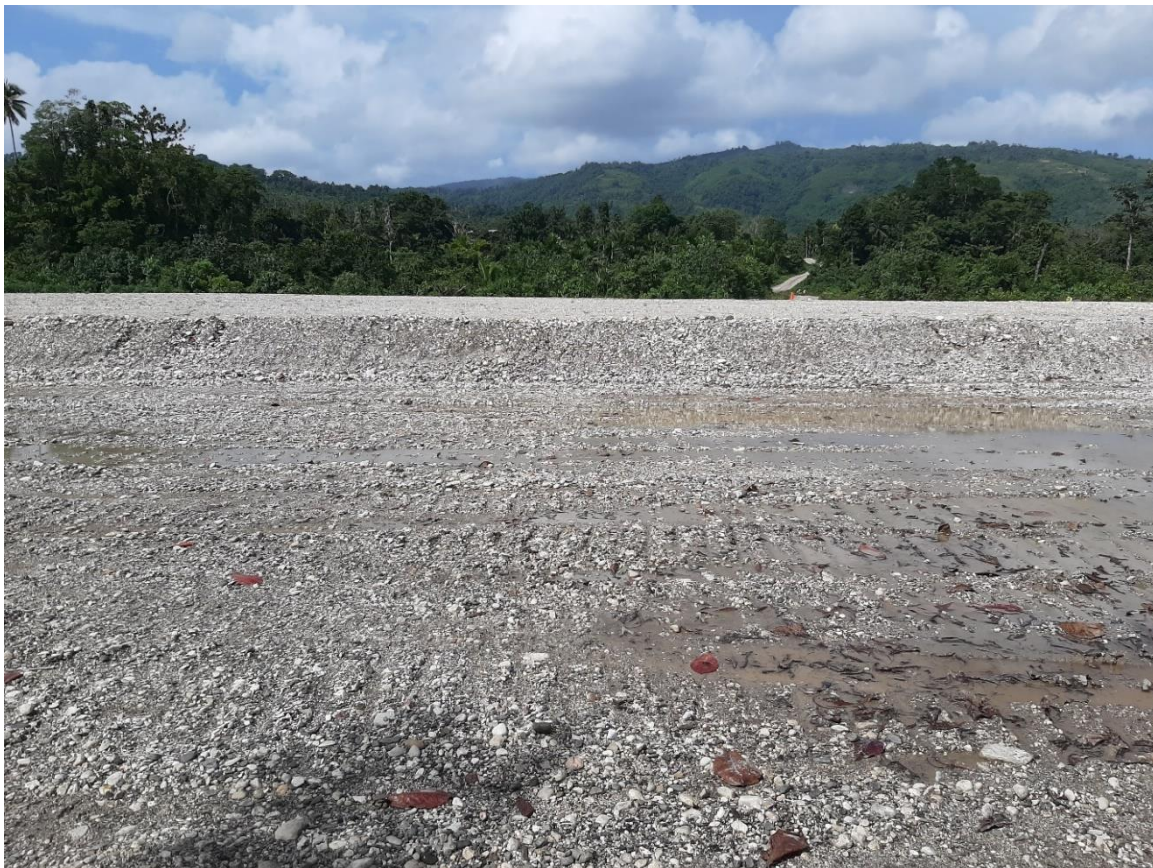
Fig 1, Backfill area proposed for the development

Earthworks is progress on site maintaining the access road and backfilling one sector of the prime site which connect to the beach (see fig 1). The reclaimed area was estimated about 200m x 50m x 2m, this section is situated at the coast and proposed for the current development. Other areas within the site are yet to developed and constructed. From our assessment and understanding the development will consist of normal foundation light structures such as, market stalls, canteen, etc, although no concept plans or foundation drawings are provided, see figure below the current site for construction.

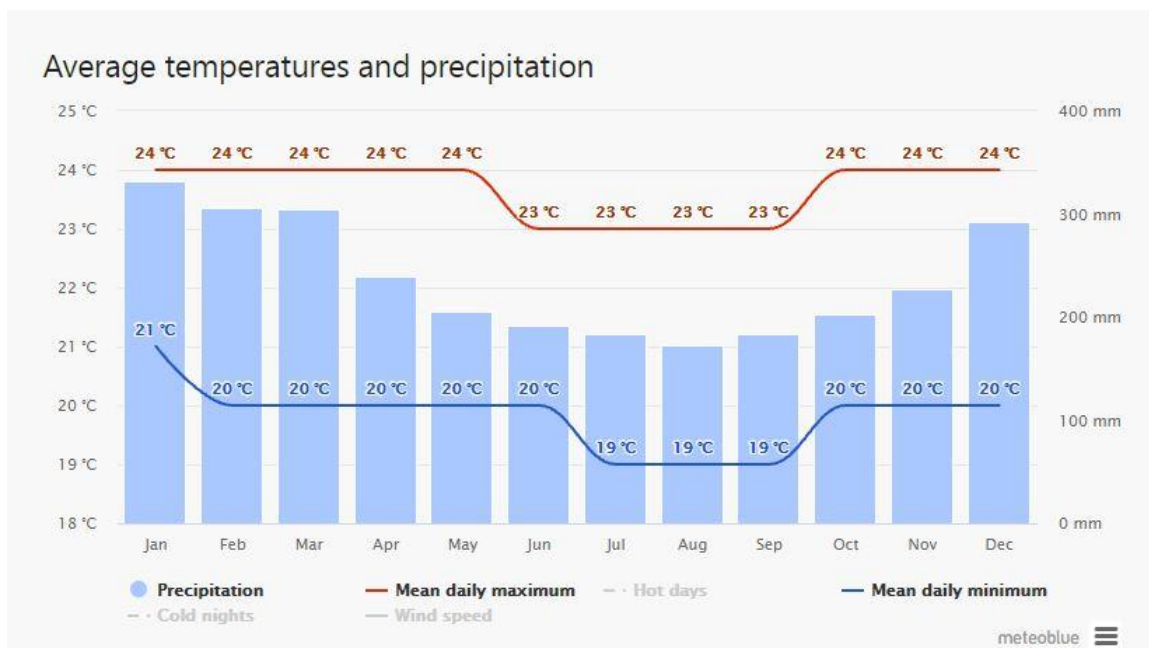
Fig 2, Average climate condition for North Malaita

Suava Bay is located in the heart of North Malaita where the climate is extremely wet. It also lies in the Intertropical Convergence Zone (ITCZ) where the trade winds of the Northern and Southern Hemispheres come together. The intense sun and warm water of the equator heats the air in the ITCZ raising its humidity and making it buoyant. Below shows a Graph depicts of the recent Average temperature and Precipitation for North Malaita extracted from a Meteoblue. Earth works and construction activities on site must consider the weather pattern in order to mitigate and minimise any disruption of work due to effects the climate may cause.

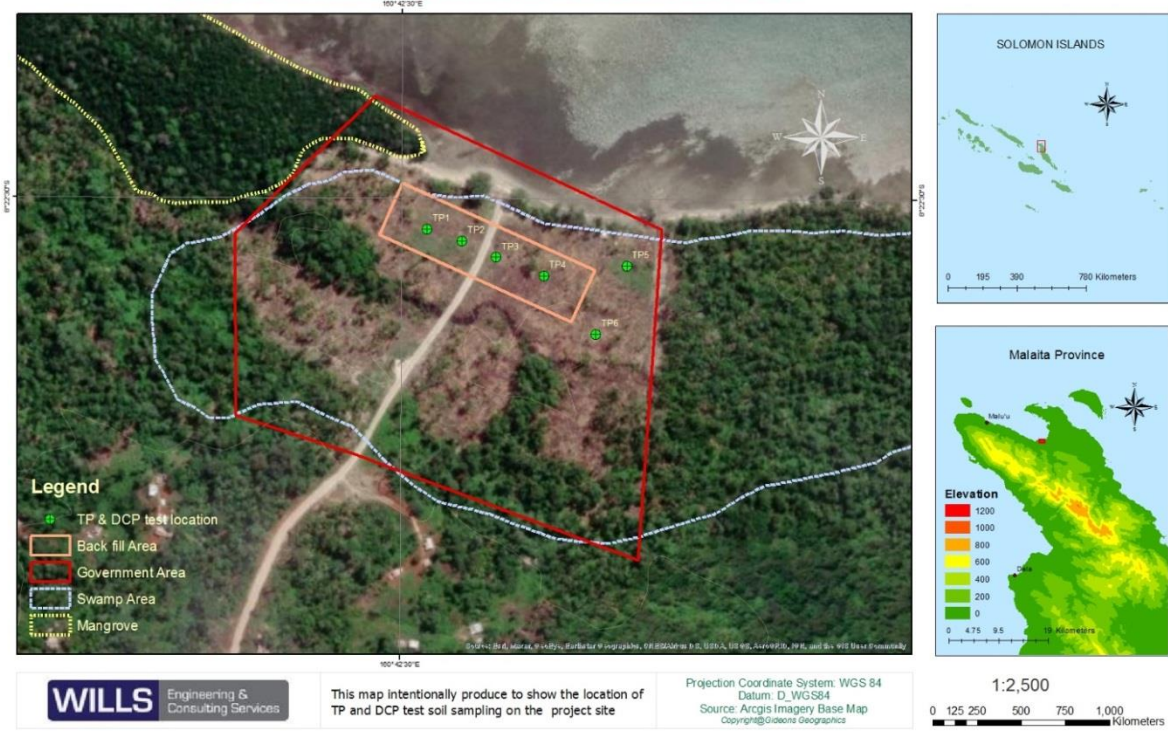
A. Geotechnical Site Location

GEOTECH ASSESSMENT SOIL SAMPLING TEST LOCATIONS

A site walkover and inspection was carried out before actual testing was done. This is to identify test points and spots for testing and assessments within the vicinity. Six test points were located and marked along building footprints and sites that are anticipated for construction.
