TONGA

MANGO VILLAGE, MU'OMU'A DISTRICT, HA'APAI DIVISION

IMAGERY ANALYSIS: 18/01/2022 PUBLISHED 20/01/2022 V2

Damage assessment in Mango Island, Mu'omu'a district, Ha'apai division, Tonga as of 18 January 2022

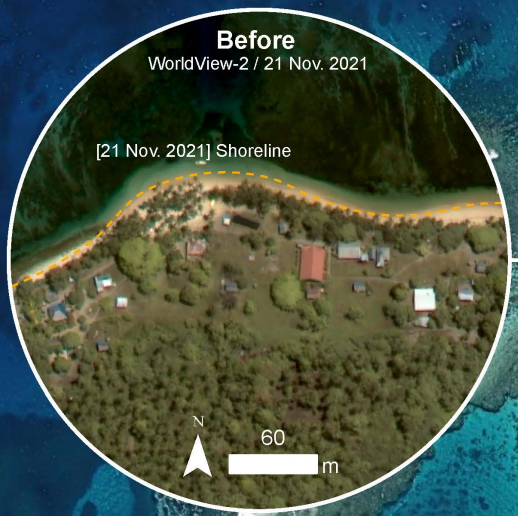
This map illustrates effects of the Hunga Tonga-hunga Ha'apai volcanic eruption in Mango island (Mu'omu'a district, Tonga) and damage assessment as detected from a Komsat-3 image acquired on 18 January 2022, 14:22 local time. In this island, UNOSAT identified 26 structures as damaged and/or destroyed and 1 structure as potentially damaged. The entire island appears to be covered with ashes. This is a preliminary analysis and has not yet been validated in the field. Please send ground feedback to UNITAR-UNOSAT.

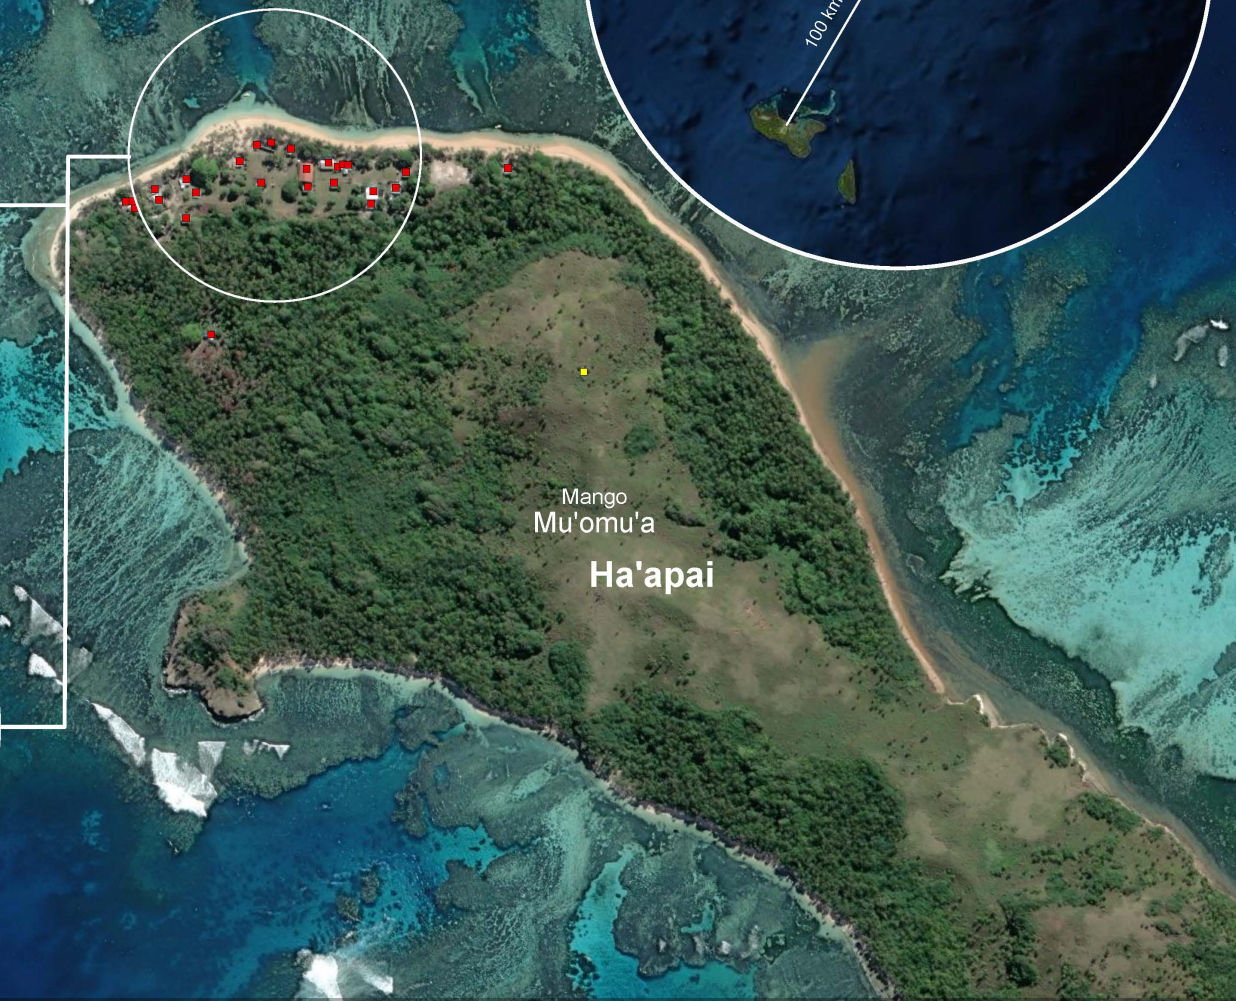
DAMAGED STRUCTURES
26

POTENTIALLY DAMAGED STRUCTURE
1
