Water Quality Test Results

Post TC Gita Water Quality Assessment – ‘EUA

Water Resources Section

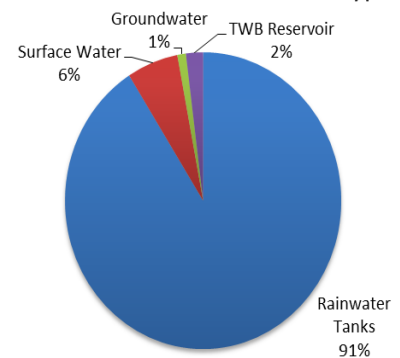
Figure 1 Distribution of water sources by type.

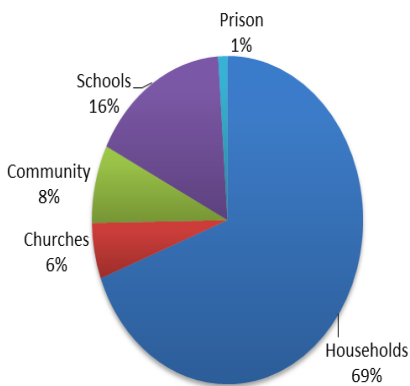
Figure 2 Distributions of Rainwater Sources

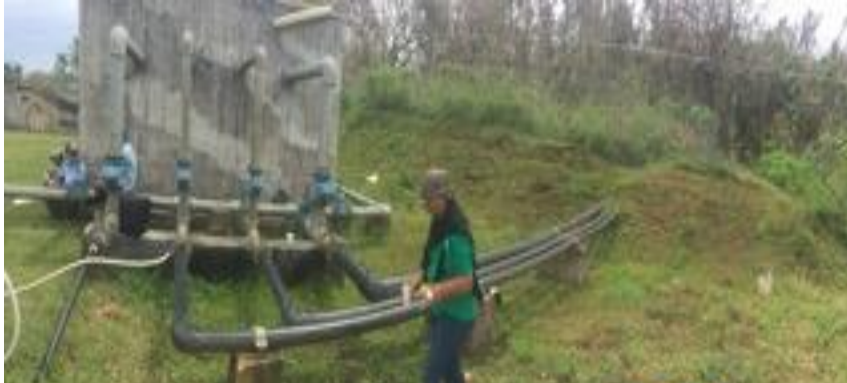
Figure 3 TWB reservoir field. Assistant geologist 'Amelia Sili is standing in front of the individual pipeline from different springs.

Furthermore, the 4 springs Pekepeka, Matavai, Fern Gully and Saoa were sampled at each of the main pipeline that brings water from the springs into the TWB reservoir field in Petani. Again this was due to inaccessible roads.

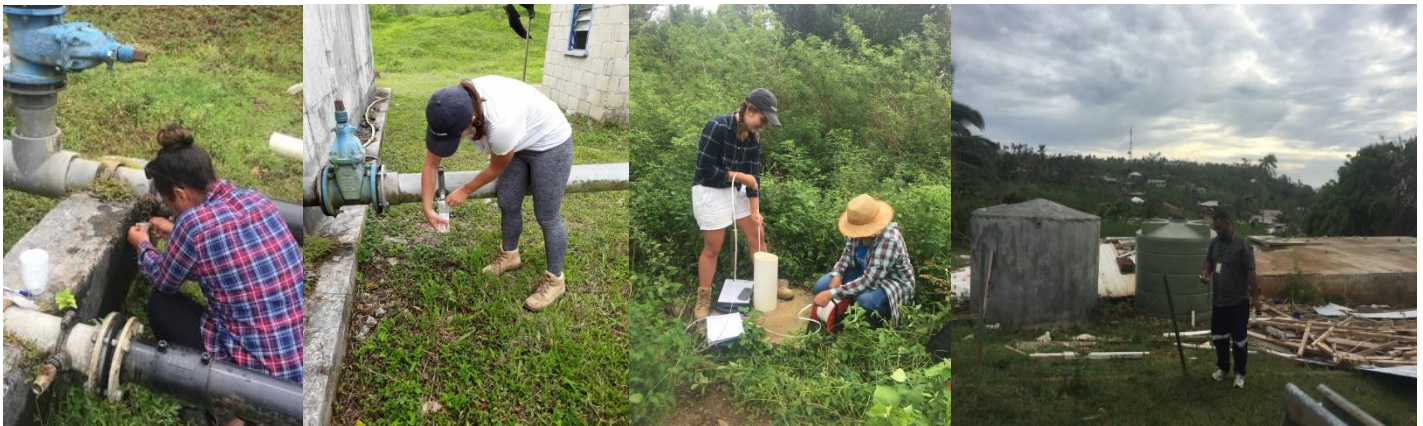
The bore well was monitored using a multifunction dipmeter that measure the temperature and electrical conductivity at different water levels inside the bore well. A sample of water for nutrient and bacteria testing is collected via bailing water up from inside the bore well using a bailer. The pH of bore well samples is taken using a handheld pH meter.

The rainwater catchment and spring samples were first tested for electrical conductivity and pH at the source using a handheld pH meter and EC meter . Global positioning system (GPS) coordinates of each testing site was recorded for mapping.

Figure 4 L-R, Assistant Hydrogeologist Sesimani Lokotui sampling spring water at Tonga Water Board supply pipeline from springs. New Zealand Student volunteer Georgia Crisp is Microbiological sampling at the Tonga Water Board Reservoir, Georgia Crisp and Assistant Hydrogeologist 'Asena Foliaki monitoring 'Ohonua borewell 2, Senior Geological Assistant 'Apai Moala taking GPS coordinates at sites

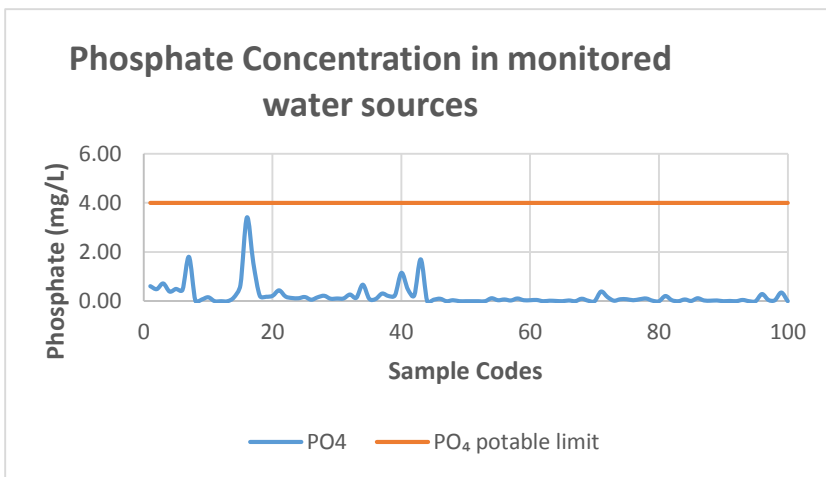
Figure11 - Phosphate concentration in monitored water sources

All monitored water sources tested below the potable limit for phosphates in drinking water sources

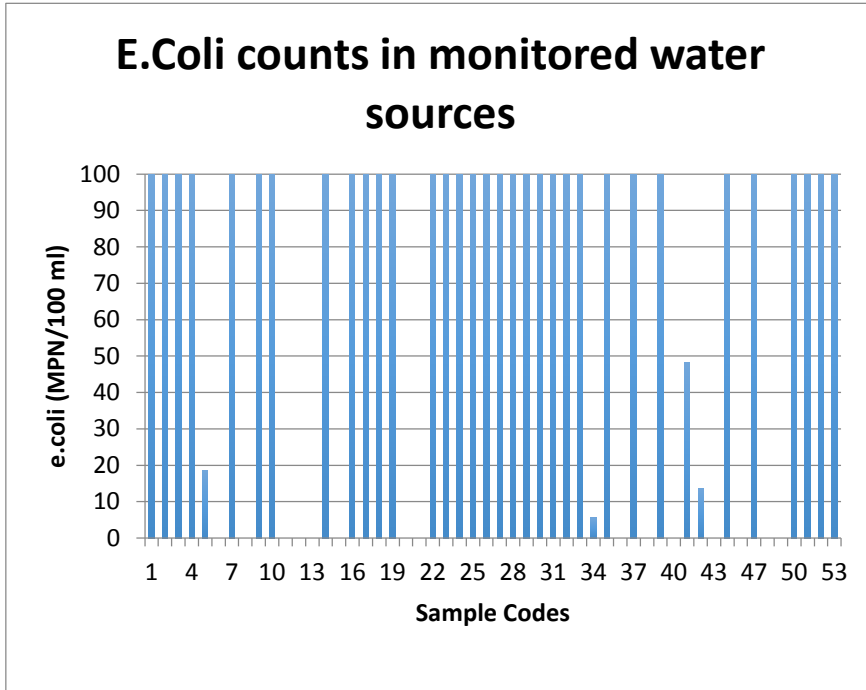
Figure 12. E.coli Counts (MPN/100mL) using compartment bag tests

The first method is called the compartment test bags and was used in 52 sites during the first two days of monitoring and testing. These resulted in E.coli found in 37 sites out of the 46 tested.

Although the E.coli counts are variable, it is from experience that the colony forming unit counts for rain catchment tanks vary between 100-300 cfu/mL in Tonga. This has been attributed to the guttering and catchment tanks conditions. There usually none found in groundwater unless contaminated.
