Assessing vulnerability and adaptation
to sea-level rise: Lifuka Island
Ha'apai, Tonga

B 1: Physical resources
1.2: Groundwater resources assessment

Peter Sinclair, Amit Singh, Quddus Fielea, Kate Hyland, A'pai Moala

Secretariat of the Pacific Community
Suva, Fiji
2014

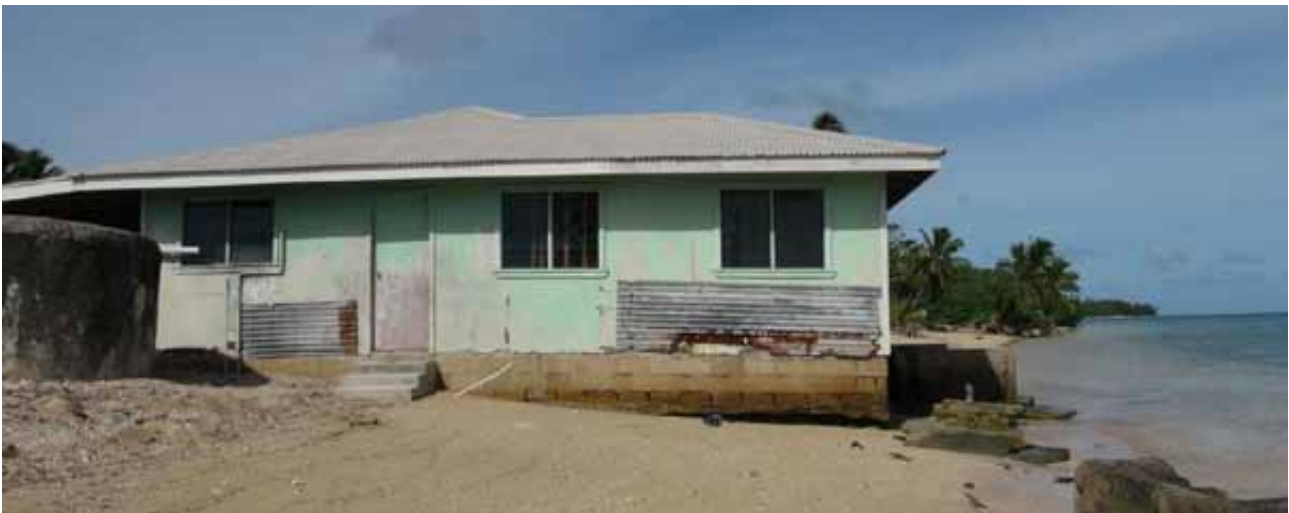
Figure 3: A house that is inundated by waves at high tide

On 3 May 2006 the Ha’apai group experienced a 7.9 magnitude earthquake, resulting in subsidence measured at 23 cm on Lifuka (Cummins et al. 2006). Coastal erosion has greatly damaged infrastructure along the western coastline, including the harbour, residential dwellings, a broadcasting tower, a church and the Lifuka hospital; locals attribute this to the earthquake and subsidence. It has been reported that the coastline has receded between 2 m and 11 m at some specific locations. During daily high tides, some the homes are within 2 m of the water and face inundation during strong on-shore winds (Figure 3).

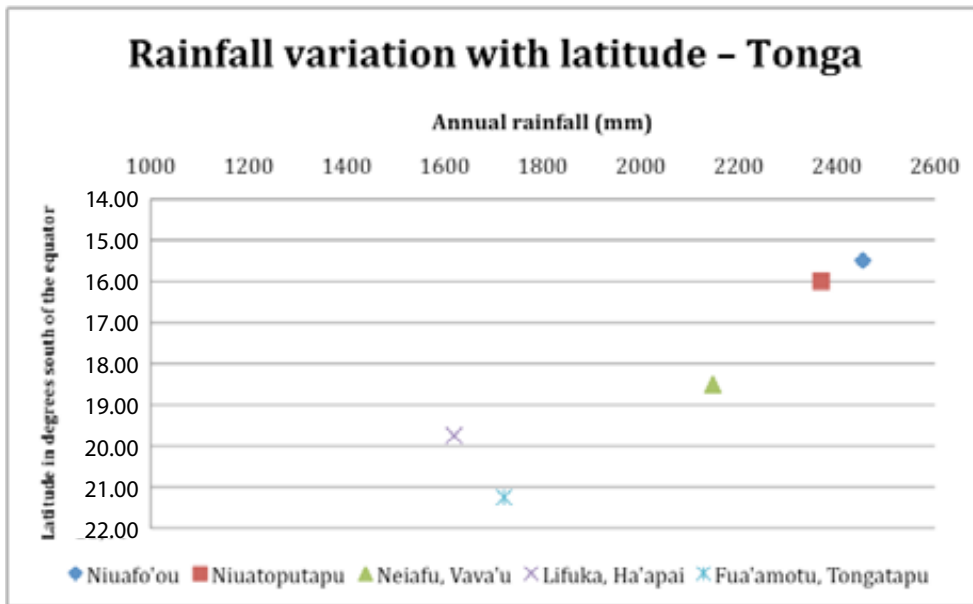
Figure 5: Average annual rainfall for selected stations in Tonga and the variation associated with latitude. Note that Lifuka has the lowest annual rainfall of the stations and is somewhat of an anomaly in an otherwise linear relationship between average annual rainfall and latitude (source: Tonga Meteorological Services, 2013).

The Ha'apai group of islands sits in a relatively dry zone and receives less rainfall than southern Tonga – refer to Figure 5. Rainfall in the islands of the Ha'apai group averages about 1,706 mm per year (1947–2011). The rainfall is variable from year to year, ranging from 826 mm to 2,664 mm. Persistent prolonged periods of low rainfall in Tonga are associated with El Niño events. Drought-like conditions can result, and can be severe if the event is strong. The 1997/1998 a strong El Niño event caused drought conditions that affected Tongatapu and Ha'apai.

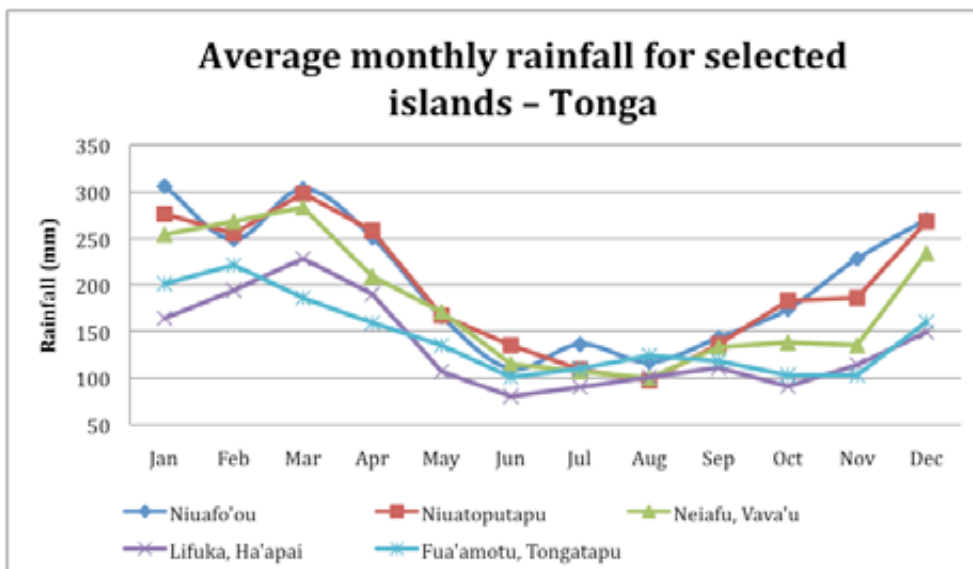
Figure 6: Monthly average rainfall for selected stations in Tonga, 1971-2000 (source: Tonga Meteorological Services, 2013)

Records of average monthly rainfall for different islands in Tonga over a 30-year period (1971–2000), show the pattern and variation of rainfall experienced across the island groups (Figure 5). Note that Lifuka (Ha'apai) has the lowest overall average rainfall and correspondingly some of the lowest monthly averages, indicating that it sits in a rain shadow relative to other locations in Tonga.

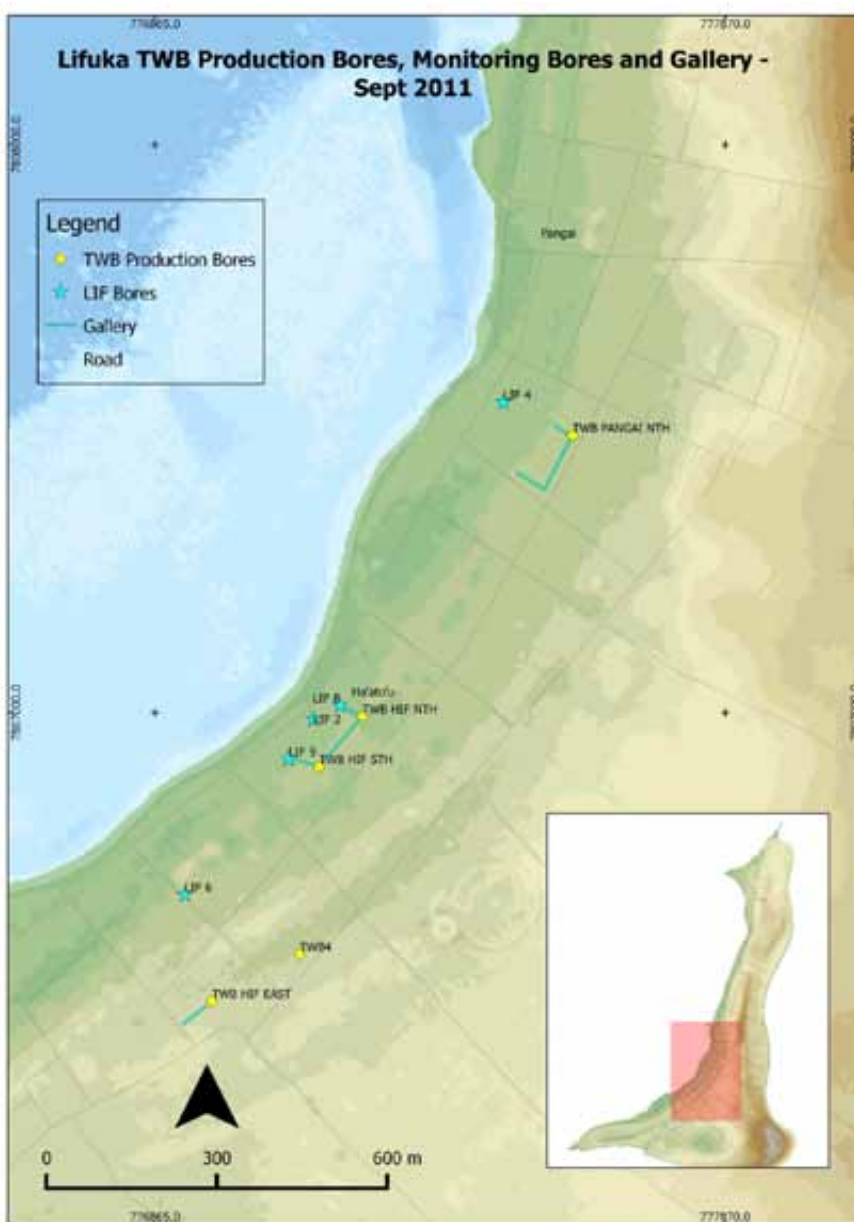
Figure 7: Location of TWB production bores and galleries and LIF salinity monitoring bores

TWB has four sites constructed and equipped to abstract groundwater. Horizontal galleries are found at the Pangai North, Hihifo North (both located in rugby fields), and Hihifo East sites, and a well is located near Hihifo at a site referred to as TWB4. Locations are shown in Figure 7.

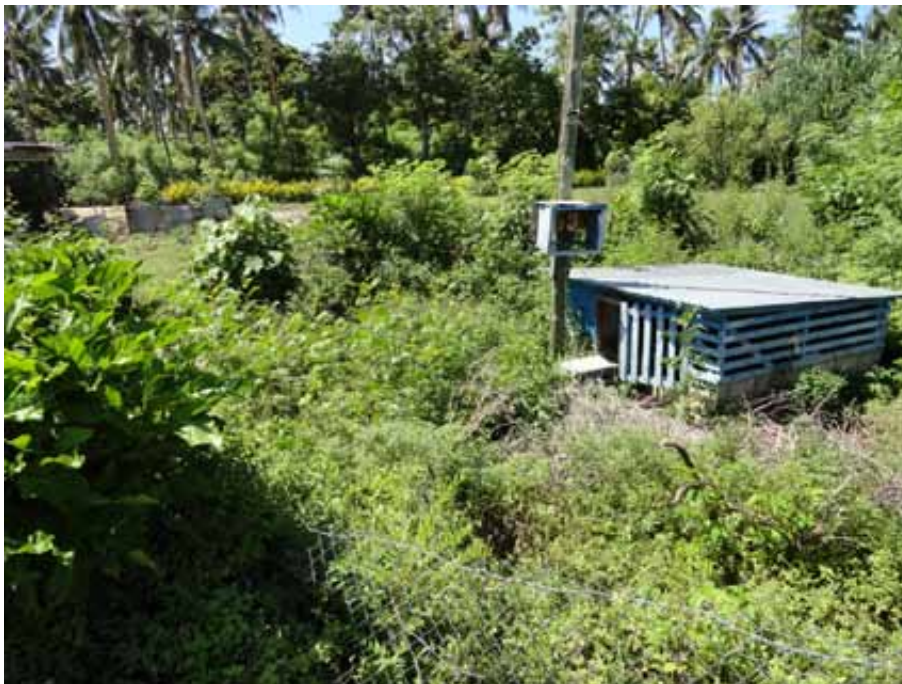
Figure 8: TWB production well, TWB4, in Hihifo

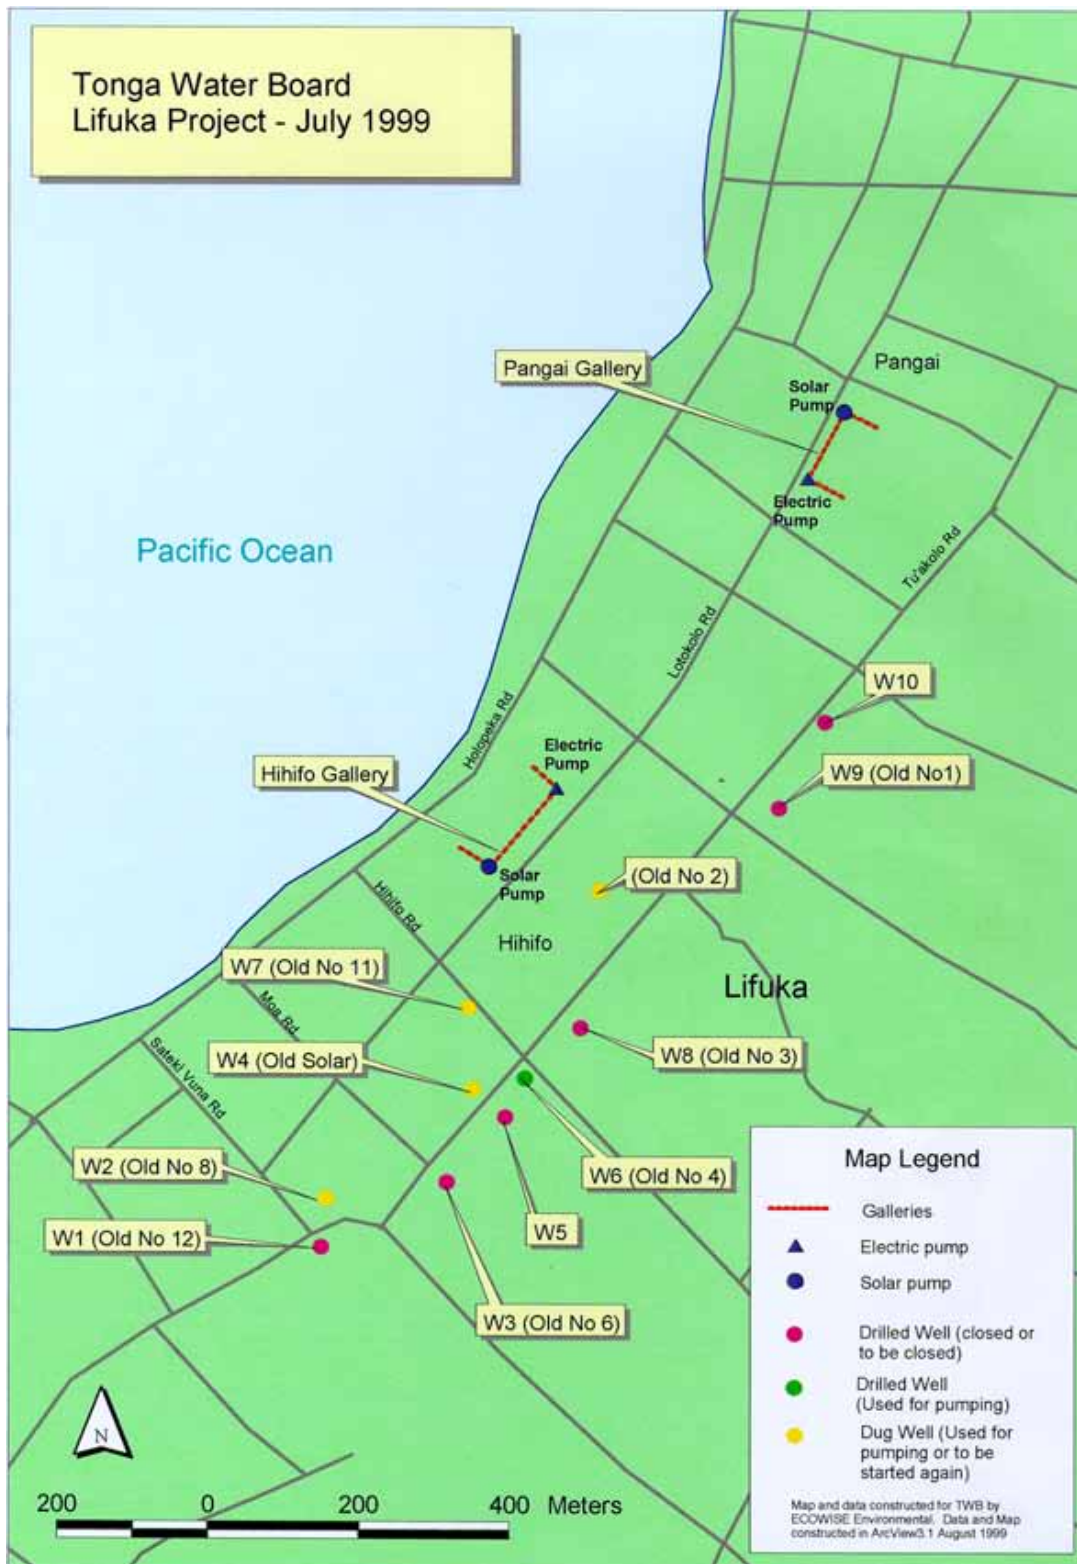
Figure 10: Location of old and new production wells and galleries (Falkland 1999)

Falkland (1997, 1999) undertook further groundwater investigations, confirming the freshwater lens and its potential as a water supply, which resulted in a water supply improvement project in the late 1990s. This included the construction of two 200 m-long, 4 m-deep U-shaped infiltration galleries at Pangai and Hihifo and the installation of nine monitoring bores for salinity monitoring (Turner 1998).

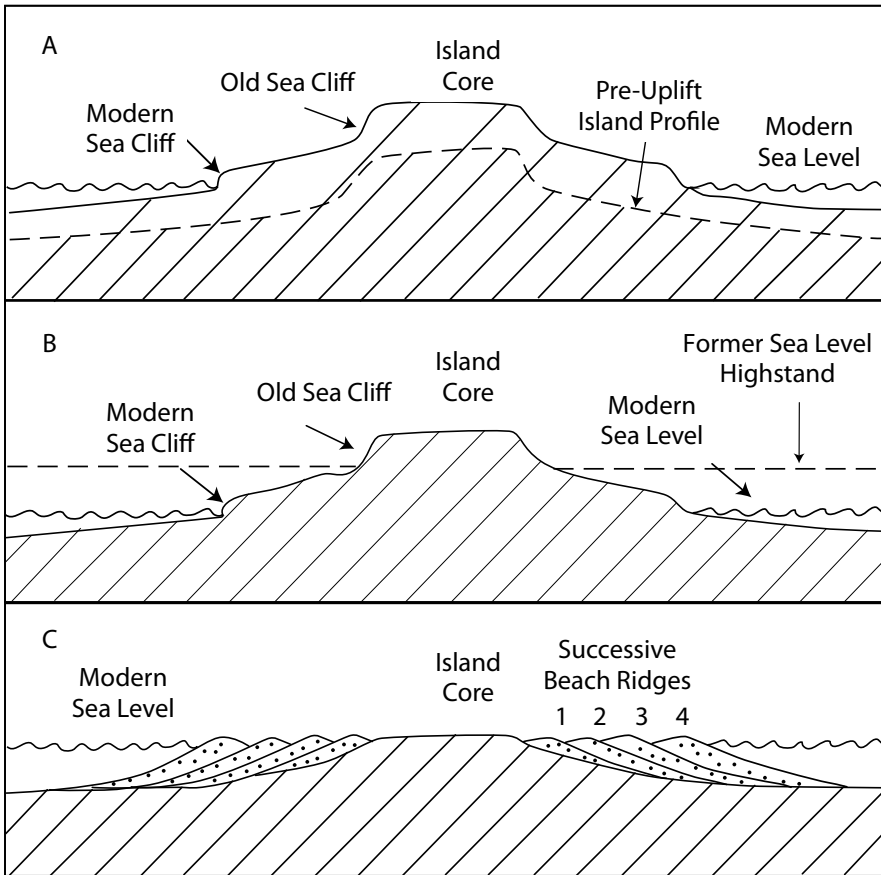
Figure 11. Schematic of potential geologic processes proposed by Dickinson et al. (1994). A and B indicate uplift and relative sea-level decline, resulting in an exposed old sea-level bench and an erosive exposed reef flat (Holocene). C indicates accretion with or without sea-level change. It is suggested that this model of tectonic uplift and subsidence with relative changes in sea level would help account for the geology and the accretion of the sediments in the western portion of Lifuka.

Dickinson et al. (1994) propose a model of uplift, erosion and sea-level changes to account for the erosive and accretionary geological setting found on Lifuka. A conceptual diagram of the processes proposed by Dickinson et al. is presented in Figure 11.

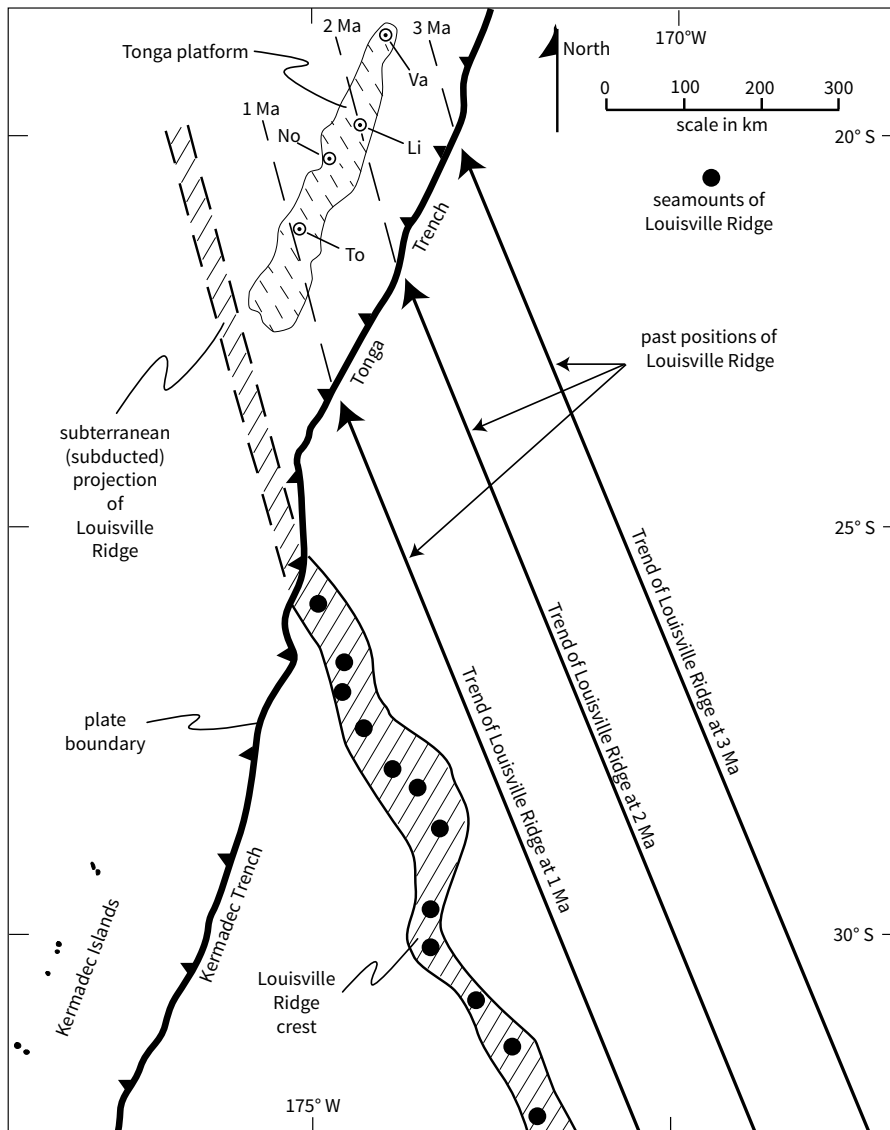
Figure 12: Relation of forearc uplift of Tonga platform to subduction of Louisville Ridge at Tonga Trench, proposed by Dickinson and Burley 2007. Selected islands and estimated timing of their uplift due to subduction of Louisville ridge. Va = Vava'u; Li = Lifuka; No = Nomuka; To = Tongatapu (Dickinson and Burley 2007).

Dickinson and Burley (2007) provide a model in which the estimated uplift of the islands along the Tonga platform took place in response to the subduction of the Louisville Ridge. It suggests that uplift of Lifuka occurred about two million years ago (Ma) (Figure 12).

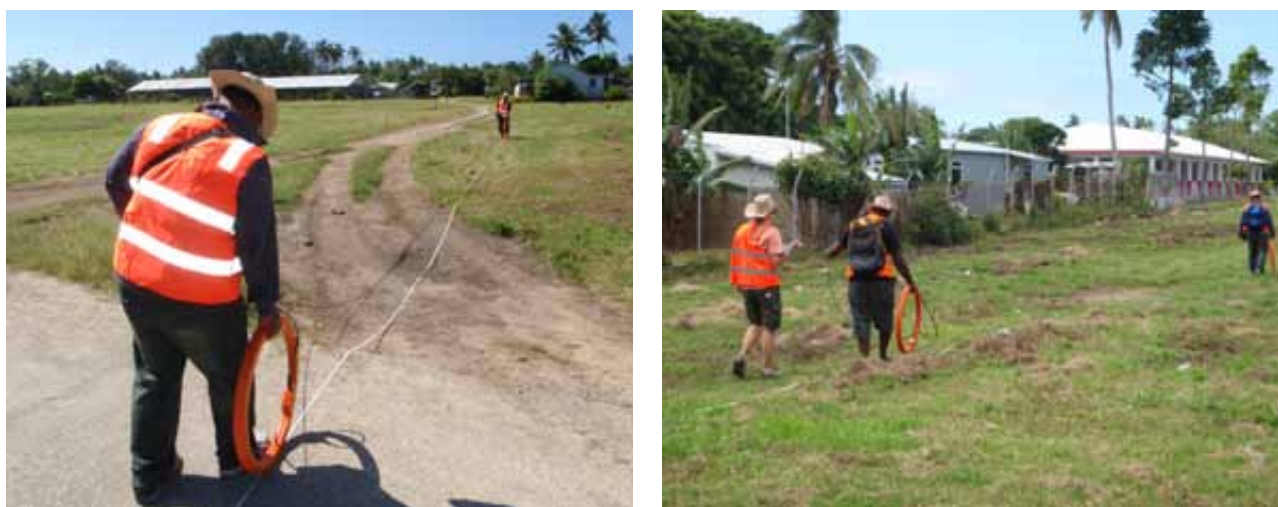
Figure 17: EM transect across the Hihifo oval (left) and across the Pangai rugby field (right).

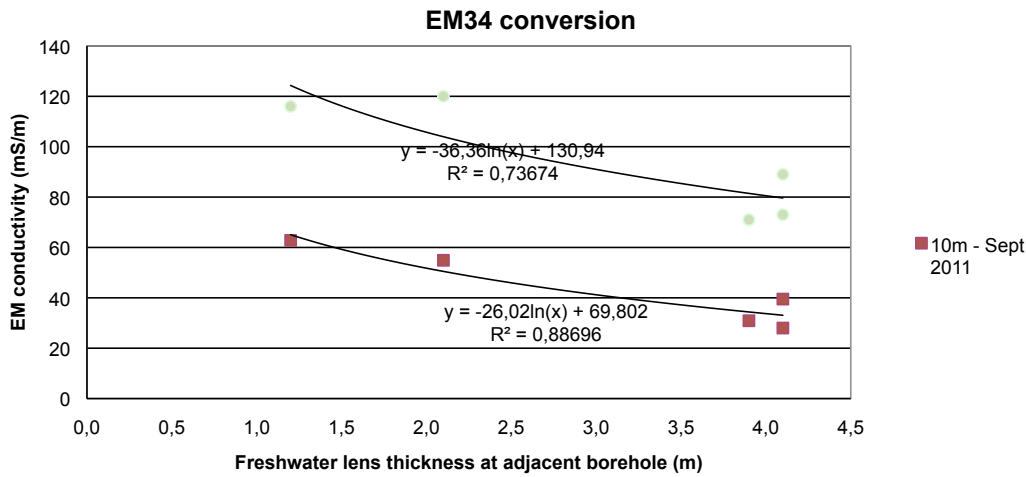
Figure 18: Relationship between EM readings (mS/m) and freshwater lens thickness (m).

Figure 18 plots the points, curve and the equation of best fit to the data (using logarithmic relationships). The (R^2), measure of the ‘goodness of fit’, is also shown for each spacing. The curve for the 10 m coil spacing gives a better fit to data than the curve for the 20 m coil spacing data, as shown by the R^2 values of approximately 0.89 and 0.74 respectively.

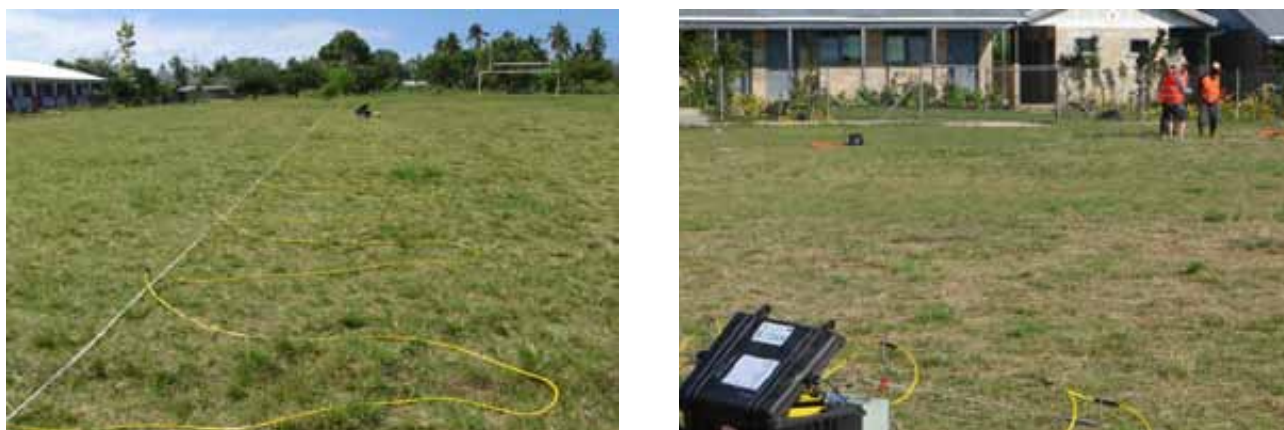
Figure 20: Resistivity surveys on Pangai rugby field (left) and Hihifo oval (right)

The spacing between electrodes for the five surveys was 1.5–2.0 m (Figure 20). Dipole–dipole arrays were used and results were calibrated against available monitoring bores where possible.

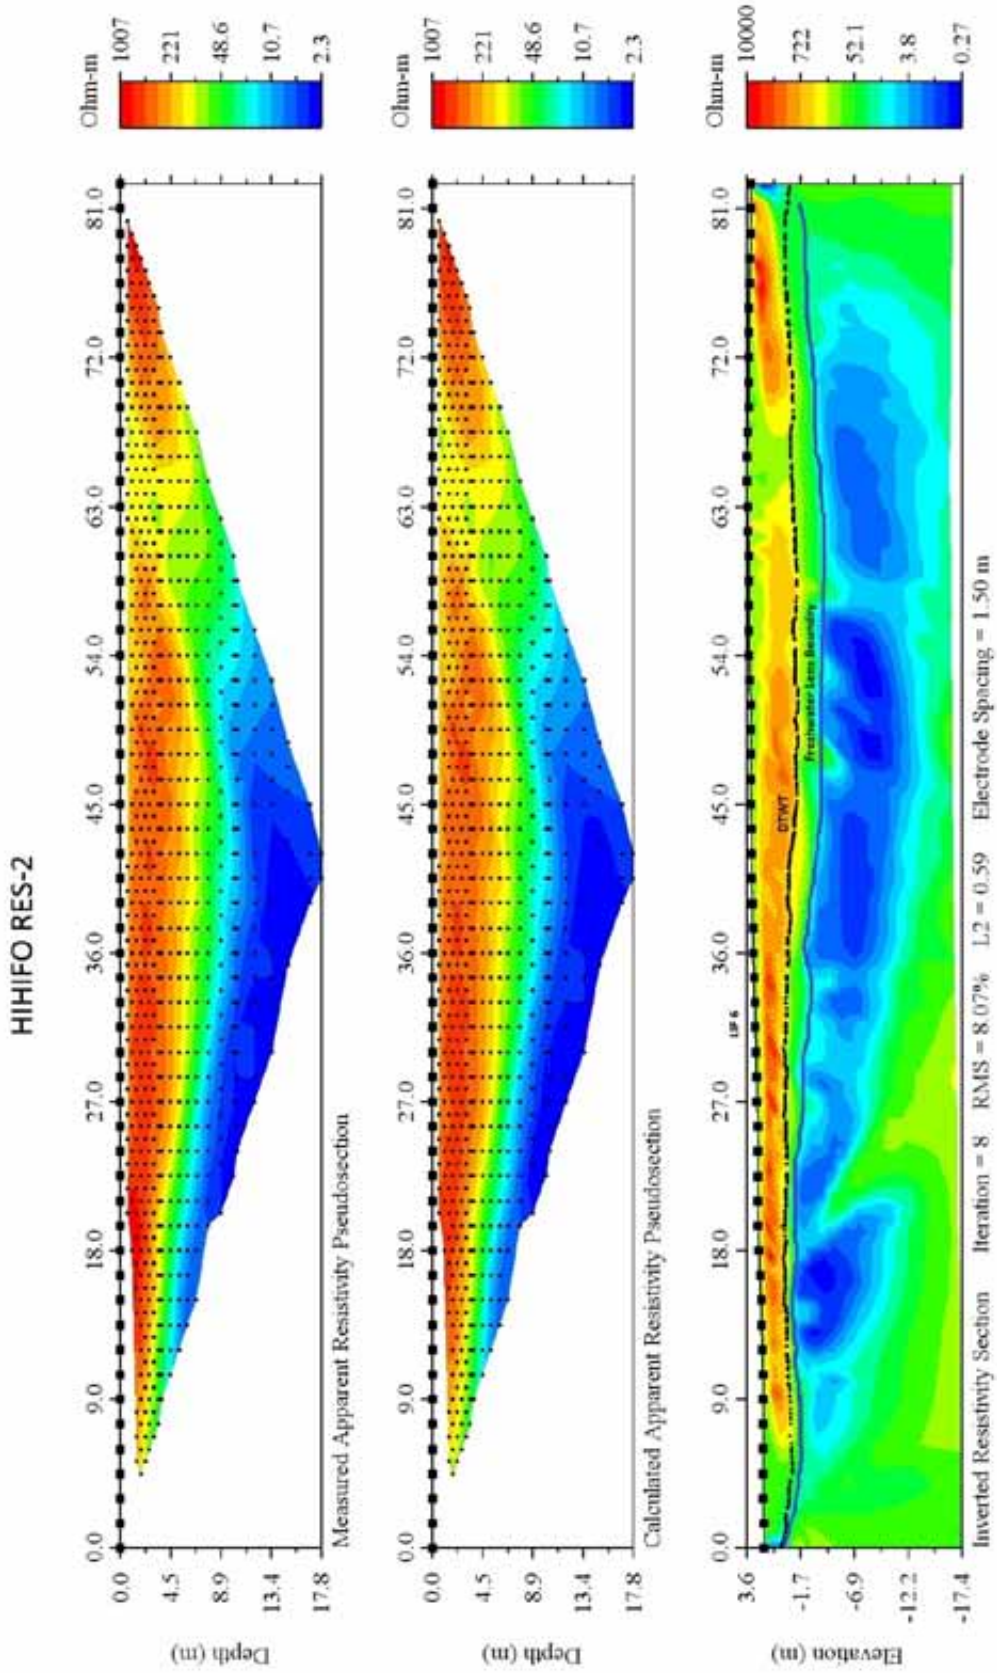
Figure 22: Resistivity profile Hihifo Res 2. The freshwater lens is wedge-shaped, thickening westward.

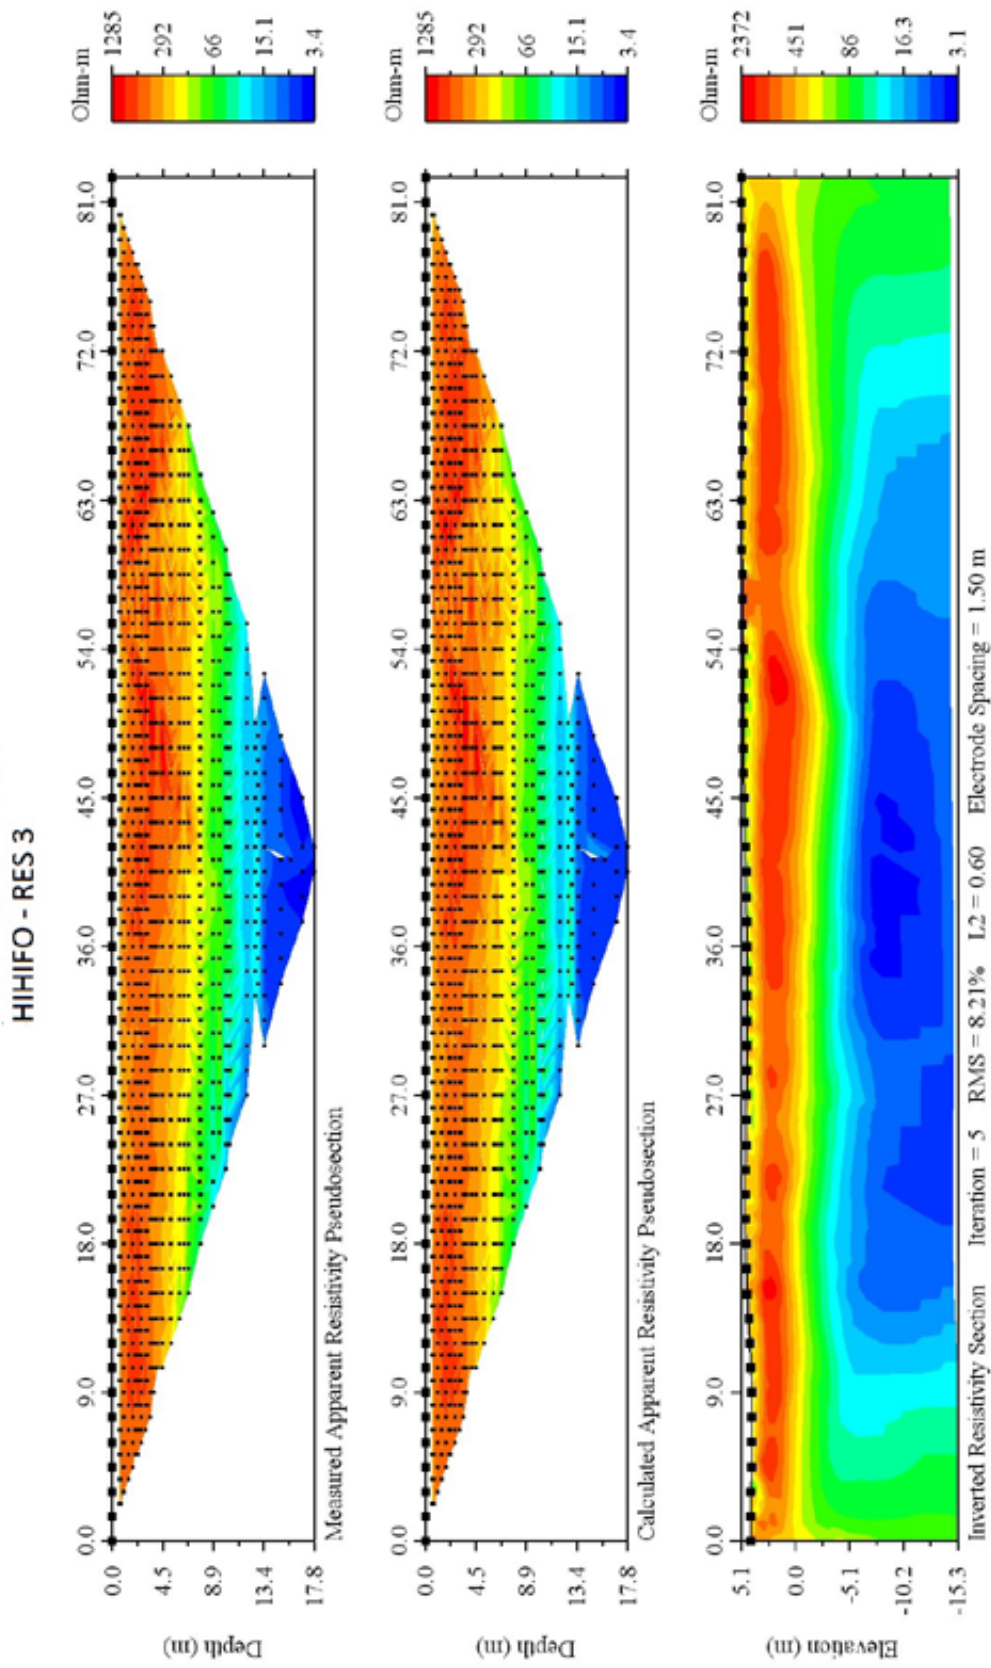
Figure 23: Resistivity profile Hihifo Res 3. The freshwater lens is 3-4.5 m thick. There is an apparent increase in the unsaturated zone at 45-52 m. Note that the Hihifo Gallery East is located at about 45 m on the profile. This apparent increase in unsaturated zone thickness could be a response to abstraction from the gallery with some induced drawdown, or a response to disturbed ground during installation.

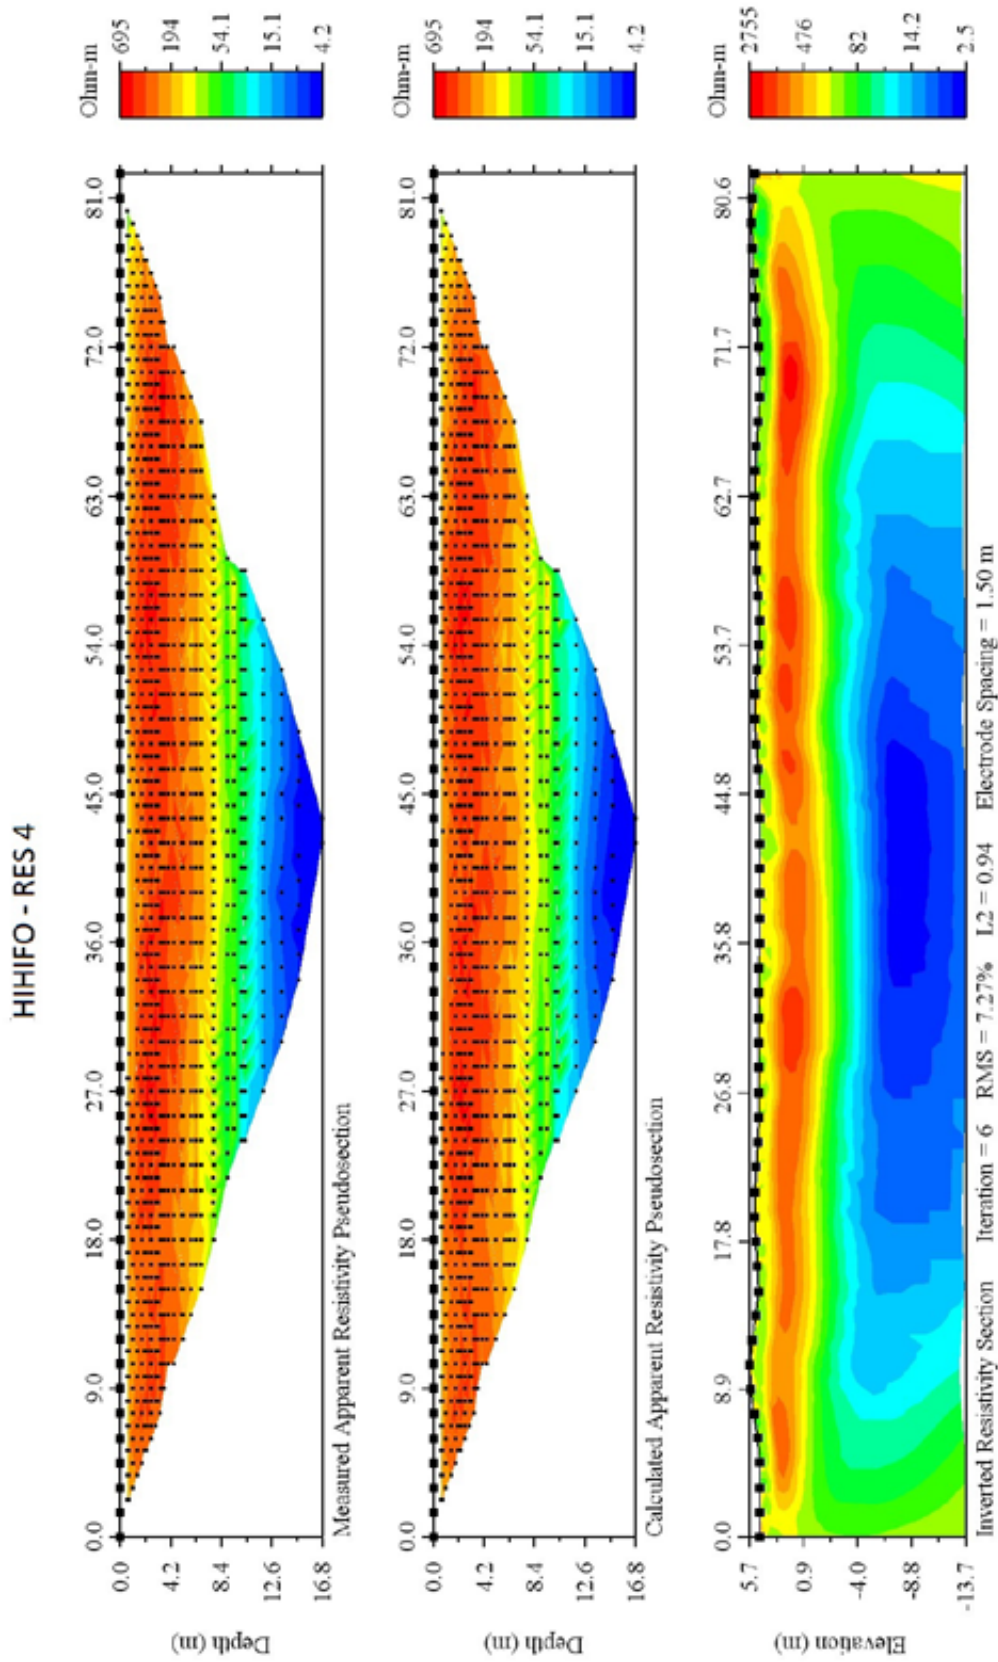
Figure 24: Resistivity profile Hihifo Res 4. This profile transect shows the silty sands and the limestone. The freshwater lens is approximately 3 m thick.

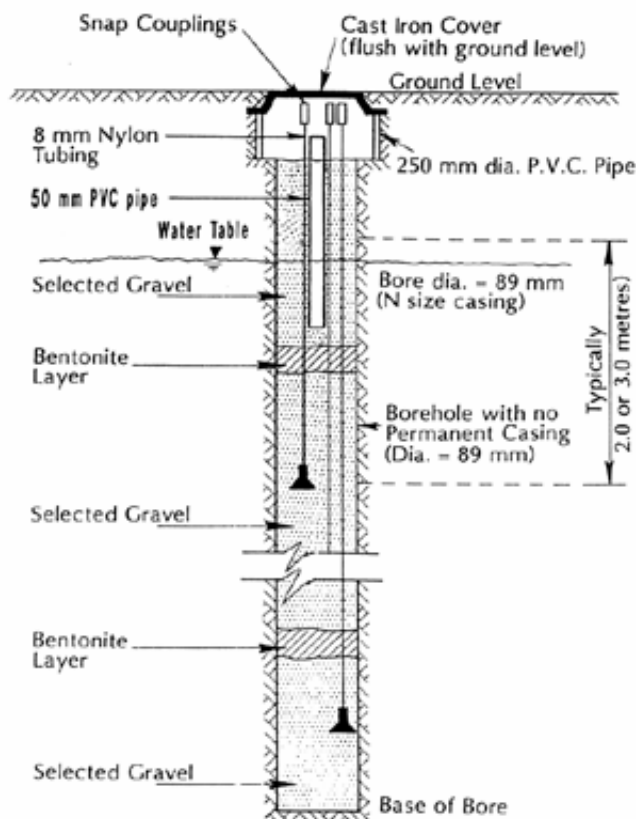
Figure 27. Multi-level borehole system for monitoring salinity and water level (Falkland et al. 2003)

The design of the Type A multi-level borehole system is shown in Figure 27 (Falkland et al. 2003).

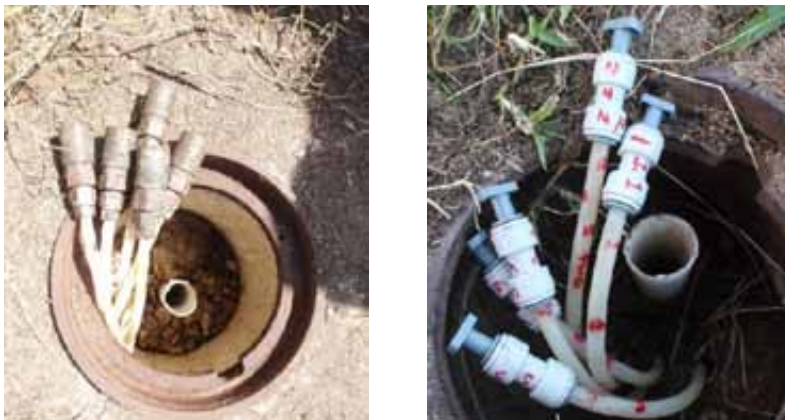
Figure 28: Brass snap couplings (left) were replaced with John Guest fittings (right)

During the initial monitoring, the bores were cleaned and purged and any seized brass snap couplings fitted at top of each tube were replaced with the John Guest couplings. Gatic covers that had been damaged or lost were replaced for a number of monitoring bores.

Figures 28 and 29 show the sampling tubes and couplings and sampling setup using the diaphragm pump.

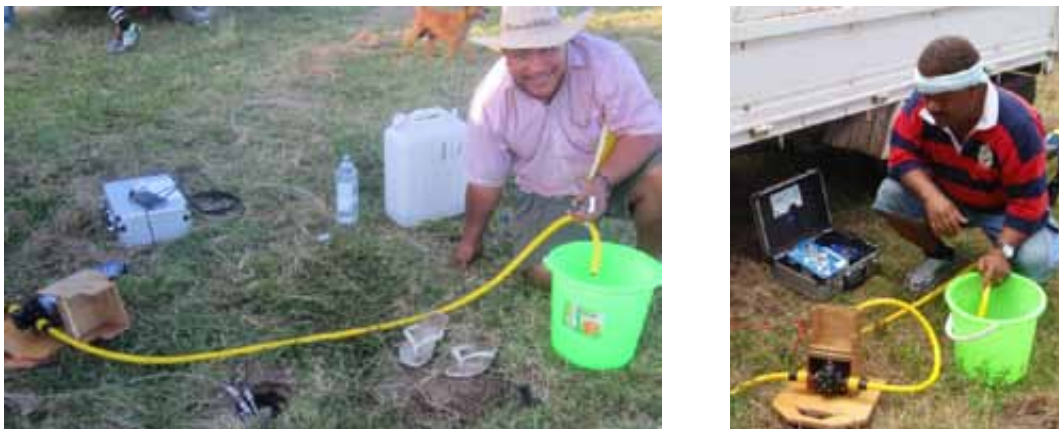
Figure 29: Sampling at the monitoring bores

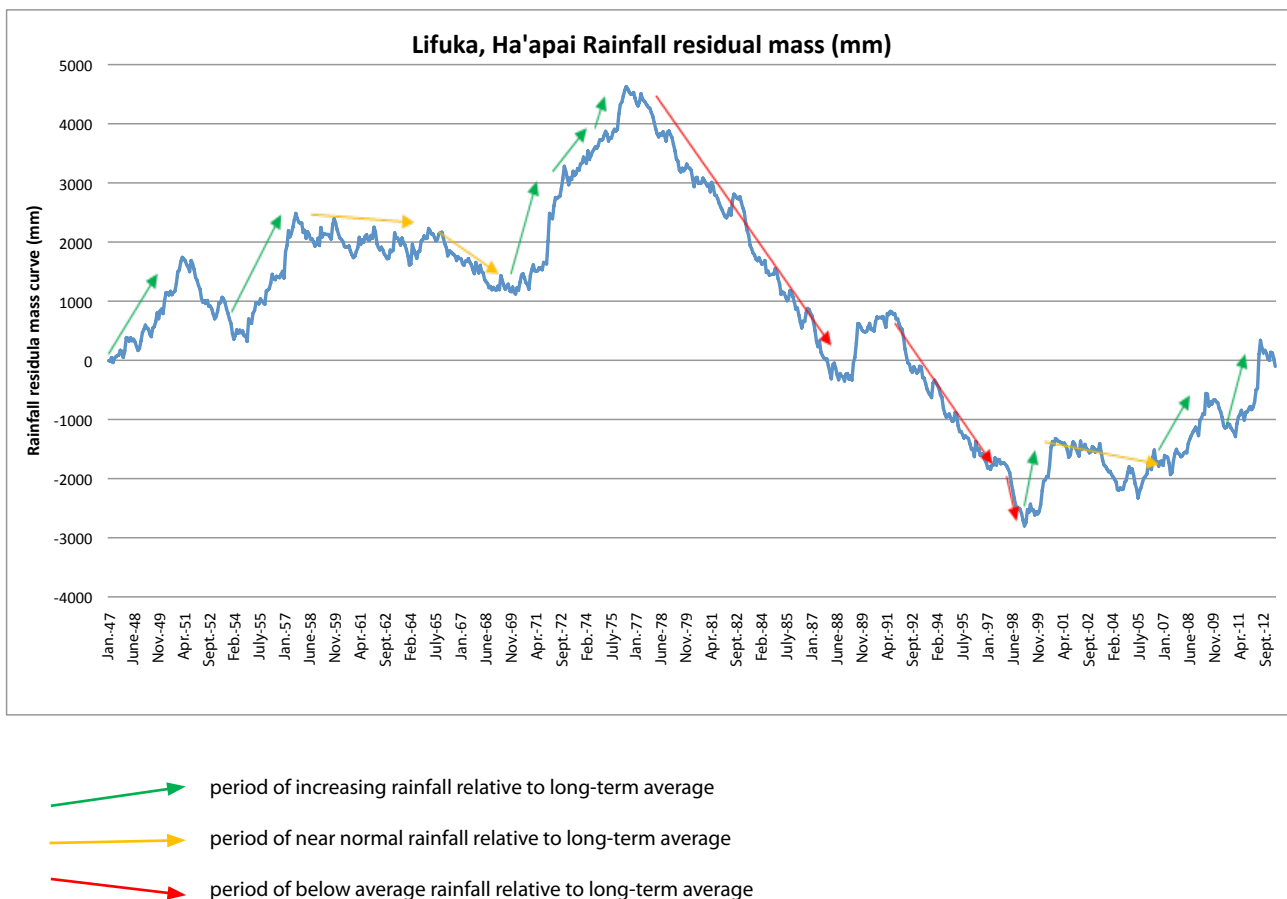
Figure 30: Rainfall residual mass curve for Lifuka, Ha'apai

The residual rainfall mass curve has been plotted for monthly rainfalls for Lifuka (Figure 30). It shows that 1947 to 1977 has been, on average, a wetter period with above average rainfall, albeit with a significant dry period of below average rainfall from March 1951 to November 1954. This was followed by a significant dry period spanning nearly two decades, from January 1977 to November 1998, where, in general, rainfall recorded was below average. Since 1999, there has been a pattern of increasing rainfall overall.

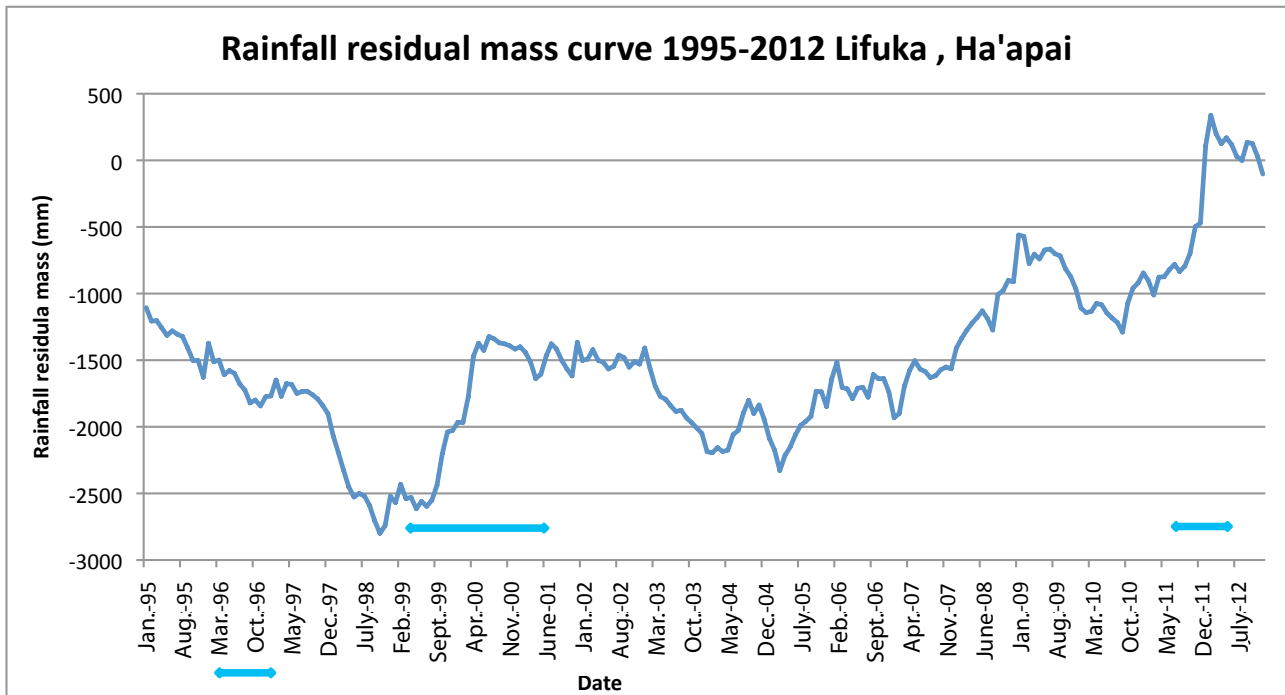
Figure 31: Rainfall residual mass curve for Lifuka 1995–2012 with groundwater monitoring periods identified

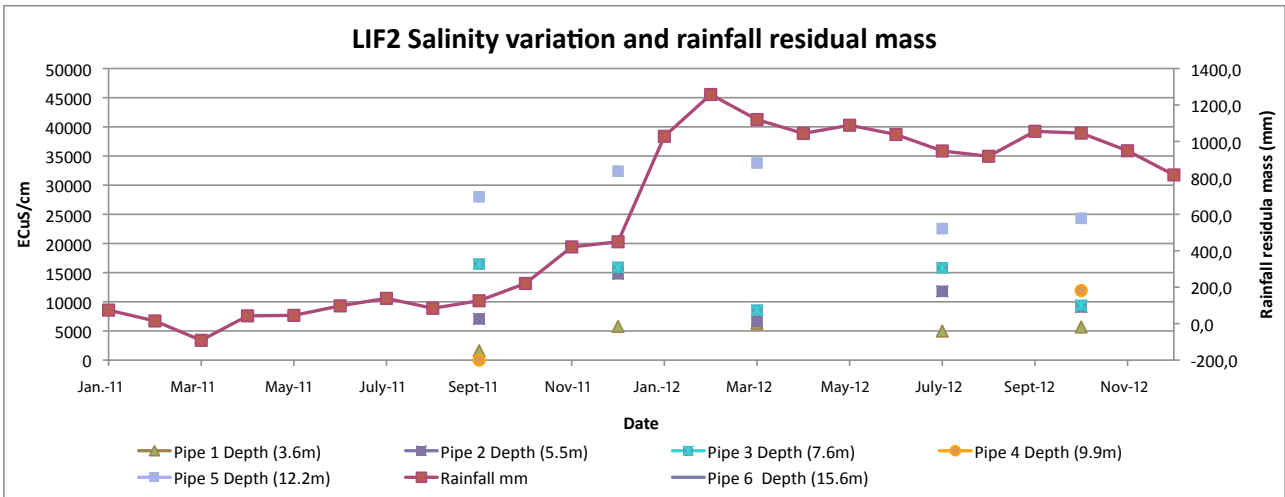
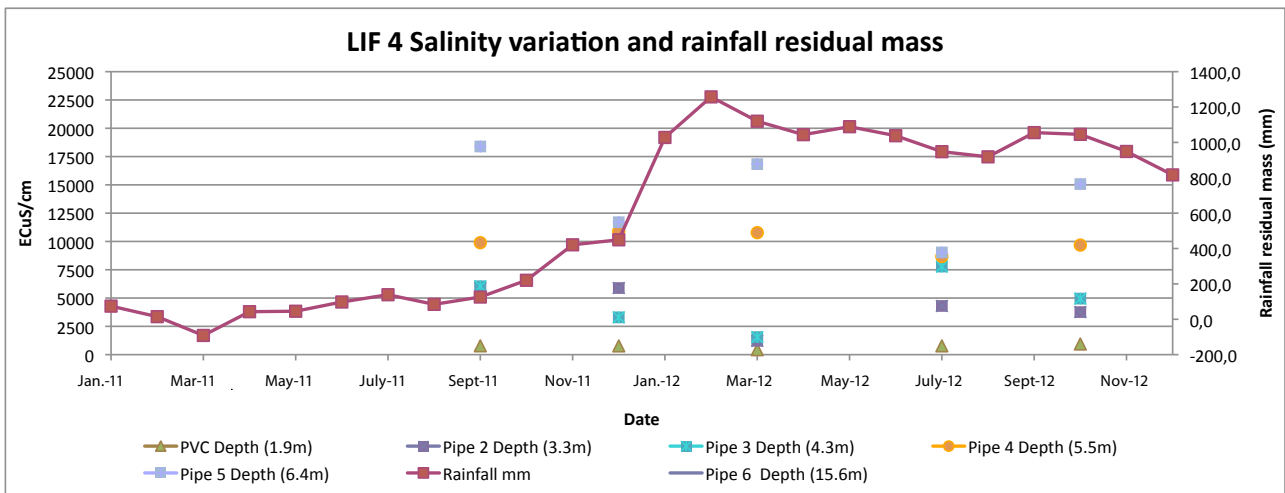
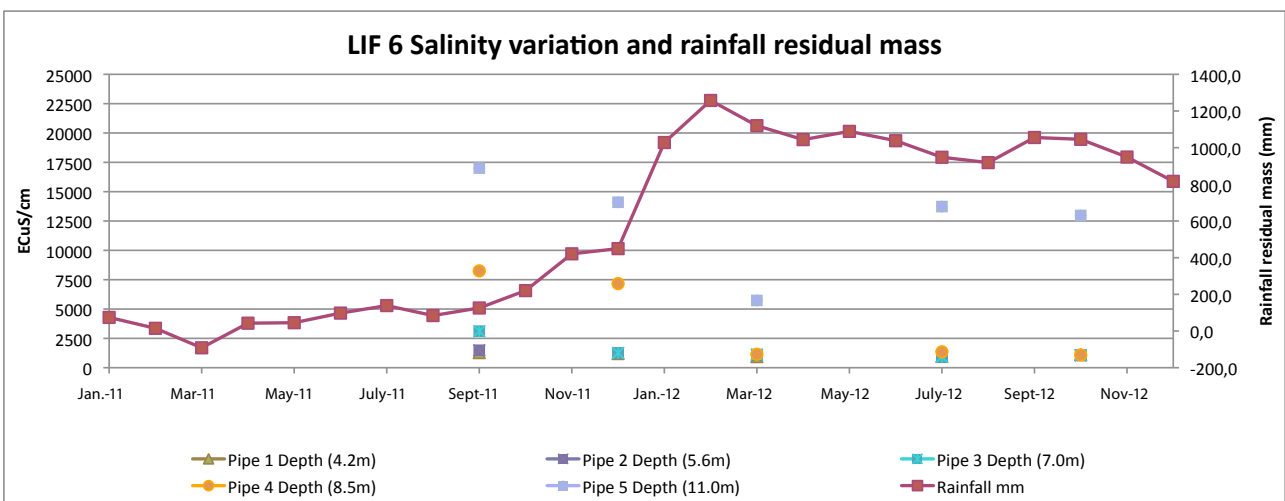
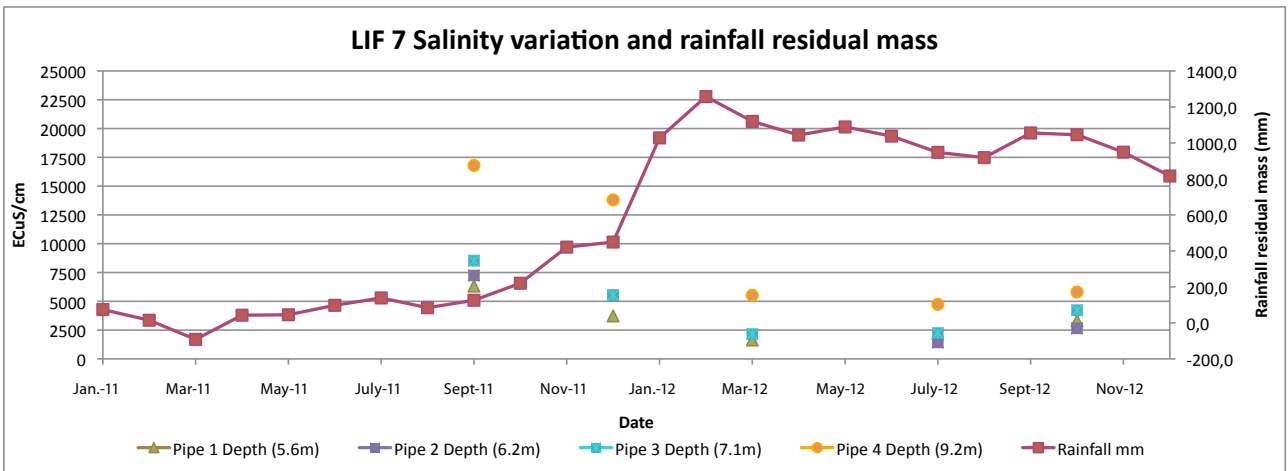
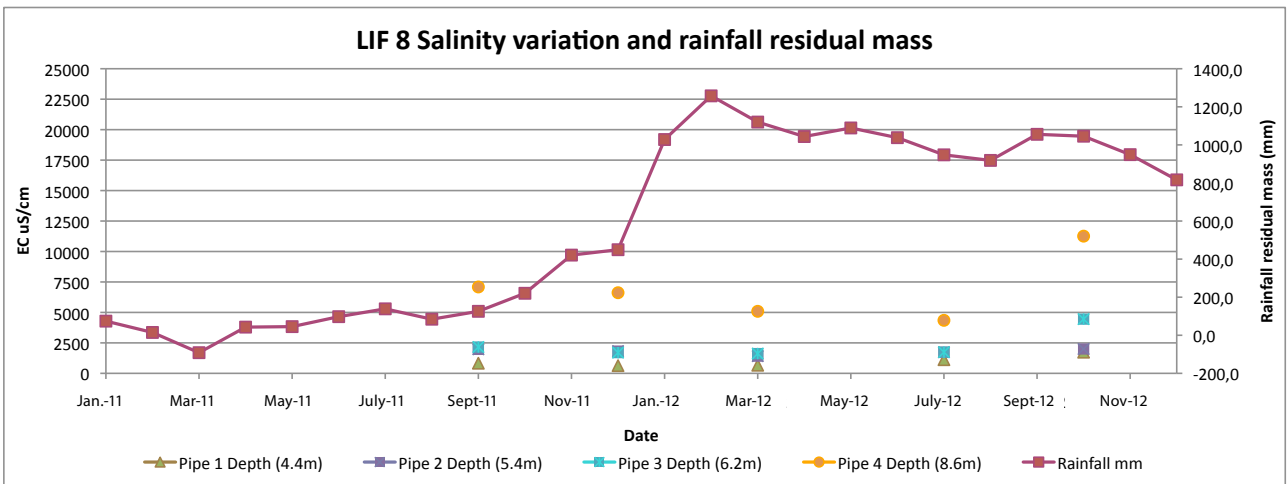
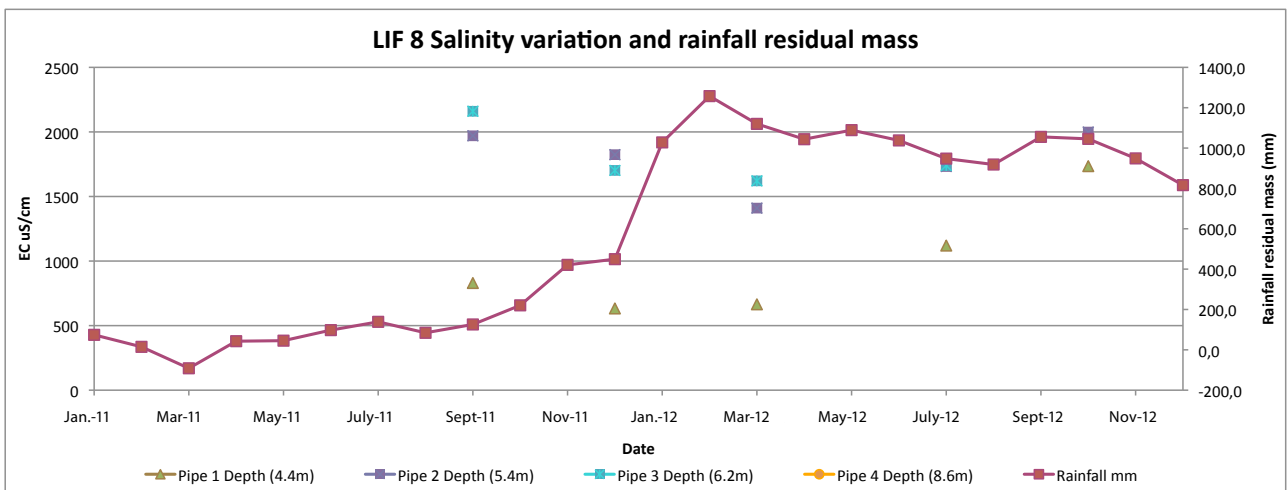
Figure 33: Salinity variation and monthly rainfall comparison
