Assessing vulnerability and adaptation
to sea-level rise: Lifuka Island
Ha'apai, Tonga

B 1: Physical resources
1.2: Groundwater resources assessment

Peter Sinclair, Amit Singh, Quddus Fielea, Kate Hyland, A'pai Moala

Secretariat of the Pacific Community
Suva, Fiji
2014

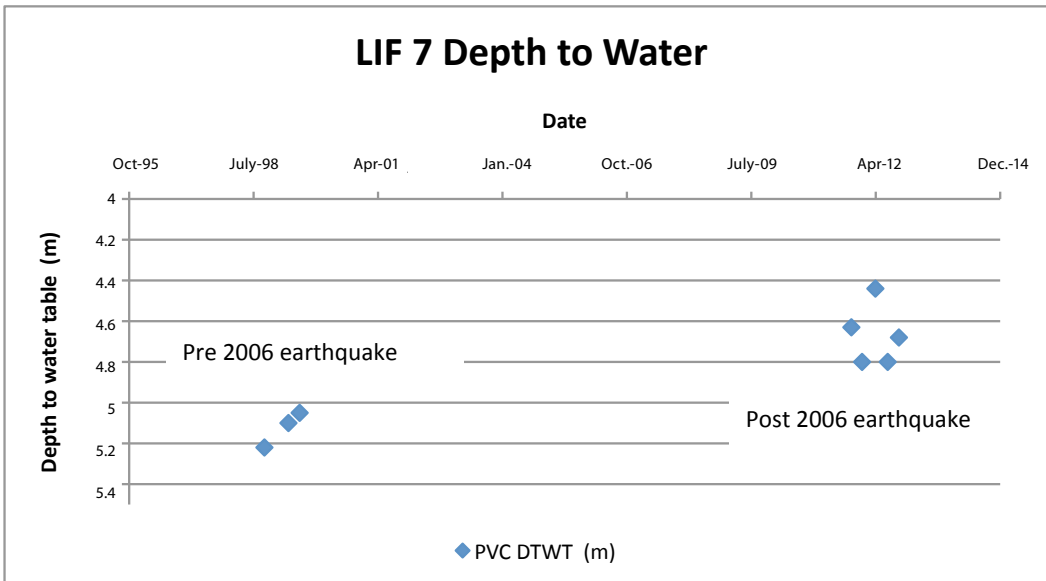
Figure 34: Depth to water table values for LIF 7 PVC 1, indicating a general increase of 0.45 m in the depth to the water table in response to the 23 cm subsidence

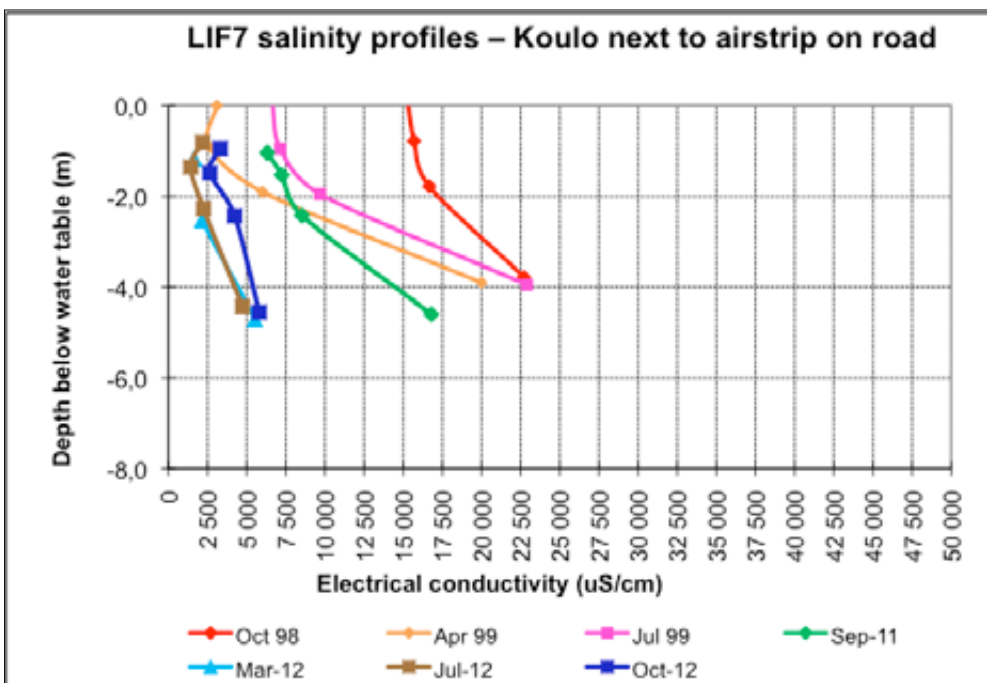
Figure 35: Freshwater thickness values for LIF 7 below the water table over selected monitoring periods. Note the predominantly fresher water lens in recent times.

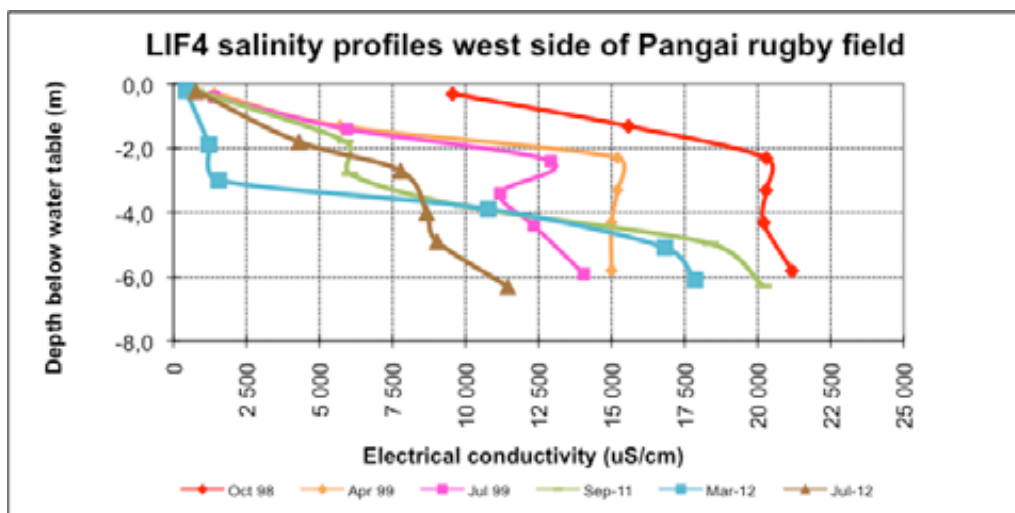
Figure 36: Freshwater thickness values for LIF 4 below the water table over selected monitoring periods. Note the greater thickness of brackish water, indicating a less defined boundary between the fresh and brackish water at times of low recharge and greater mixing.

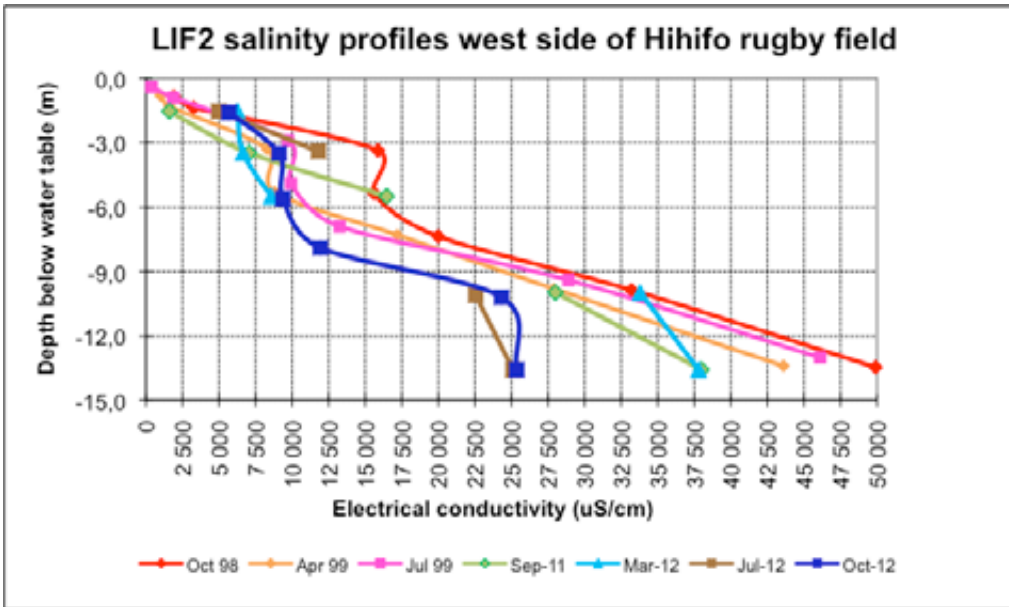
Figure 37: Freshwater thickness values for LIF 2 below the water table over selected monitoring periods. Note the greater thickness of brackish water at times of low recharge and reduced discharge, allowing greater mixing.

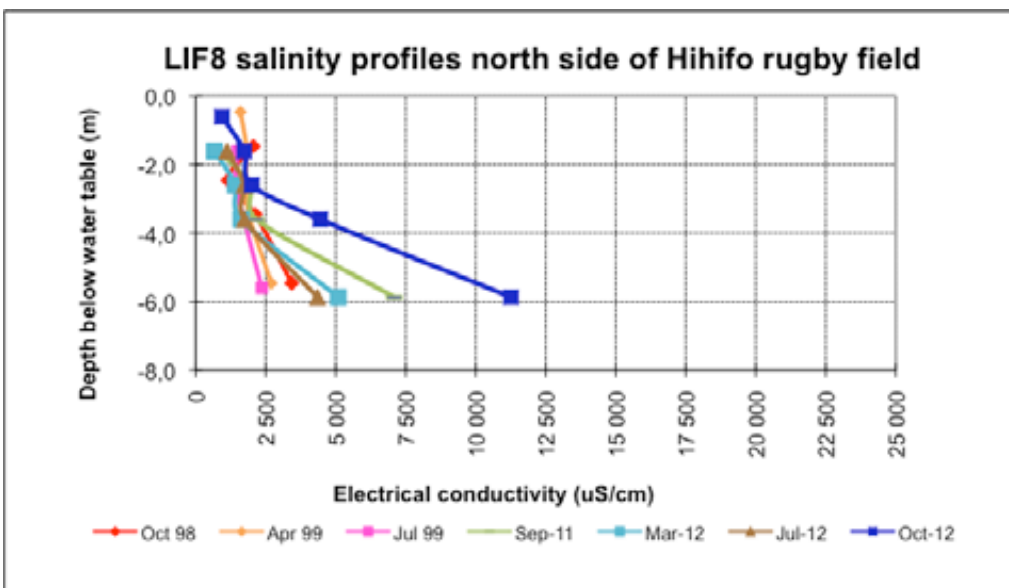
Figure 38: Freshwater thickness values for LIF 8 below the water table over selected monitoring periods. Note the apparent increase in salinity in the wells during recent times, suggesting that the lens is thinning, possibly in response to a rise in sea level.

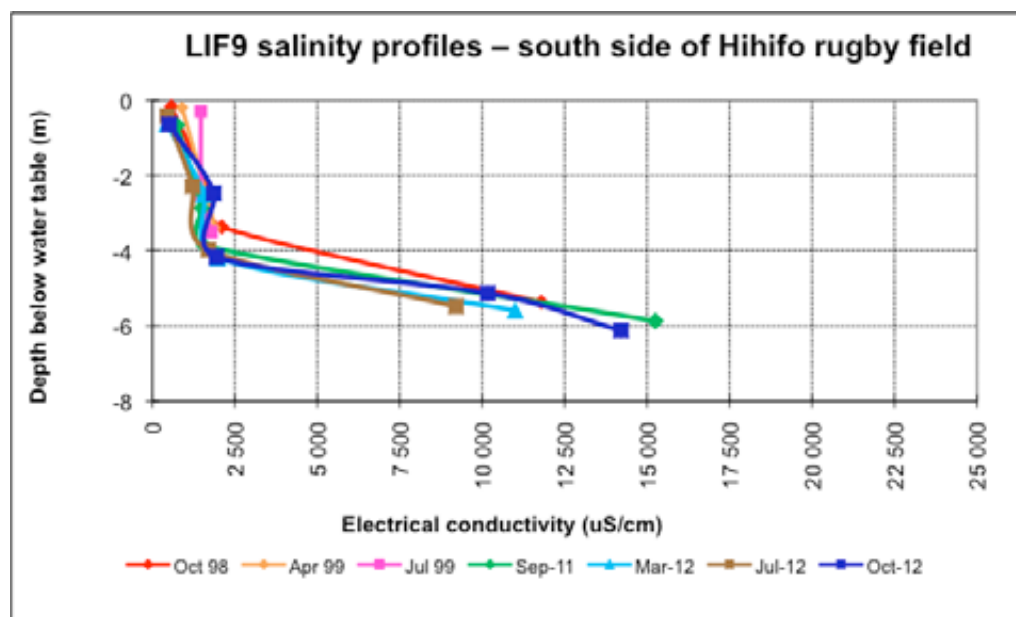
Figure 39: Freshwater thickness values for LIF 9 below the water table over selected monitoring periods. Note that the salinity in the sampling tubes at depth are generally indicating an increase in salinity at depth, suggesting a rise in the salinity of the deeper sampling tube in response to the rise in the sea level as a result of subsidence.

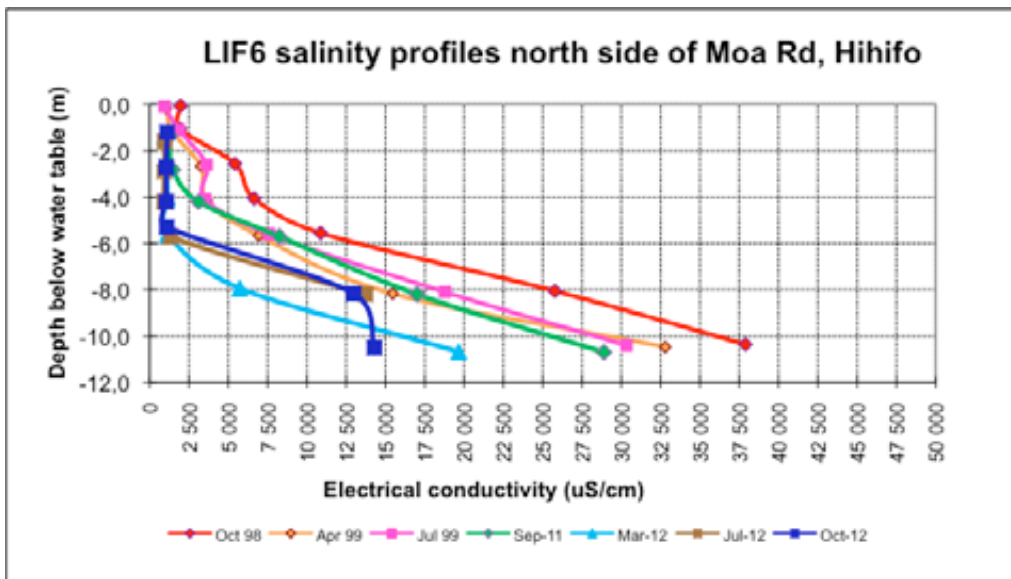
Figure 41: Freshwater thickness values for LIF 6 below the water table over selected monitoring periods. Note the considerable variability of freshwater lens thickness over time in response to rainfall. At the end of the extended dry period in 1998, the lens thickness was measured at less than 2.0 m, whilst during periods of higher rainfall, the freshwater lens was greater than 6.0 m thick.

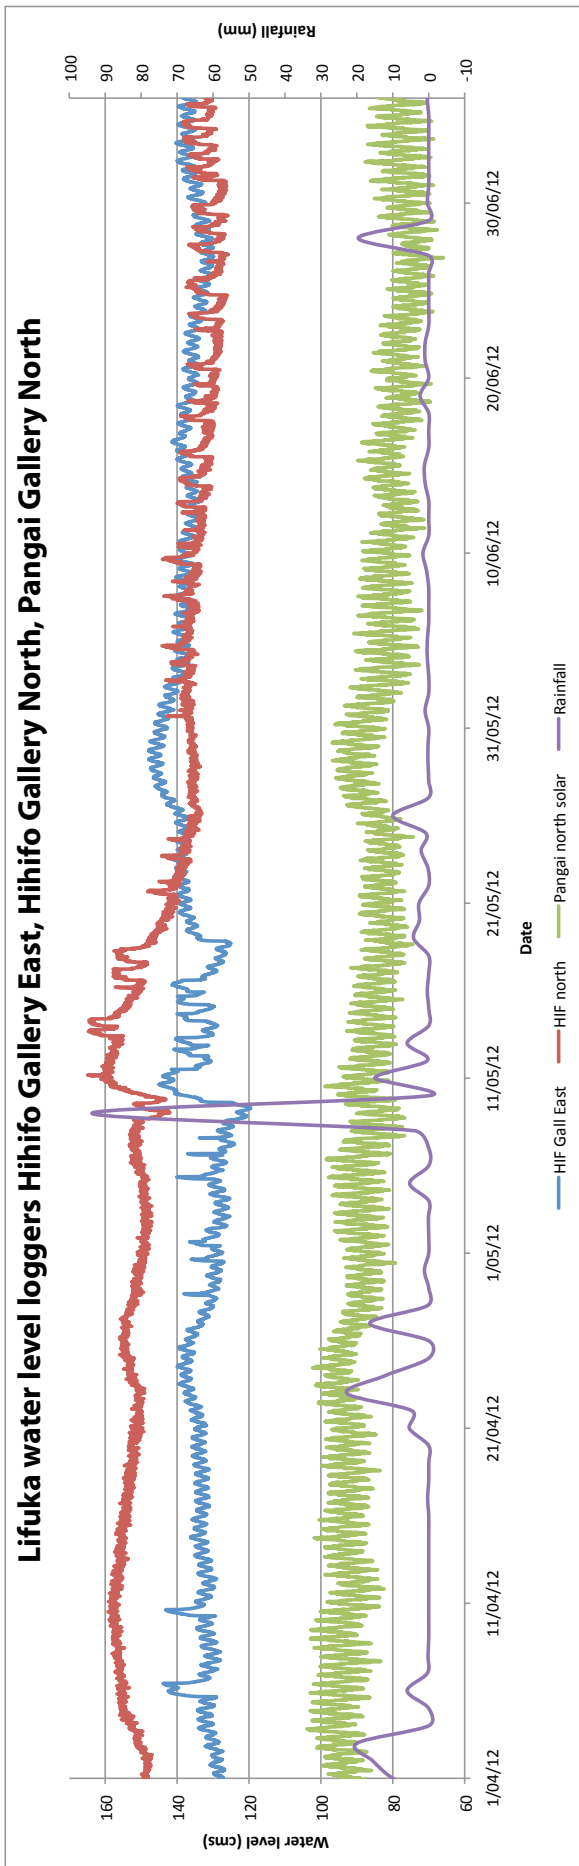
Figure 42: Water level profiles for Hihifo Gallery East, Hihifo Gallery North, and Pangai Gallery North (solar). Hihifo Gallery East and Pangai Gallery North demonstrate tidal influence on the water table. This is less discernible at Hihifo Gallery North. All water-level profiles indicate a response to rainfall recharge and periods without rain. During June 2012, a period of low rainfall, Hihifo Gallery North shows evidence of drawdowns, during which the water level dipped below the level of automatic cut-off for the pump, causing it to switch off. Once the water level recovered sufficiently, the pump resumed pumping until it again drew the water table below the automatic cut-off level, resulting in a step-type signature on the logged water level.

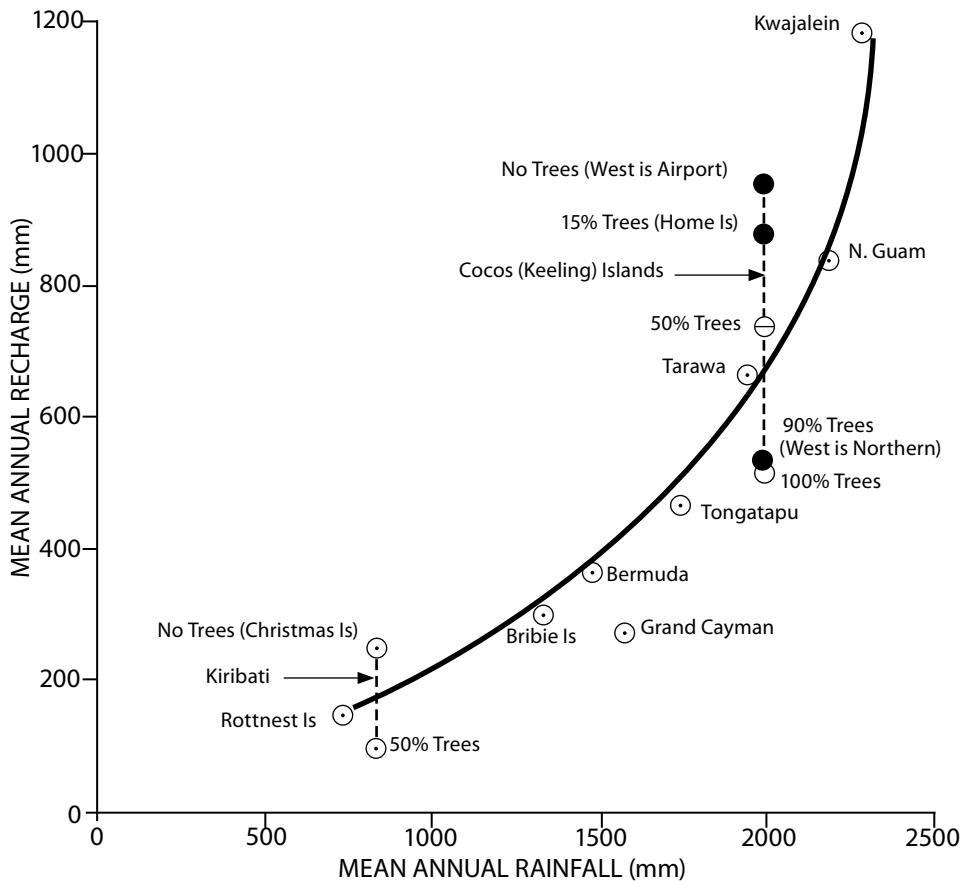
Figure 43: Annual rainfall recharge analysis and relationship for a number of islands (UNESCO 1991)

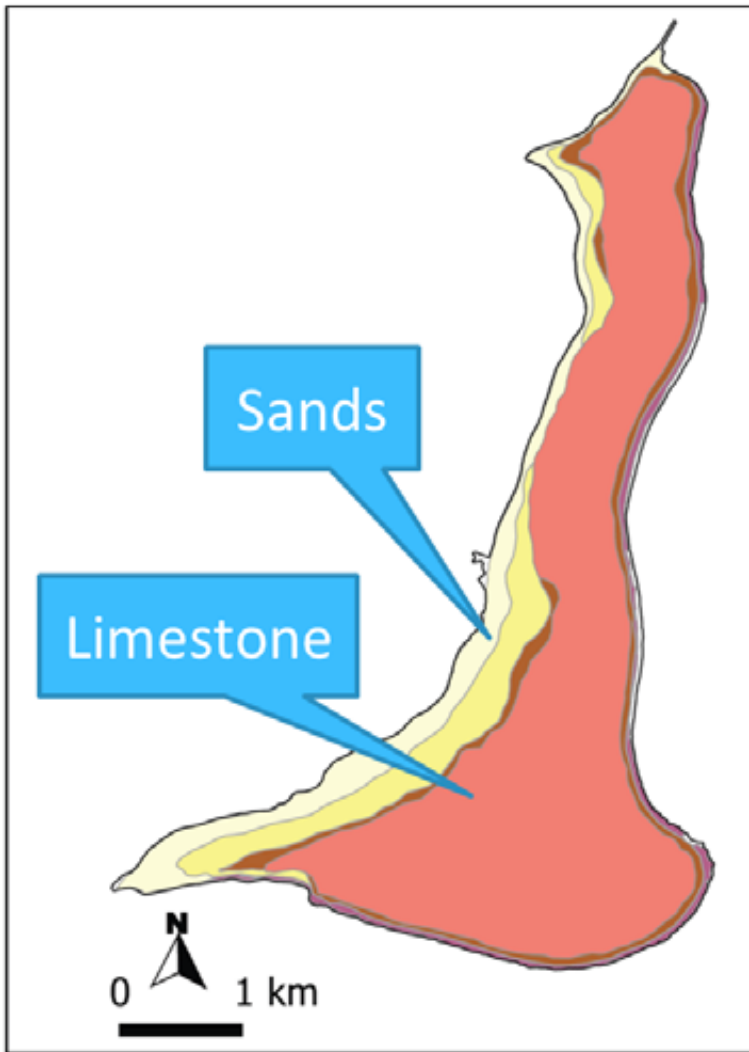
Annex 1: Soil map of Lifuka

This is a simplified soil map of Lifuka. Note that the low-lying coastal plains of the western shoreline comprise unconsolidated sands.

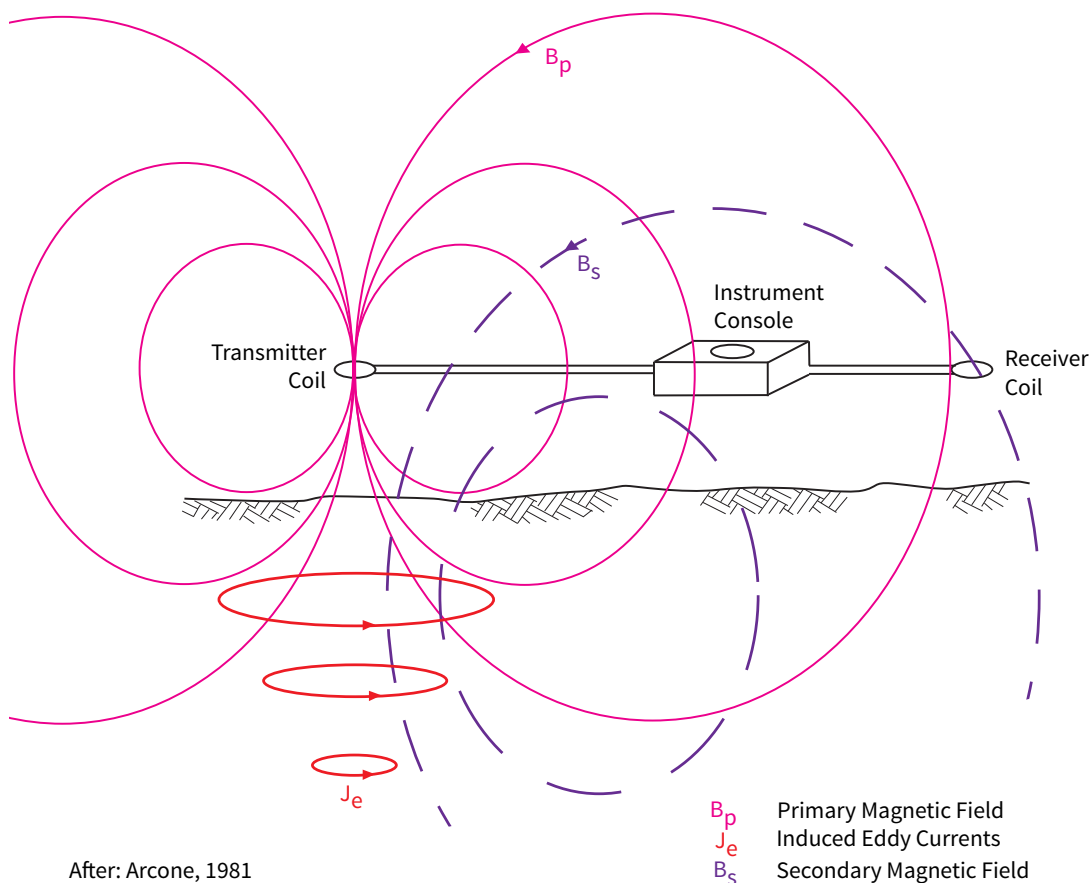
Figure 1: EM survey principle of operation (NGA 2000, p 1)

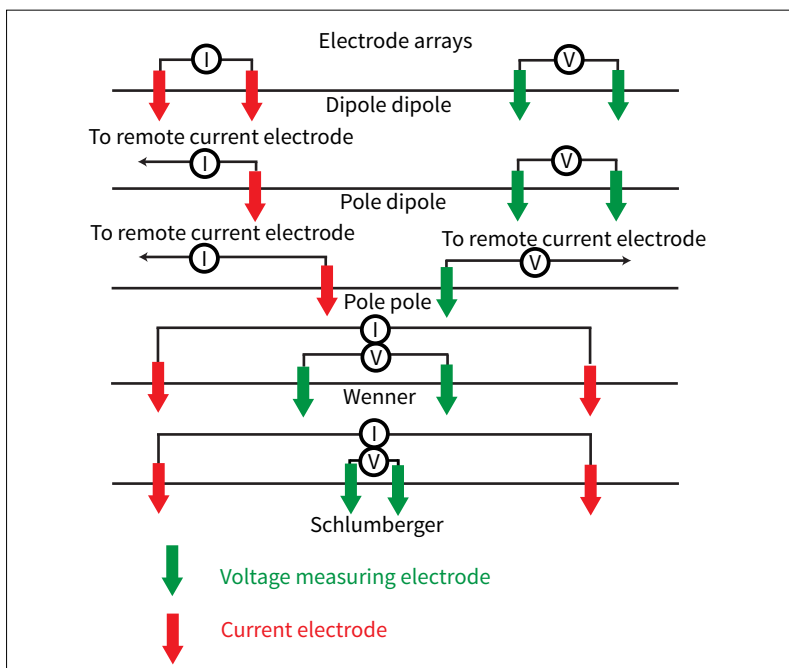
Figure 1. Electrode arrays used to measure resistivity
