MARINE BIOLOGICAL SURVEYS AND RESOURCE INVENTORY

AMERICAN SAMOA

Corps of Army Engineers
Pacific Branch

Contract No. DAGW84-74-C-0014

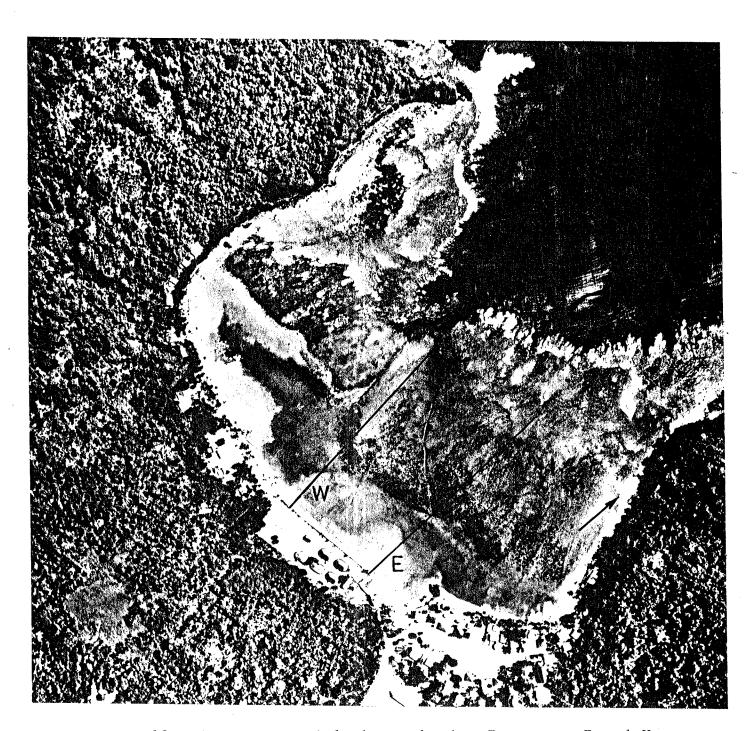
Fig. 12 - Aoa Bay; aerial photo showing Transects E and W.

On April 23rd we conducted a transect beginning at the seawall on the east side (Transect E of Fig.12) beginning at 1435 hours. The first 25 m of this transect is clean sand without rock; it was entirely exposed at low tide and completely covered at high tide (high tide mark at seawall observed morning of April 24th). In the outer part of this 25 m sector there are shallow ripple marks nearly parallel to shore. Numerous small holes (about 5 mm or less), usually rimmed by sand occur between 9 and 51 meters from shore. At 25 m from the seawall, the density of the holes ranged between 17 and 49 per m² (n = 5; x = 35). Several fragments of annelid worms, perhaps the animal responsible for the burrows, were obtained by digging deeply into the sand (on April 24 and May 4).

A transect (W on Fig. 12) off the west side of the school, 10 m east of the basketball court, was conducted on April 24th, beginning at 1110 hours during a falling tide. The bottom for the first 20 m from the seawall is predominately clean white sand without evident biota except a few burrows of ocypod crabs near the seawall. At the outer half of the first 25 m sector we observed an organism not seen along the eastern transect. Small tentacular crowns 1-2 mm diameter appear close together on the surface of the sand. They withdraw rapidly upon stimulation, leaving small holes. These animals were dug out of the fine sand; they proved to be a sipunculid. They occurred nearly to the $100\ \mathrm{m}$ mark. Also from about $20\ \mathrm{m}$ offshore to $75\ \mathrm{m}$ there were scattered groups of parchment-like tubes of about 2 mm diameter sticking 2.5 cm above the surface of the sand and covered with epiphytic algae; the tubes are formed by terebellid worms.

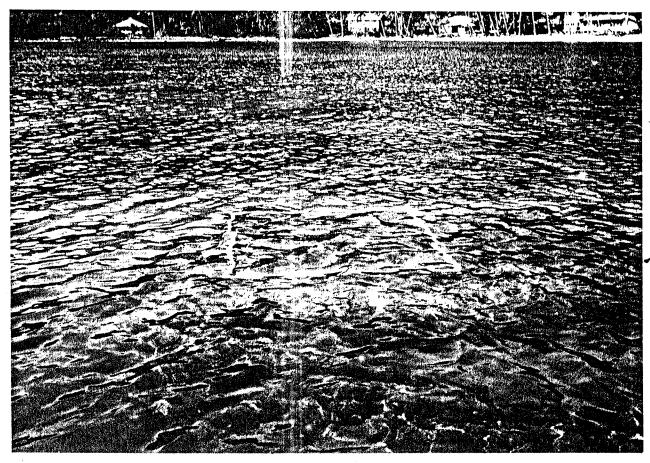
Fig. 13 - Aoa Bay; meter square on Transect E, partially covering Porites <u>lutea</u>, 100-125 m off shore.

Live coral was first observed between 101 and 125 m from the Scattered heads of Porites lutea, the largest more than a meter in diameter (Fig. 13) are present. These large heads, however, have the live coral growing only at the outer edges; the broad central part is truncate to slightly concave. The largest head of P. lutea in which all the coral was alive measured 33 cm in diameter. Visibility under water was about It was in this sector of the transect that the water depth was greatest, 0.7 m, and here that the first reef fishes were seen. The most common was the damsel Plectroglyphidodon leucozona (brown with a pale bar in middle of body). Others frequently seen were the surgeonfish, Acanthurus triostegus, the damselfish Eupomacentrus albofasciatus, juveniles of the grouper Epinephelus merra, the wrasse Halichoeres trimaculatus, and the butterflyfishes Chaetodon citrinellus and Heniochus

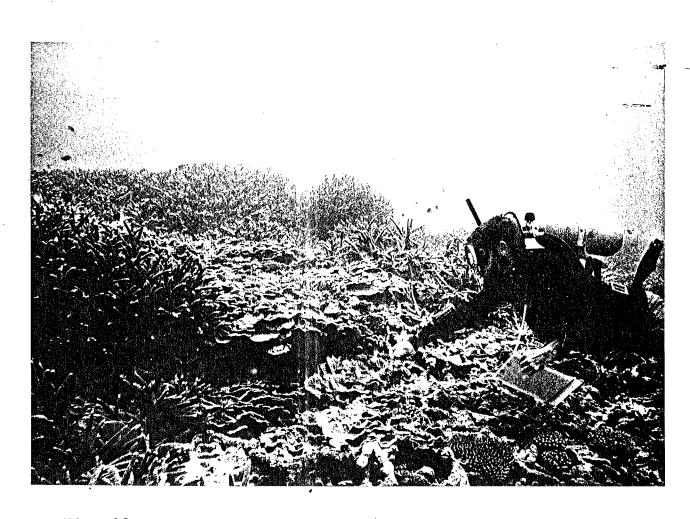
Fig. 18 - Aunuu Island; rich coral growth (<u>Acropora samoensis</u> and plate-like <u>Pachyseris speciosa</u>) shoreward from patch reef at depth of 6-7 m.

Moving shoreward around the base of the patch reef in a SE direction we swam into a sandy channel where coral growth is quite rich, especially Acropora samoensis and Pochyseris sp. in (Fig. $\overline{18}$). distinct patches Mixed with the corals, however, are areas of coral rubble and sand. The highest mounds of live coral come

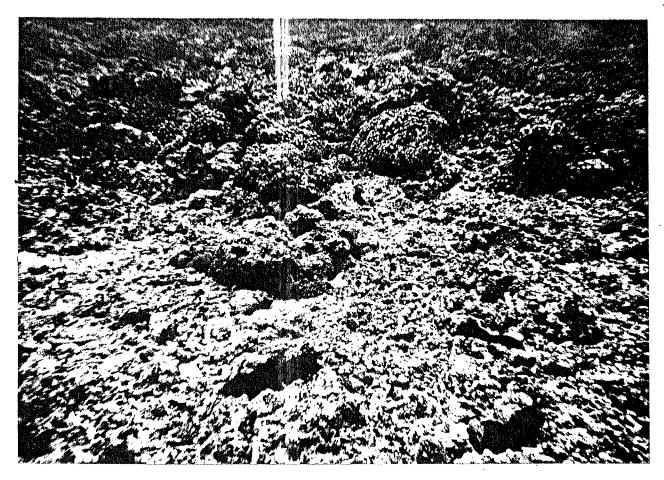
Fig. 22 - Fagaalu; low relief coral and rubble, depth 0.3 m, 25--30~m off shore on Transect S.

Just beyond 25 meters from the seawall the water shoaled to about 0.3 m and a coral rubble area (mostly of cylindrical pieces about 7 to 13 cm long) with occasional coral and basaltic boulders begins. It extends about 4 m seaward. Beyond this there is a proliferation of live coral in low relief (most colonies about 7.5 to 10 cm in diameter (Fig. 22). The domi-

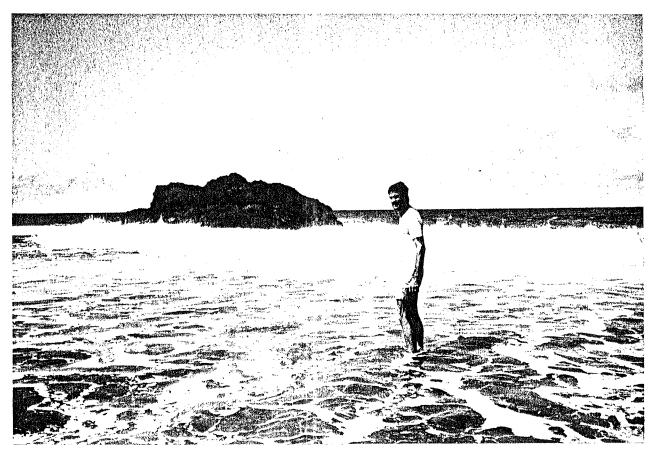
Fig. 32 - Faganeanea; reef off Utulaina Pt. facing S towards Fatuuli Rock in area of Transect S.

Heavy surf was breaking on the reef off Utulaina Point and Fatuuli Rock on April 29 (Fig. 32) and it was not possible to run a transect there at this time. Although surf continued to be heavy on the point the next few days, we were able to execute a transect nearly to the reef edge during a -0.3 low tide at 1056 hours on May 3. The direction of this transect (S of Fig.27) is due south from the west side of Utulaina Point.

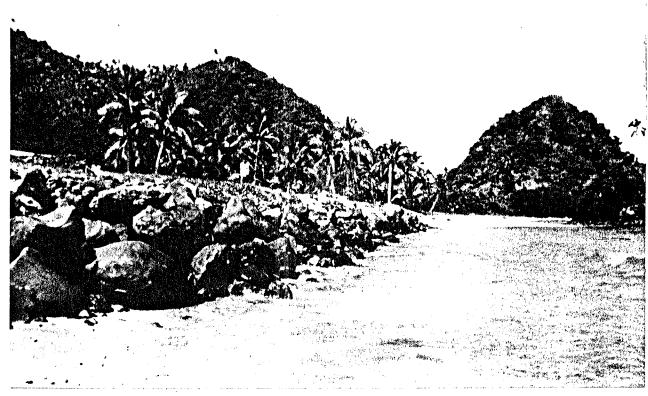
Fig. 46 - Amanave Bay; view along seaward edge of landfill and seawall between Transects S and N looking SE.

The discolored water rimmed the land fill between Leafu and Maululu streams (Fig. 46). According to sources in the Dept. of Public Works, this was a village project by the people of Amanave, without any guidance from Public Works. This fill is being eroded at this time. During our site visit we
