**U.S. DEPARTMENT OF THE INTERIOR
U.S. GEOLOGICAL SURVEY**

**TUTUILA, AMERICAN SAMOA
COASTAL RESOURCE INVENTORY SITES:
RECONNAISSANCE SHORELINE GEOLOGY**

by
Bruce M. Richmond¹
1995
Open-File Report 95-512

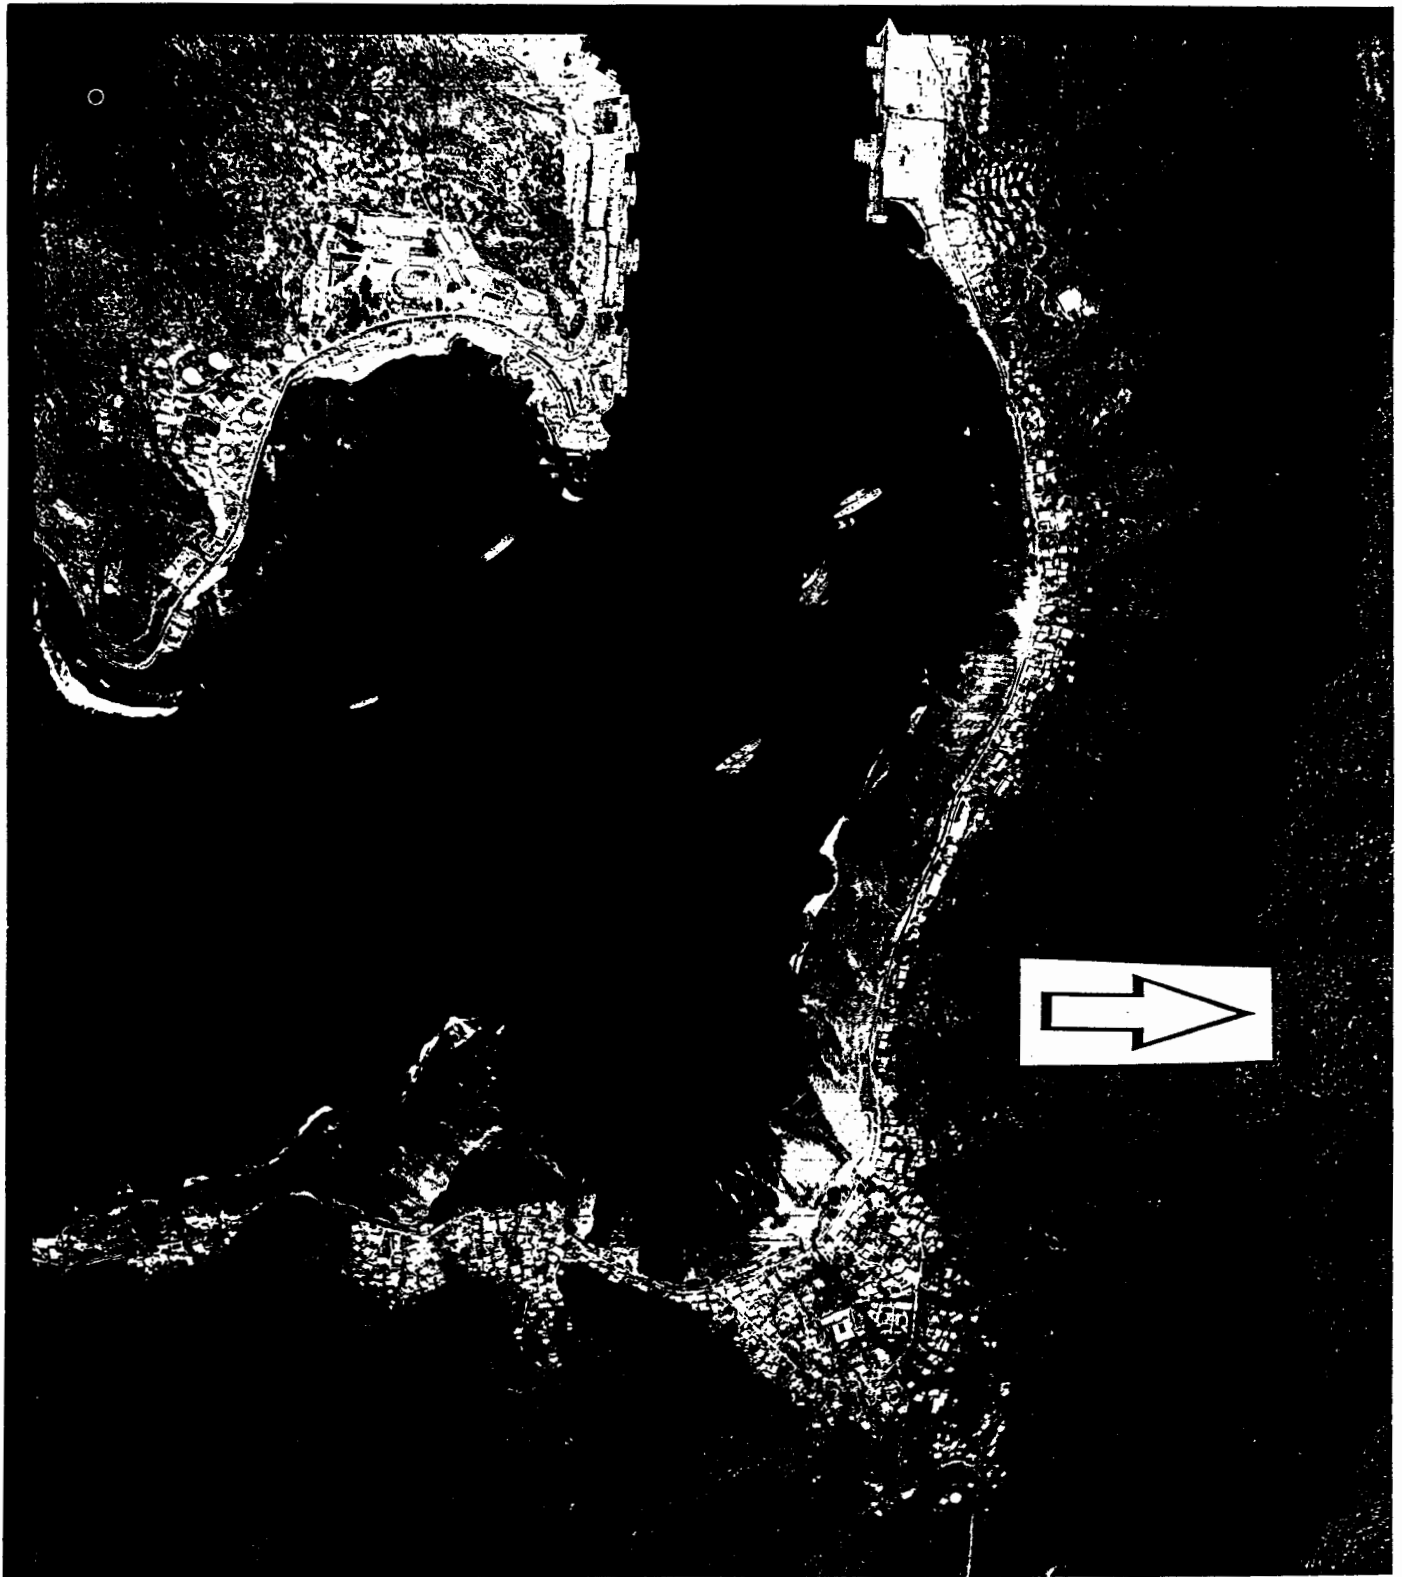
Plate 1. Vertical aerial photograph of the central portion of Pago Pago Harbor showing wharf construction, coastal plain development (most notably at Aua), and reef flat areas that have been dredged between Goat Island and Tulutulu Pts. and Aua and Anasosopo Pts. Photograph by R.M. Towill Corporation, August 1990.

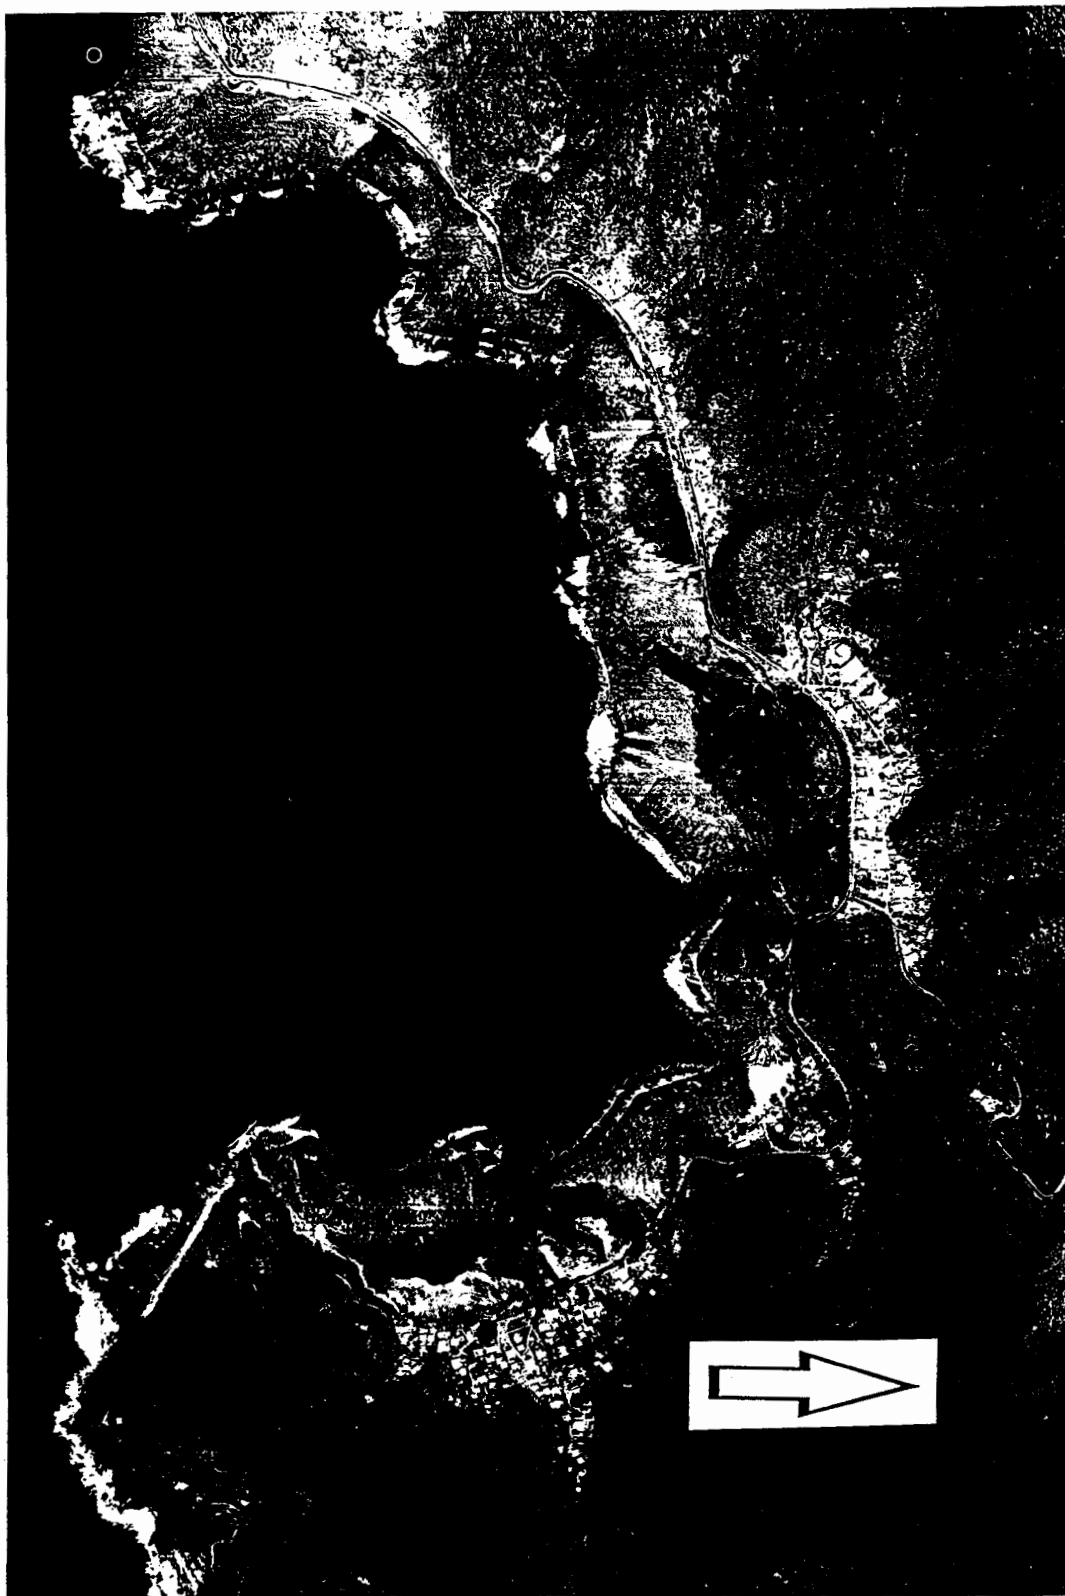
Plate 2. Vertical aerial photograph of Fagaitua Bay, southeastern Tutuila. The narrow coastal plains are well-defined by areas of housing. Several reef flat dredge sites are visible as dark areas between the reef crest and shoreline. Note the gaps in the reef opposite the stream mouths. Photograph by R.M. Towill Corporation, August 1990.

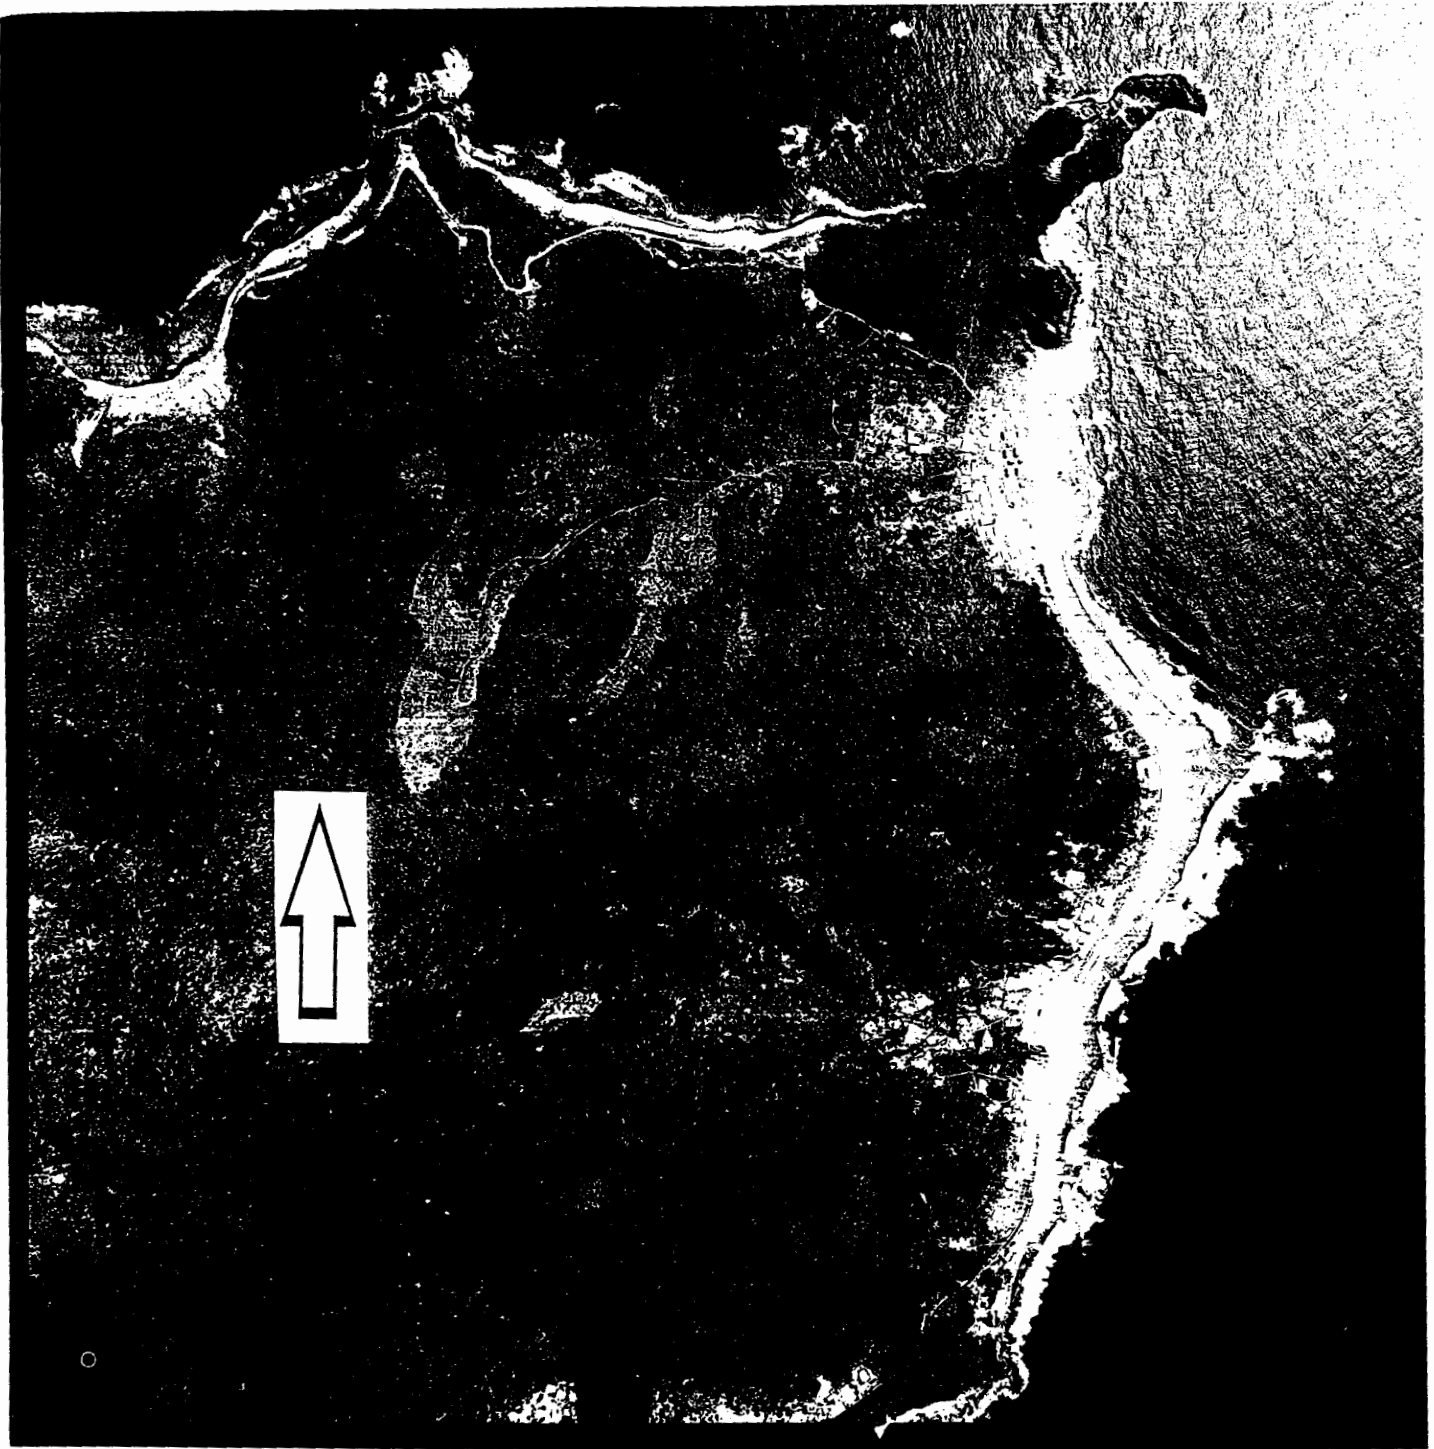
Plate 4. Vertical aerial photograph of the east and northeast coast of Tutuila showing the extensive carbonate beach and coastal plain at Alau and Tula. The alluvial and coastal plain of Onenoa (13) is to the top left of the photo. Photograph by R.M. Towill Corporation, August 1990.

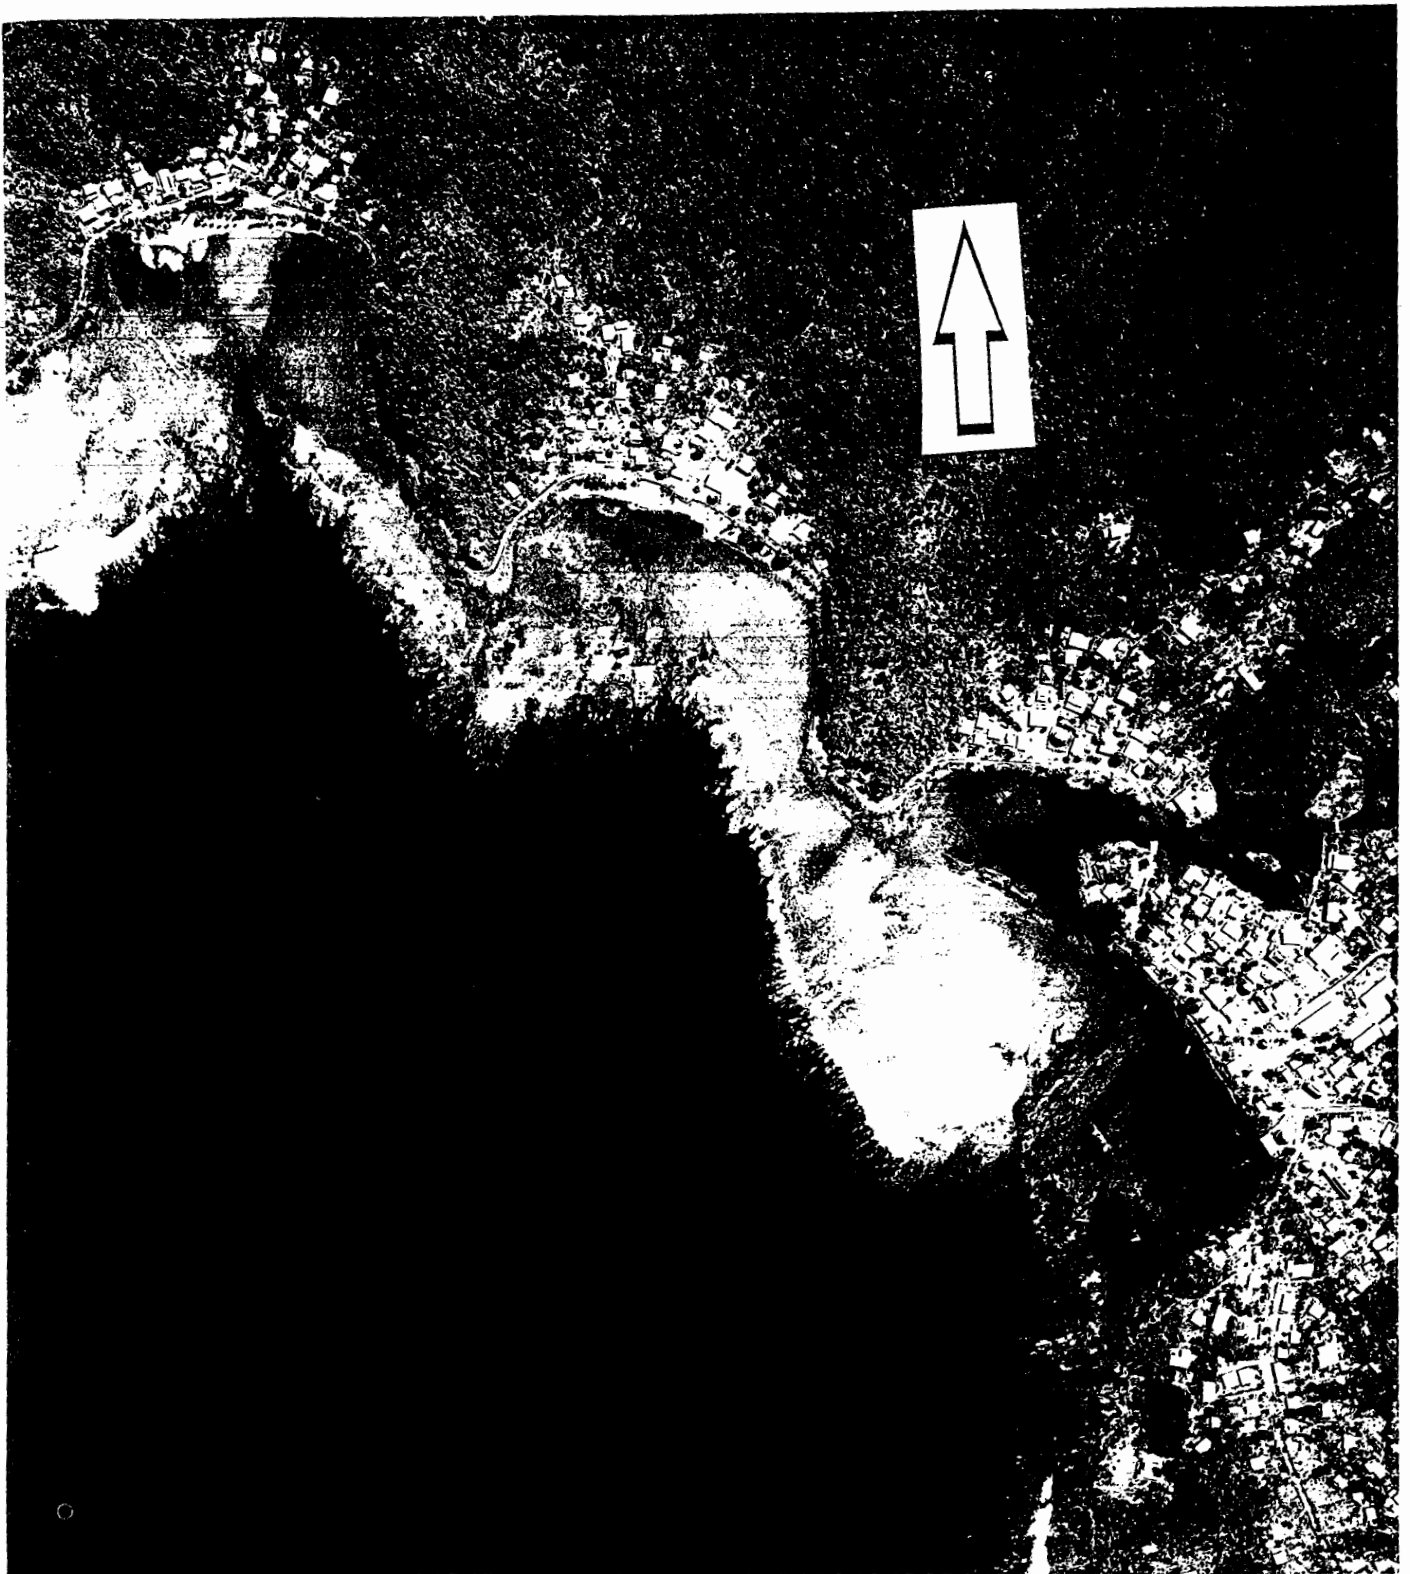
Plate 7. Vertical aerial photograph of southwest Tutuila showing Asili, Amaluia, Auma, and Leone Bays. Note the detached beachrock ridge extending across the entrance to Pala lagoon denoting the former barrier spit shoreline position. The light areas on the reef flat opposite Leone are rubble storm deposits. Photograph by R.M. Towill Corporation, August 1990.

Southwest Tutuila is an area with numerous protected embayments backed by low-lying land, which provides the setting for many coastal villages (Plates 6 & 7). As elsewhere on Tutuila the embayments form at the mouths of coastal streams. The largest of these is Leone Bay, developed at the mouth of Leafu Stream and an area where a small coastal mangrove forest is developed. The embayments and associated arcuate beaches are separated by rocky headlands and seacliffs. Terrigenous sand is the dominant beach

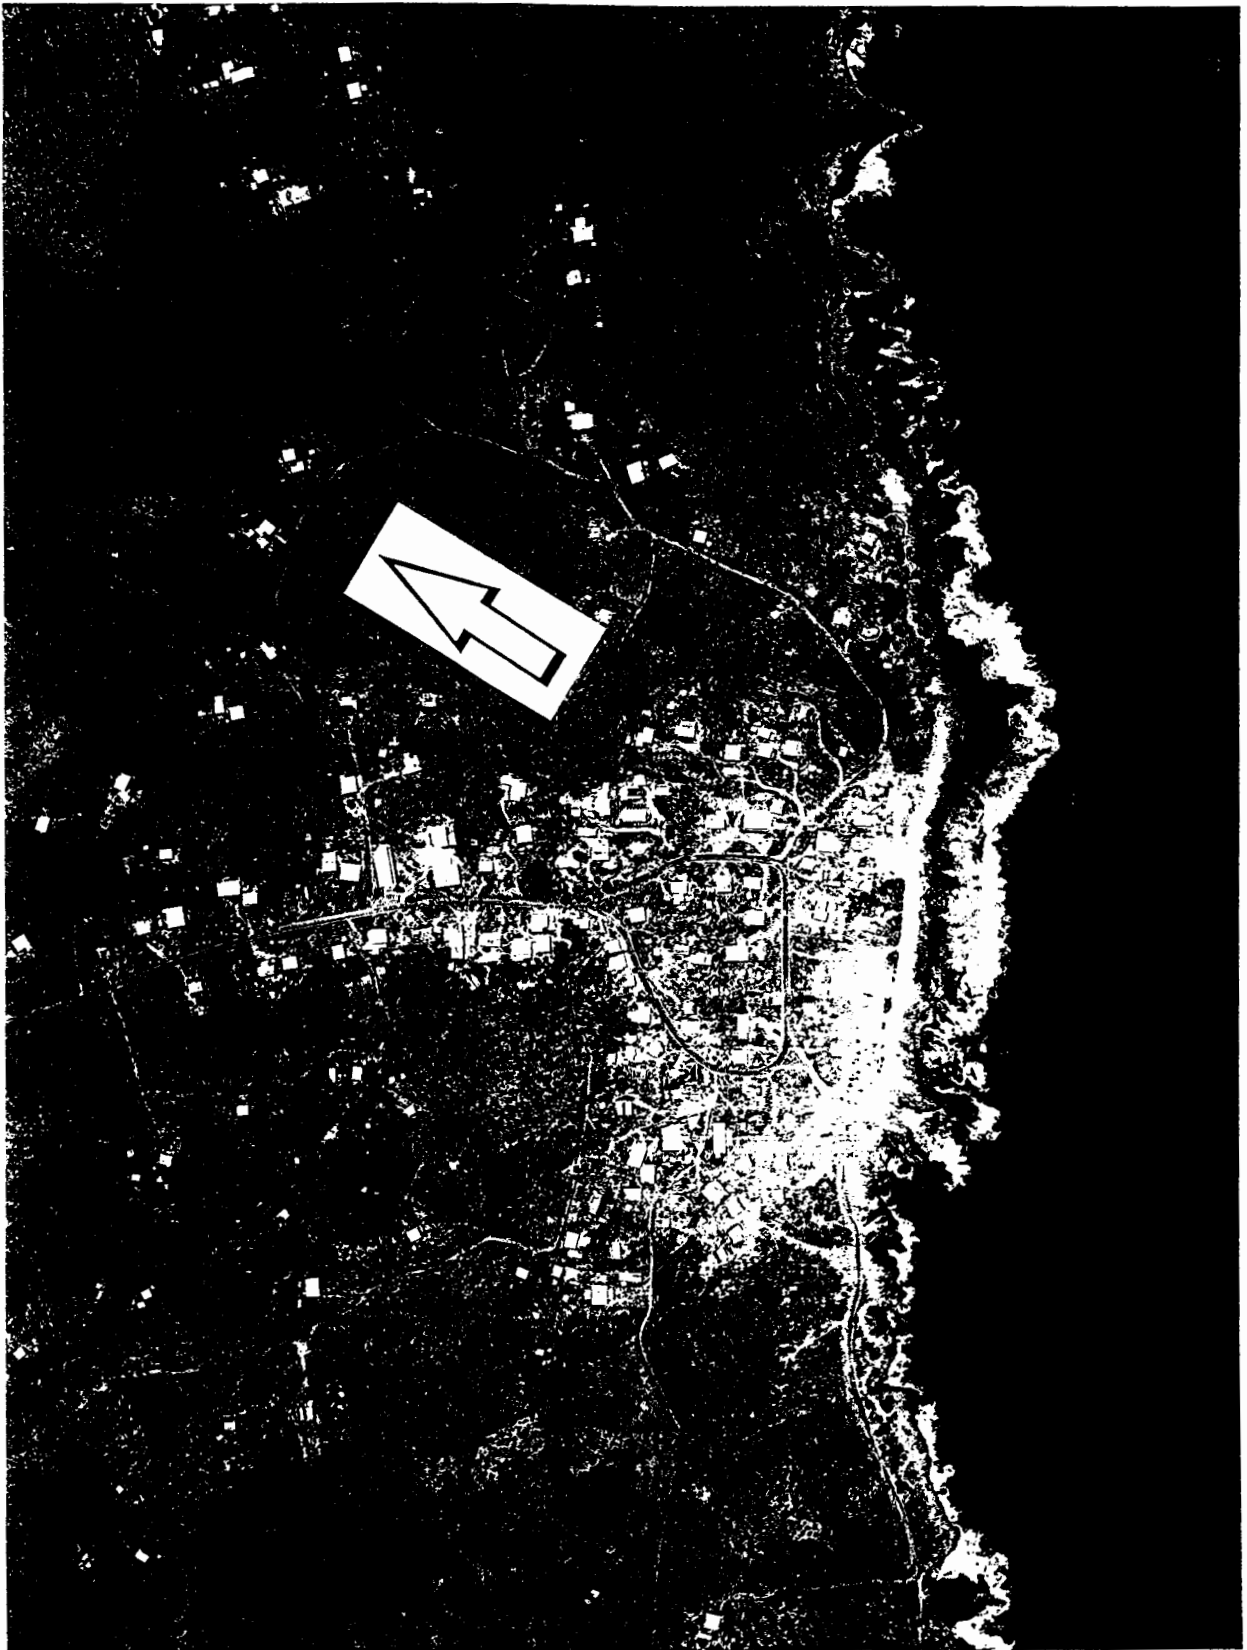
Plate 8. Vertical aerial photograph of Vaitogi showing the basalt cliffs which form most of the shoreline. A perched beach composed of carbonate sediment fronts the village. Photograph by R.M. Towill Corporation, August 1990.

The southernmost shoreline of Tutuila can be distinguished from the rest of the coast by the presence of an extensive lava seacliff of recent origin. These basalt flows form a bench that varies from a few meters to nearly 30 m above the adjacent reef. The relatively low-lying basalt flows are broken by high cliffs (up to 150 m) formed by the old craters at Fagatele and Larsen Bays. Because access to the ocean is limited in this area there only a few villages with Vailoatai and Vaitogi (Plate 8) being the largest.

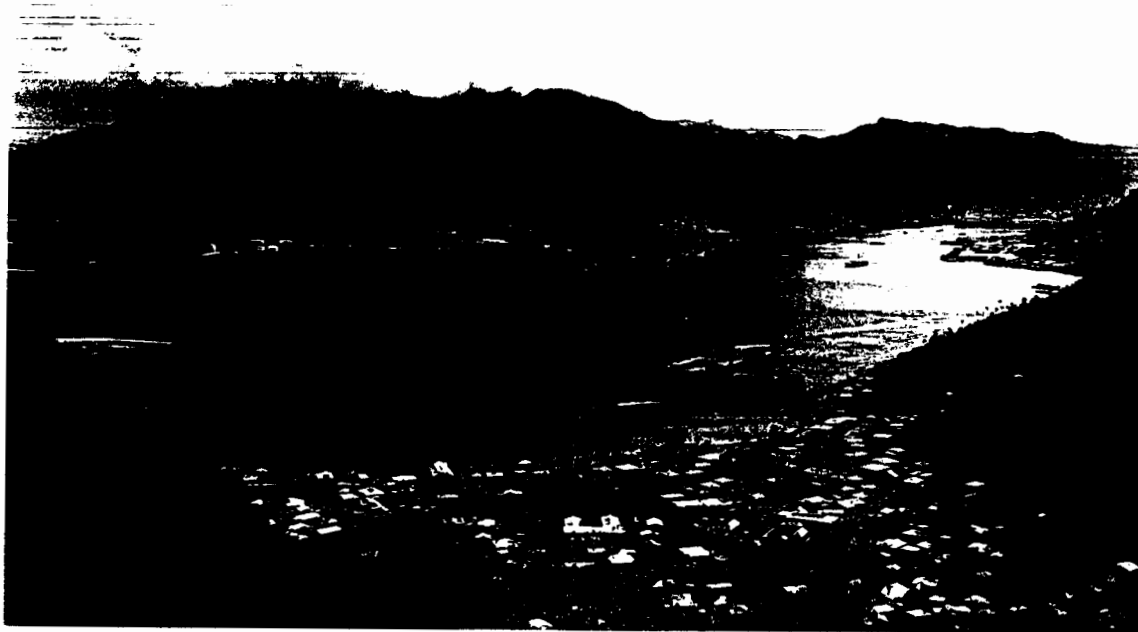
Plate A1. View to the west of Pago Pago Harbor. The village of Aua in the foreground and Site 1, Atu'u near the docks on the right.

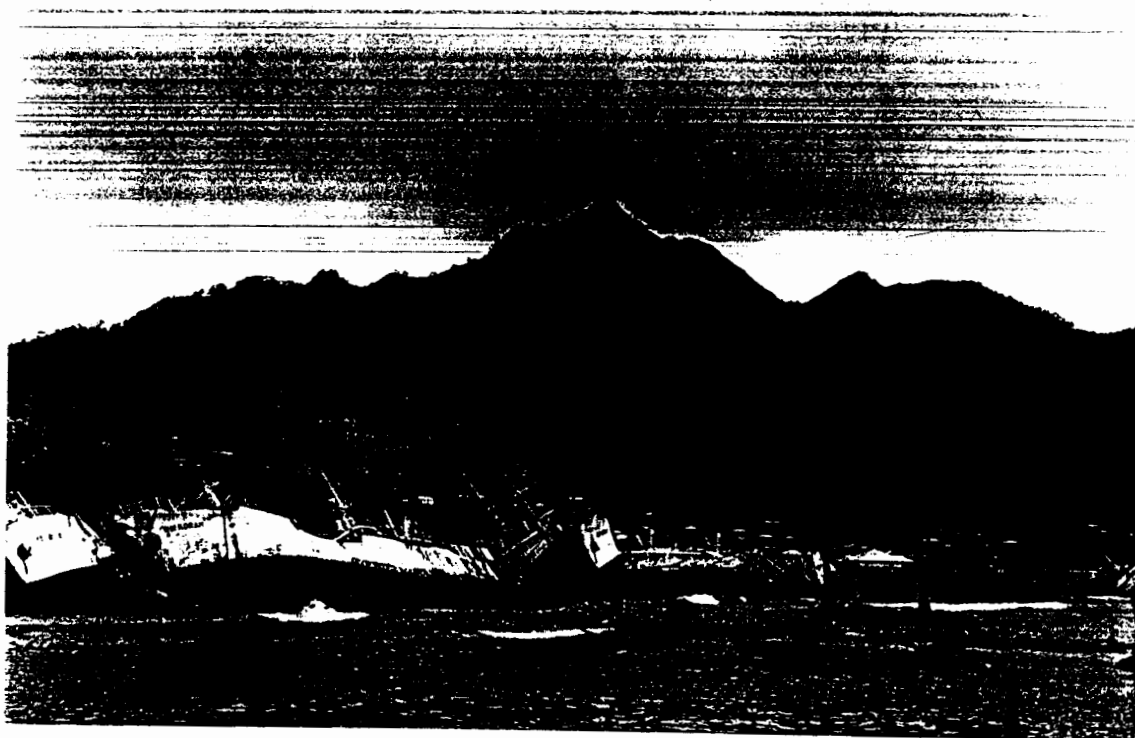
Remarks: Little remains of the natural shoreline. Photos of the groin in U.S. Army Corps of Engineers (1980, 1989) show three coconut palms; at the time of this survey only two remained.

Plate A2. Photograph showing the groin remnant and stranded ships on the reef flat at Leloaloe. View to the southwest.

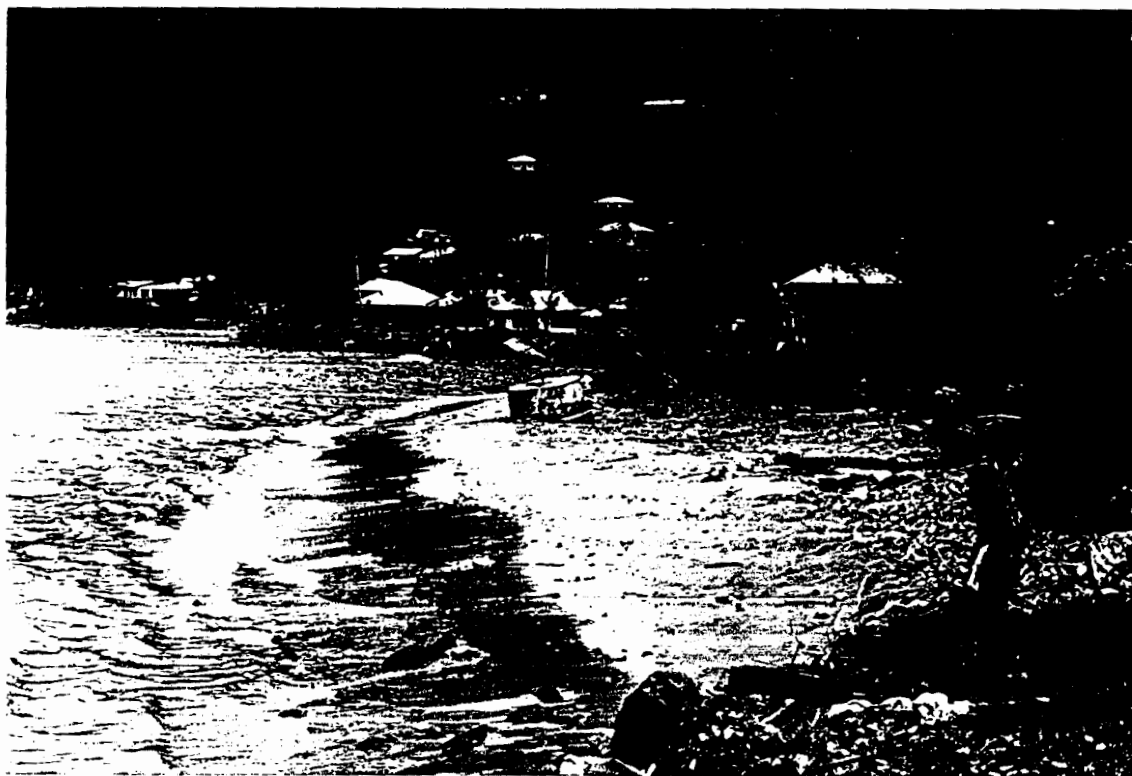
Remarks: The houses on the seaward side of the road are in a hazardous location because of the low elevation of the coastal plain and chronic erosion in the area.

Plate A3. Shoreline at Aua showing crude seawalls in the background and a narrow beach in the foreground. View to the north.

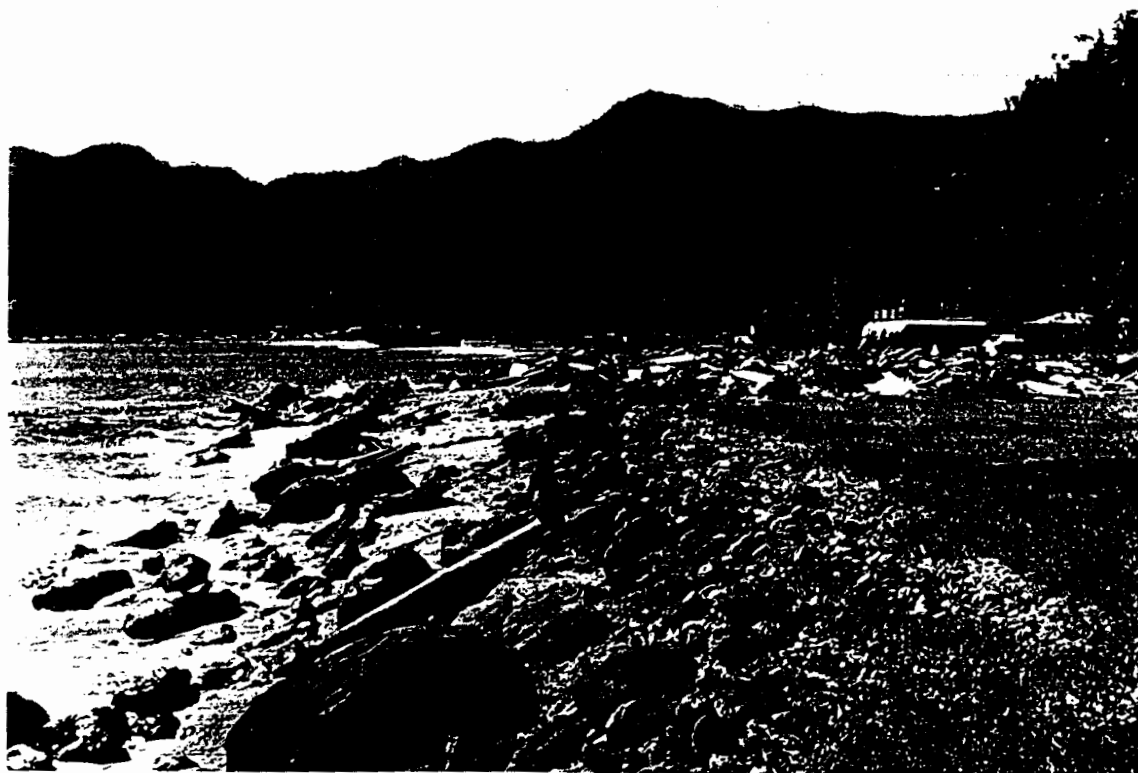
Engineering Structures and Coastal Stability: An extensive land reclamation project (sanitary landfill) has been built on the reef flat surface. It extends about 100 m seaward of the former shoreline (approximately marked by the road location) and is fronted along its seaward margin by loosely placed basalt boulders. The coastal road is also bounded by a basalt boulder revetment.

Remarks: The seaward margin of the sanitary landfill appears to be undergoing slight to moderate erosion and leaching.

Plate A4. Shoreline of the sanitary landfill reclaimed land showing loosely-placed boulders and erosion of the upper seaward edge. View to the north.

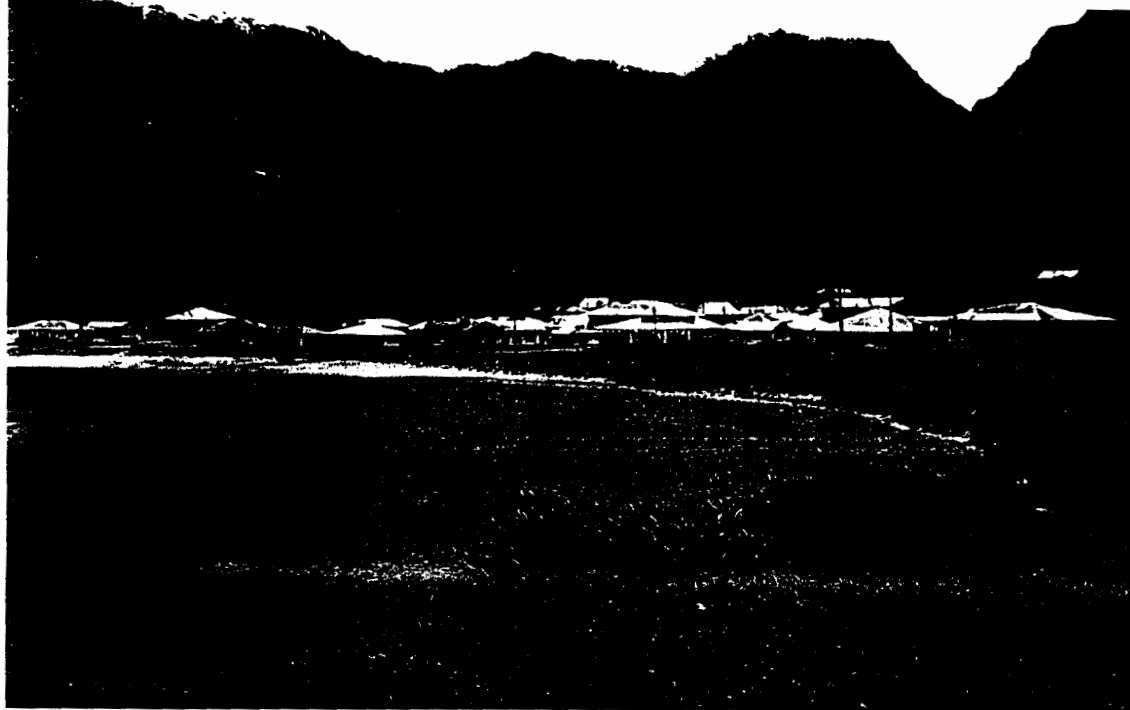
Engineering Structures: Loosely placed basalt boulders form a revetment between the beach and coastal road presumably indicative of a long-term erosion problem. Undermining and erosion of the boulders is evident in some stretches.

Remarks: The adjacent beach to the west at Lauliifou contains a building foundation on the seaward side of the coastal road, which includes a vertical seawall. This foundation has interfered with littoral drift in the area. During the study illegal sandmining using shovels and a pick-up truck was observed. At Aumi, to the east, a WWII pillbox is undermined and tilted indicating erosion has occurred since its construction.

Plate A5. View from Lafiga Pt. to the north showing the village of Lauli'ituai and the adjacent shoreline.

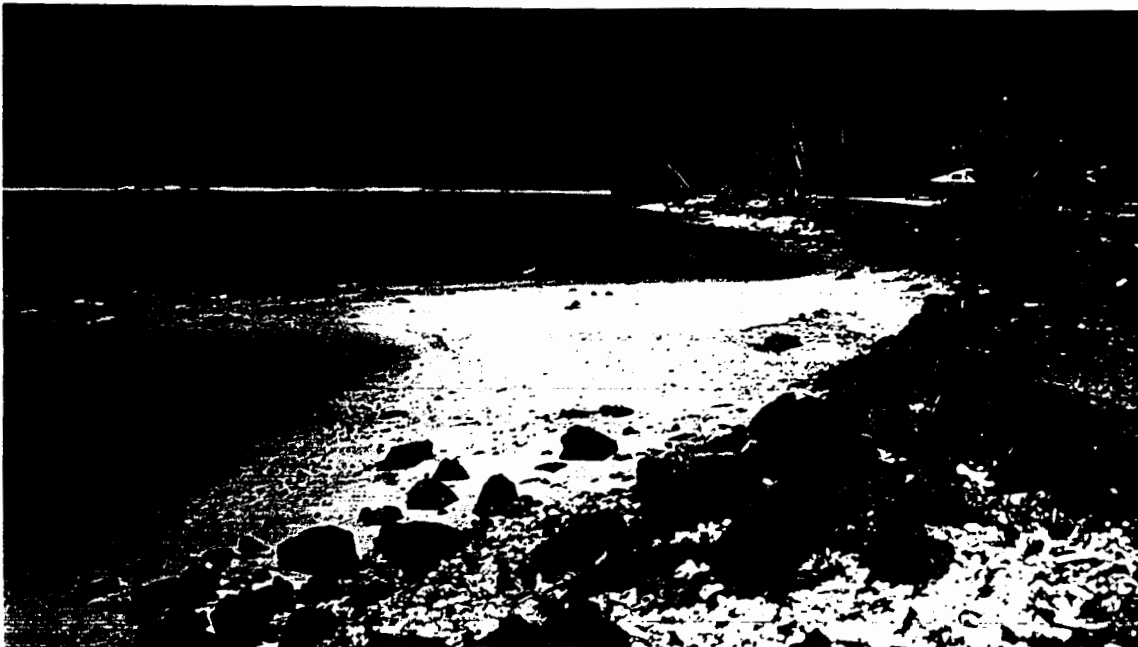
Remarks: Well-developed sandy shoreline and tombolo occurs to the west at Avaio. A WWII pillbox is stranded on the inner reef flat at Afulei indicating erosion.

Plate A6. Shoreline near Auto showing basalt boulder revetment to stabilize the coast road and an accumulation of carbonate sand on the reef flat. Only small areas of beach remain.

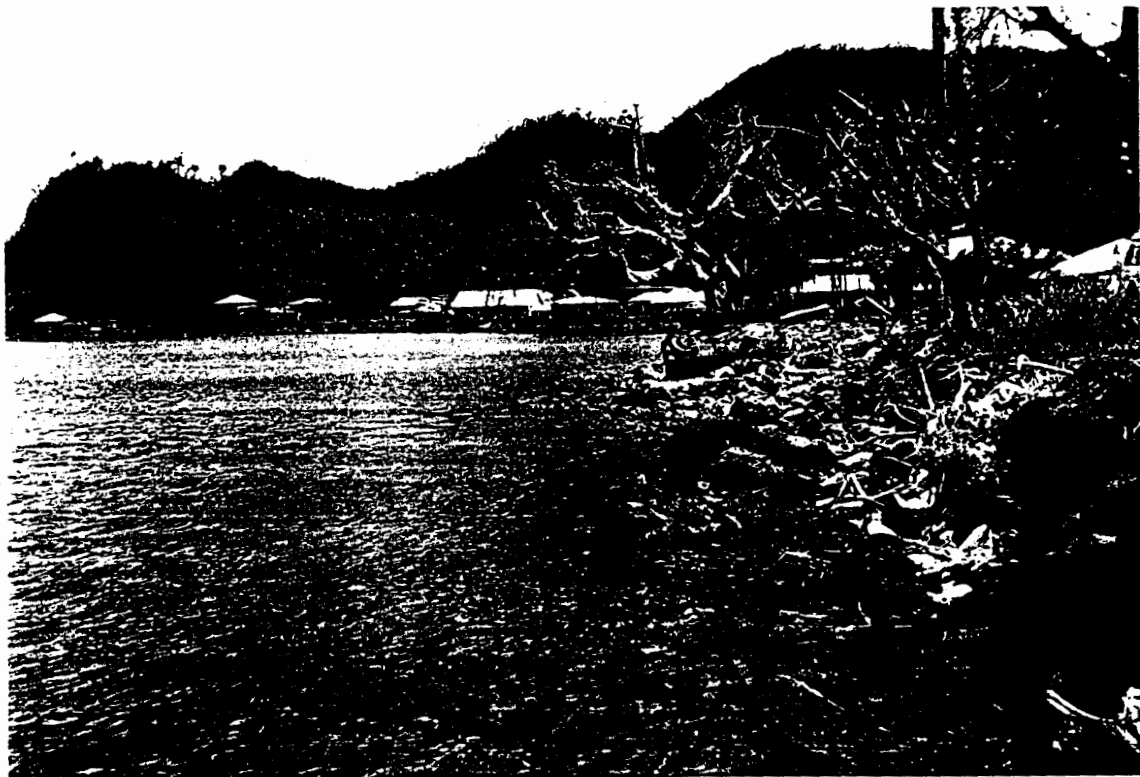
Engineering Structures and Coastal Stability: The coastal road is protected by a 600 m long boulder revetment and sits about 2.5 m above the mean low water level. Erosional scarps are common between the boulders and the road. The village is sited landward of the road with the exception of a single dwelling/foundation on the seaward side.

Plate A7. Shoreline within Fagaitua Bay showing loosely placed basalt boulders on the seaward side of the road.

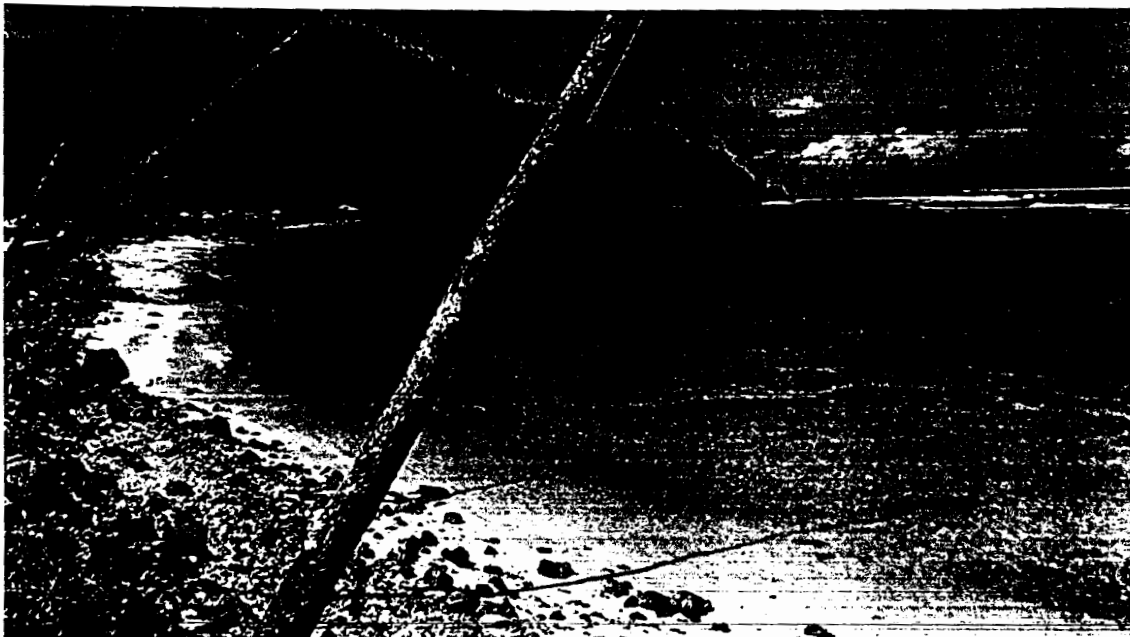
Plate A9. View to the east of the embayment at Amouli. The dark bands in the center of the picture at the toe of the beach are beachrock exposures.

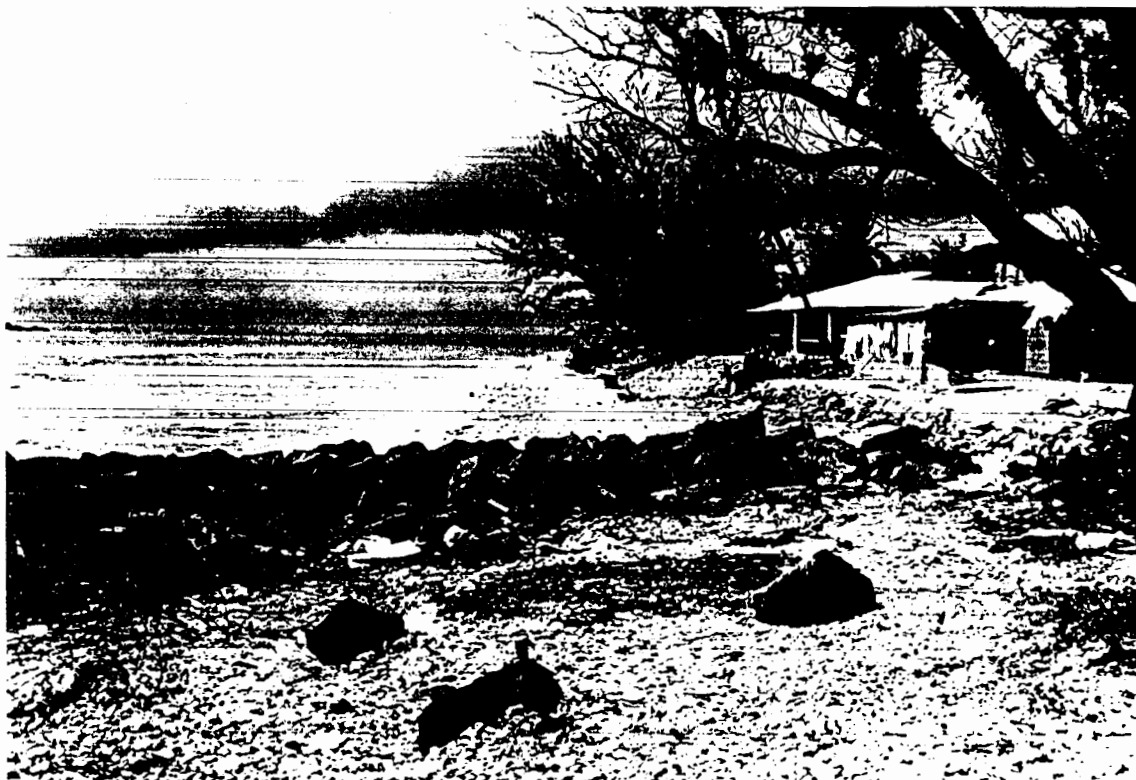
Plate A11. Shoreline of western 'Aunu'u showing a small groin of basalt boulders constructed as a result of erosion associated with the small boat harbor.

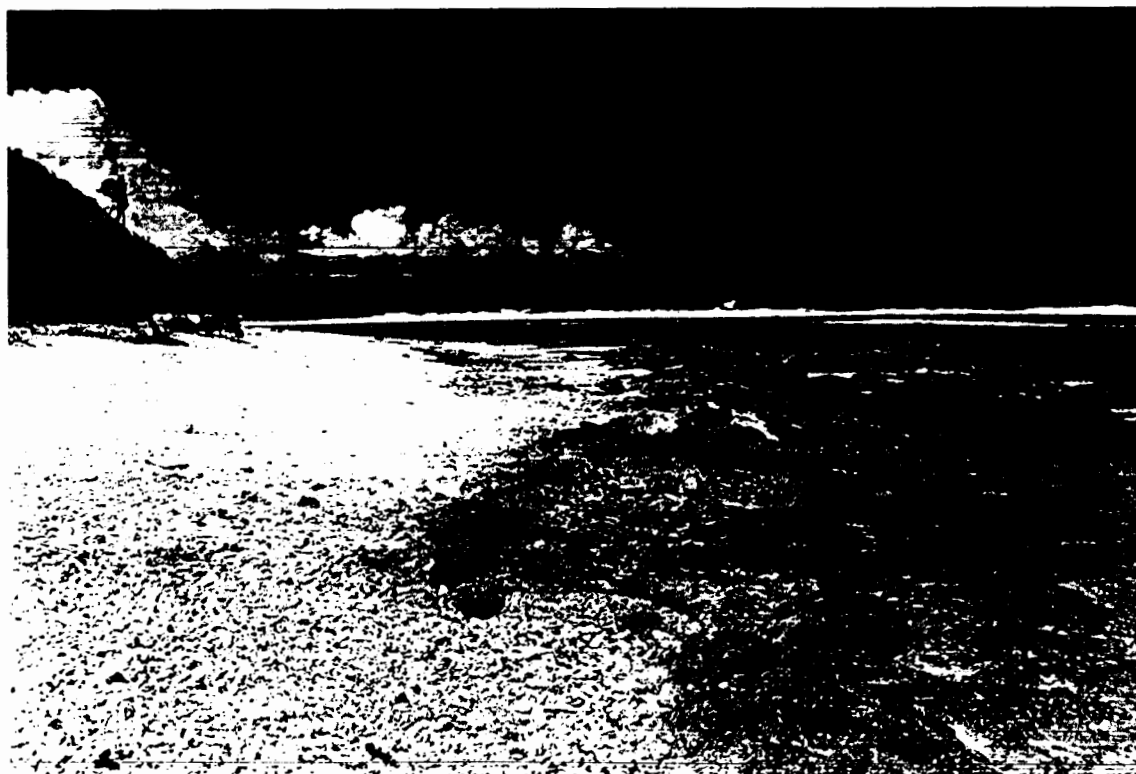
Plate A12. Southern 'Aunu'u shoreline showing extensive beachrock exposures which denote a former position of the shoreline.

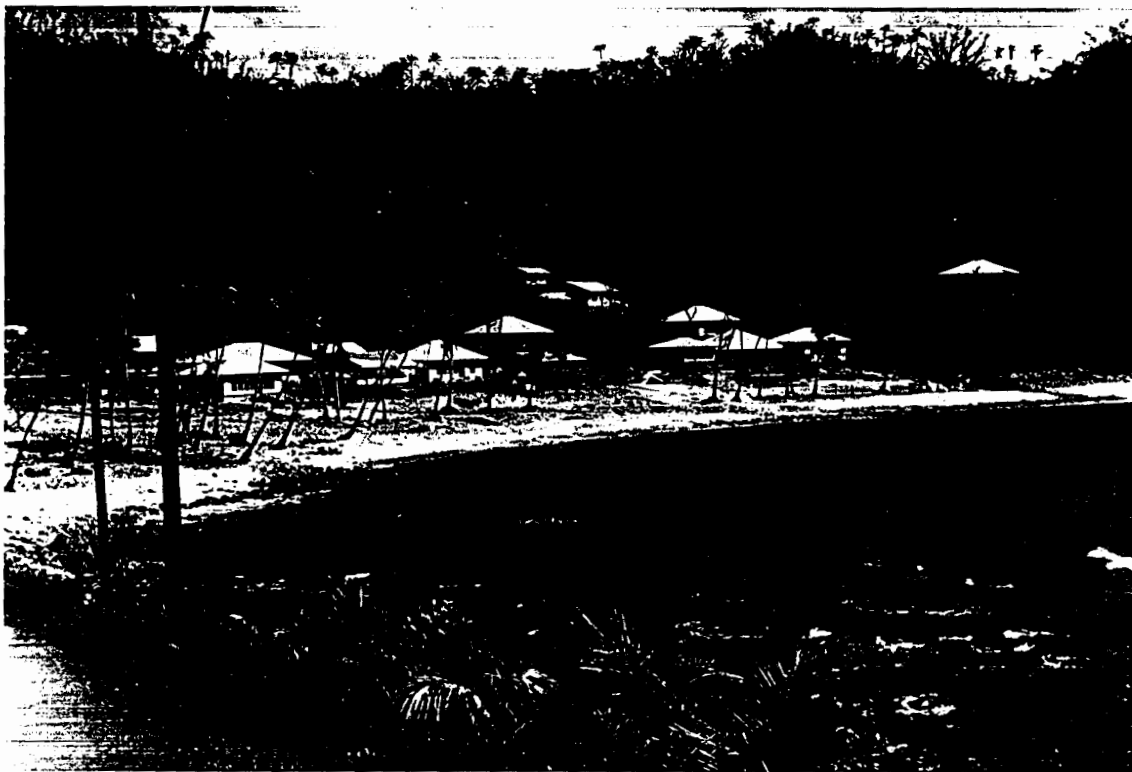
Remarks: The backbeach area has been cleared of most vegetation increasing the potential susceptibility to overwash damage.

Plate A13. The beach at Onenoe. View to the southwest.

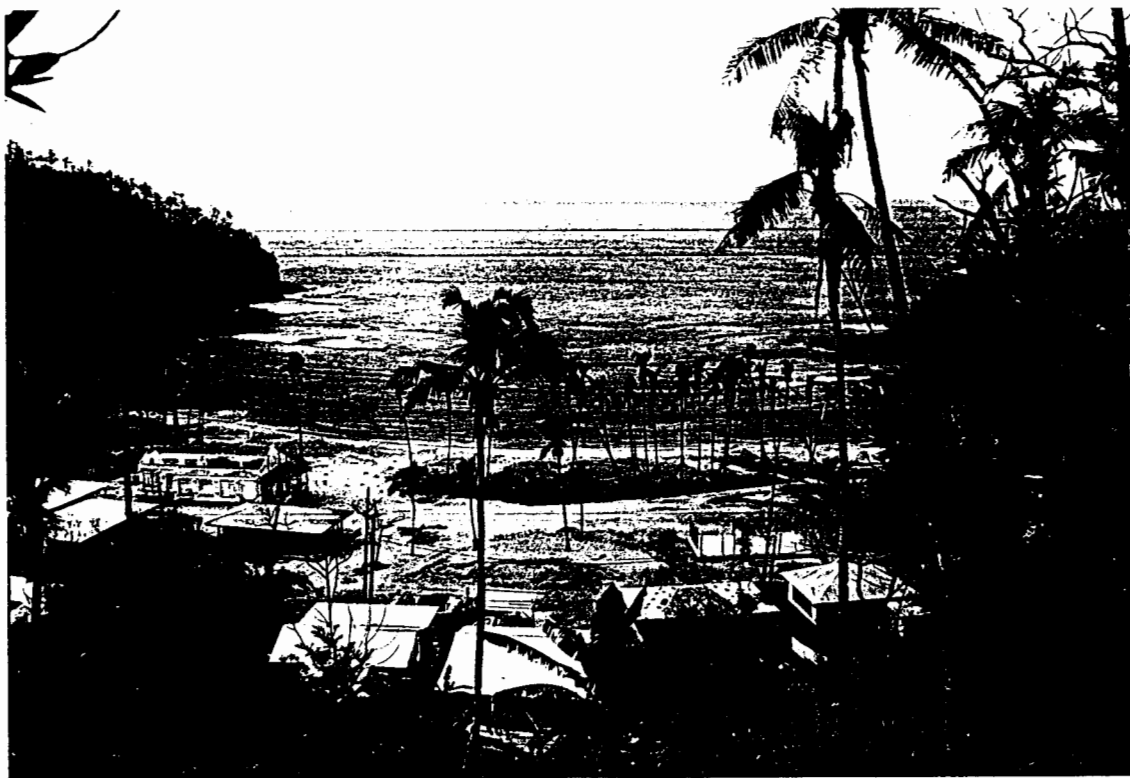
Plate A15. View to the north of the village and coastal plain at Masausi.

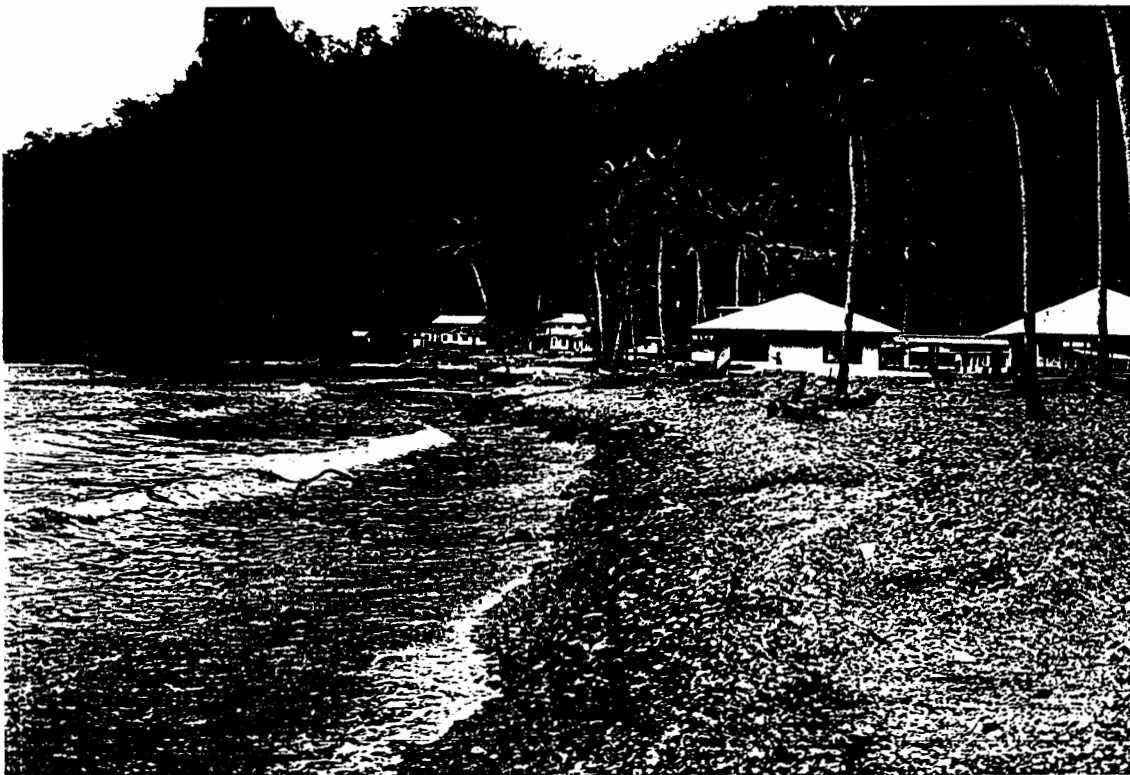
Plate A17. Gravel beach of the shoreline at Afono.
