**U.S. DEPARTMENT OF THE INTERIOR
U.S. GEOLOGICAL SURVEY**

**TUTUILA, AMERICAN SAMOA
COASTAL RESOURCE INVENTORY SITES:
RECONNAISSANCE SHORELINE GEOLOGY**

by
Bruce M. Richmond¹
1995
Open-File Report 95-512

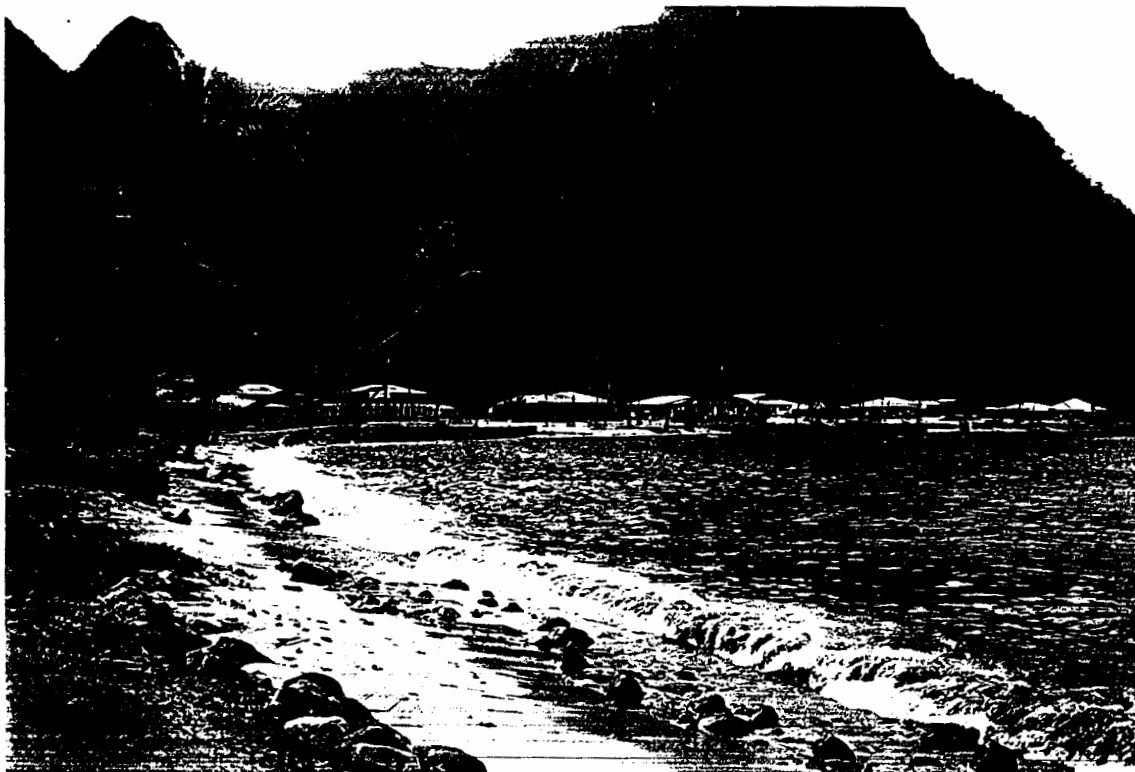
Plate A18. Shoreline near the village of Vatia showing eroded basalt boulders littering the foreshore.

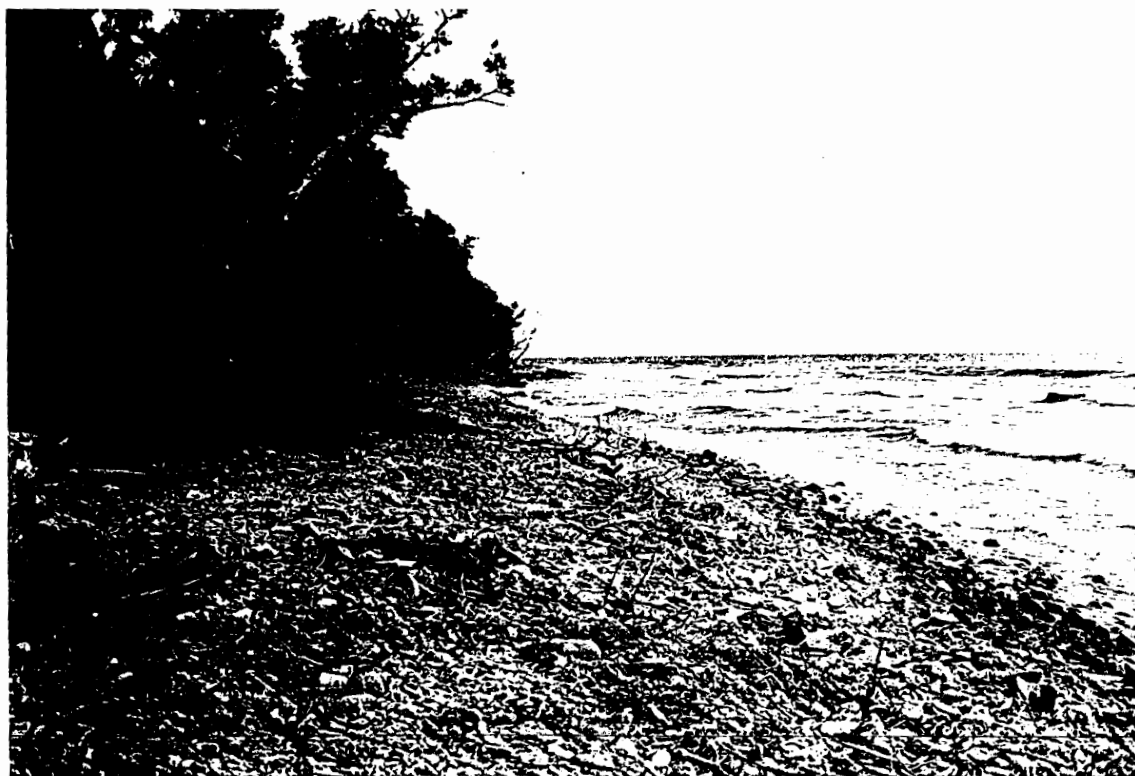
Plate A19. Gravel beach near the end of the peninsula at Vatia.

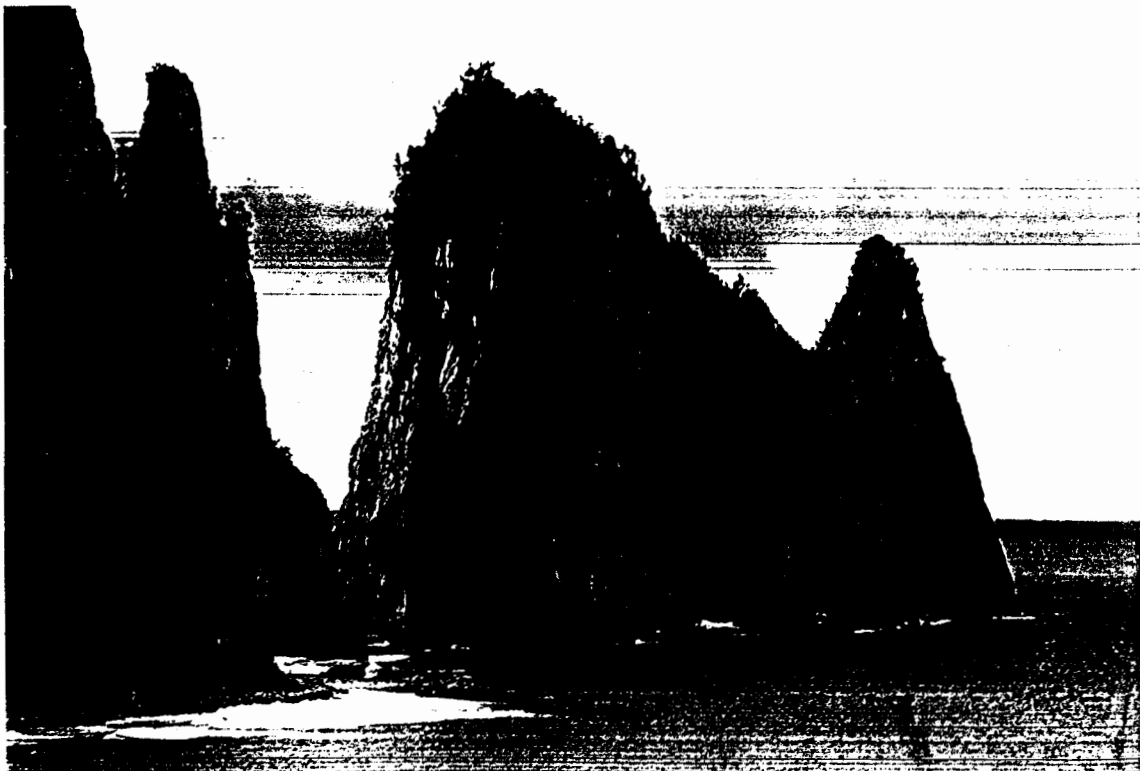
Plate A20. Eastern side of Pola Island showing the steep cliffs plunging directly into the sea.

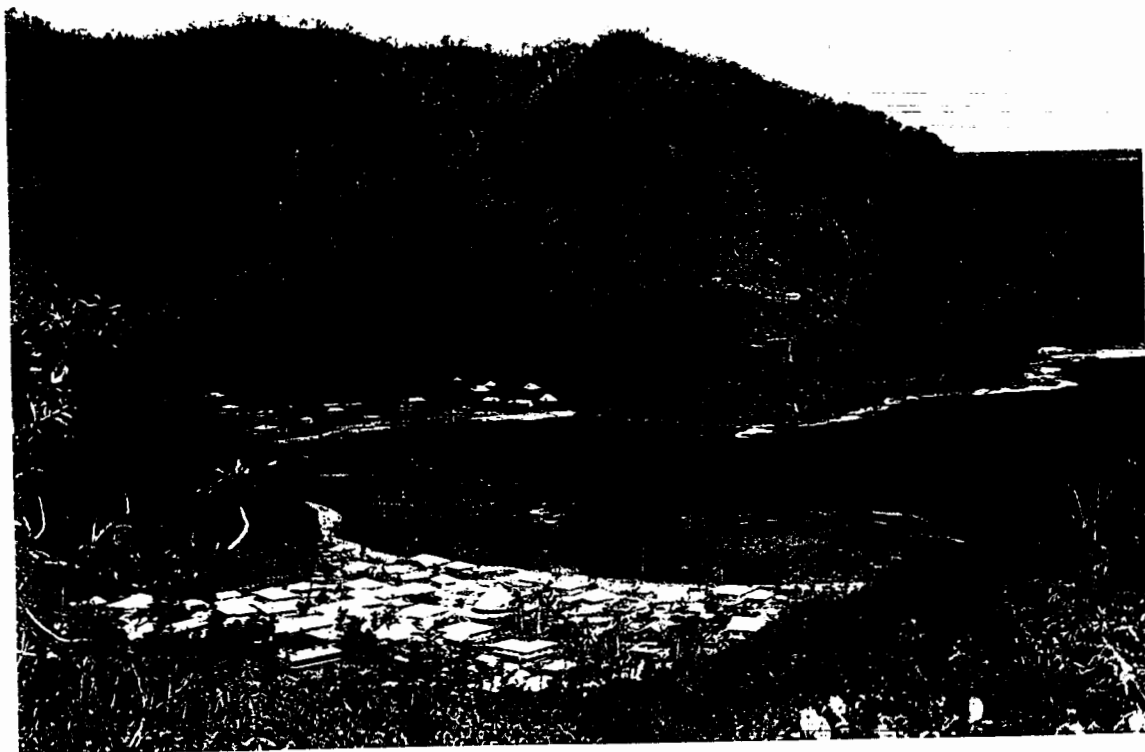
Plate A22a. Fagasa Bay from the entrance road showing the reef indentations associated with the stream mouths.

Adjacent Reef Characteristics: Natural channels in the fringing reef opposite two streams extend almost to the shoreline. The reef is up to 150 m wide and tapers to practically nothing beyond the bay entrance.

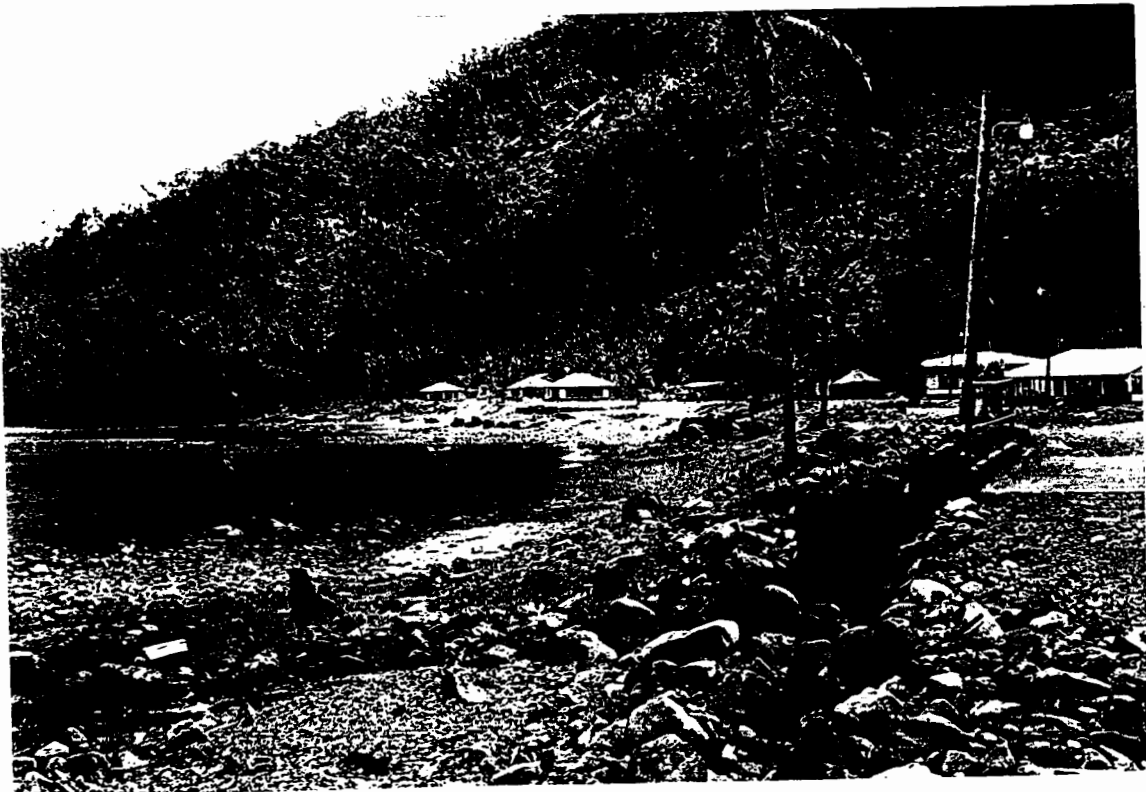
Engineering Structures and Coastal Stability: Several revetments and a concrete boat ramp mark the foreshore. The revetments are in generally poor shape. Several beach scarps were observed and a stranded WWII bunker indicates a potential chronic erosion problem.

Plate A22b. Gravel shoreline of mostly basalt sediment near the village of Fagasa.

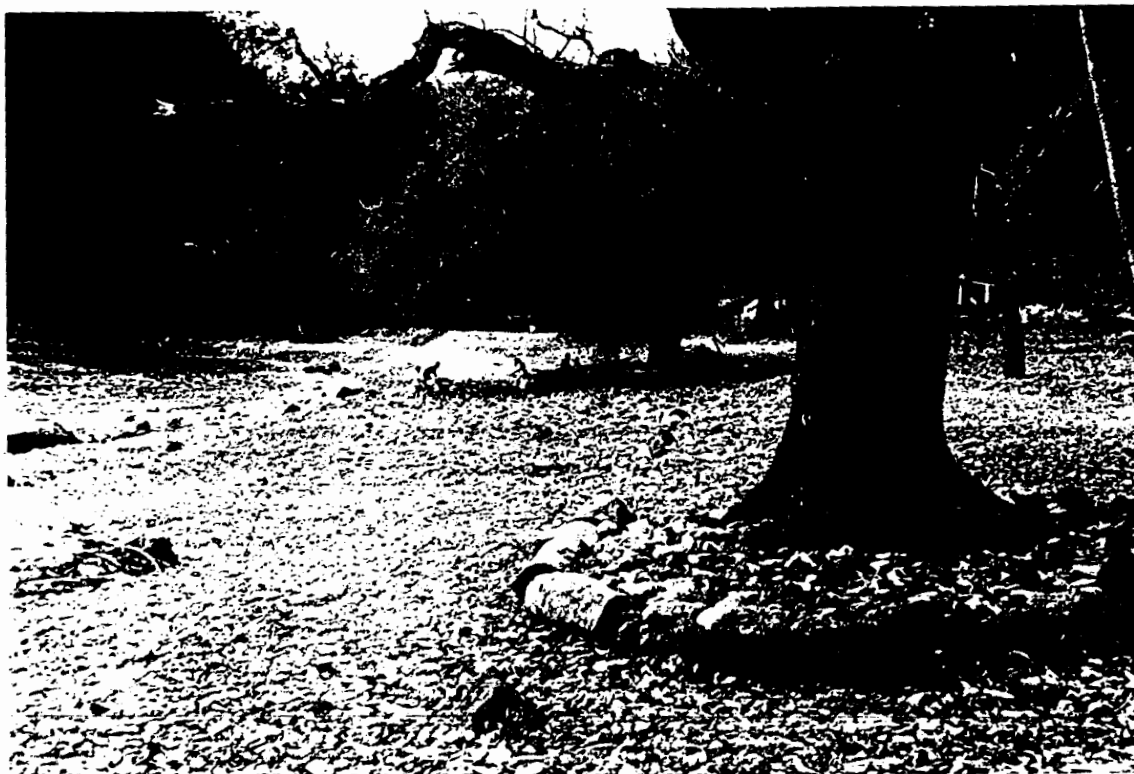
Plate A25. Gravel beach face at Fagamalo. View to the north.

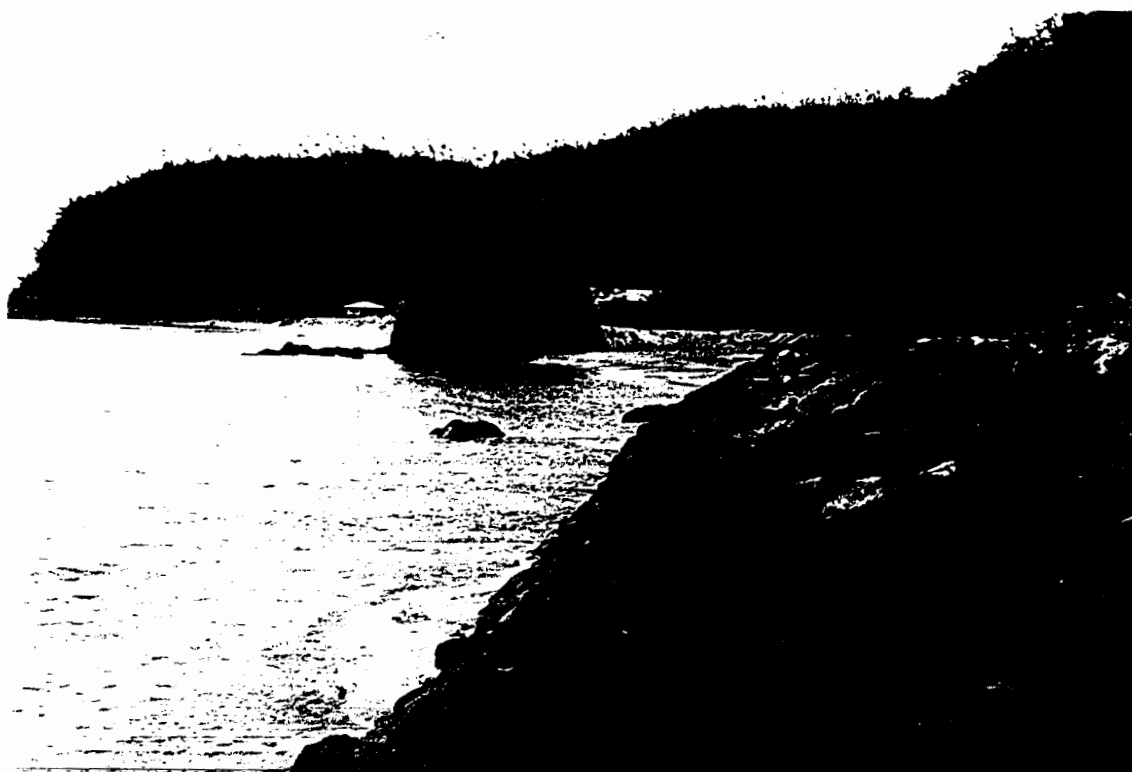
Engineering Structures and Coastal Stability: A massive revetment, about 145 m long, protects the Poloa School in the southern part of the beach. The revetment was recently overtopped causing damage to the school. Small erosional scarps were visible on the beachface, but a WWII bunker is still set back from the active beach suggesting relative long-term stability.

Plate A27. View to the north of the shoreline at Poloa showing the massive revetment (foreground) and basalt seastack (middle).

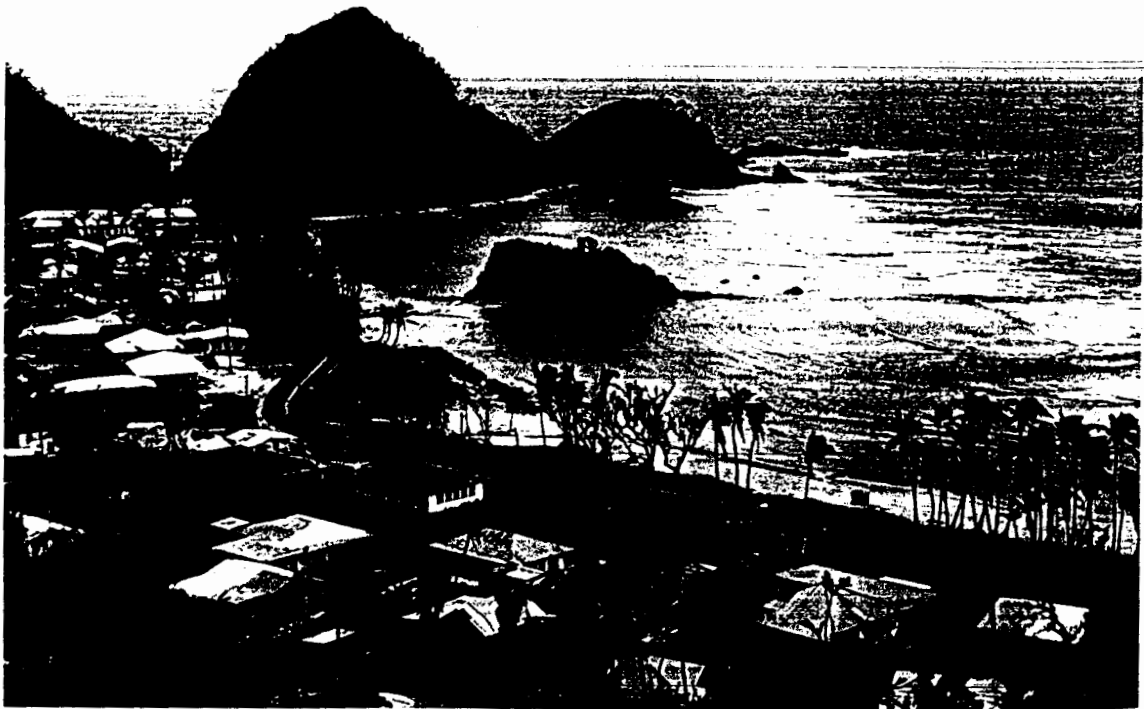
Engineering Structures and Coastal Stability: A revetment of loosely placed basalt boulders in the center of the bay forms the seaward margin of a small area of apparently reclaimed land. Small erosional scarps are common and the coastal road appears threatened in some areas. A WWII bunker is stranded in an unvegetated backbeach area indicating a small amount of long-term erosion likely. Beachrock exposures are discontinuous along the waterline.

Plate A28. View of 'Amanave Bay from the road to Poloa. The seastack and tombolo are visible in the center of the photograph.

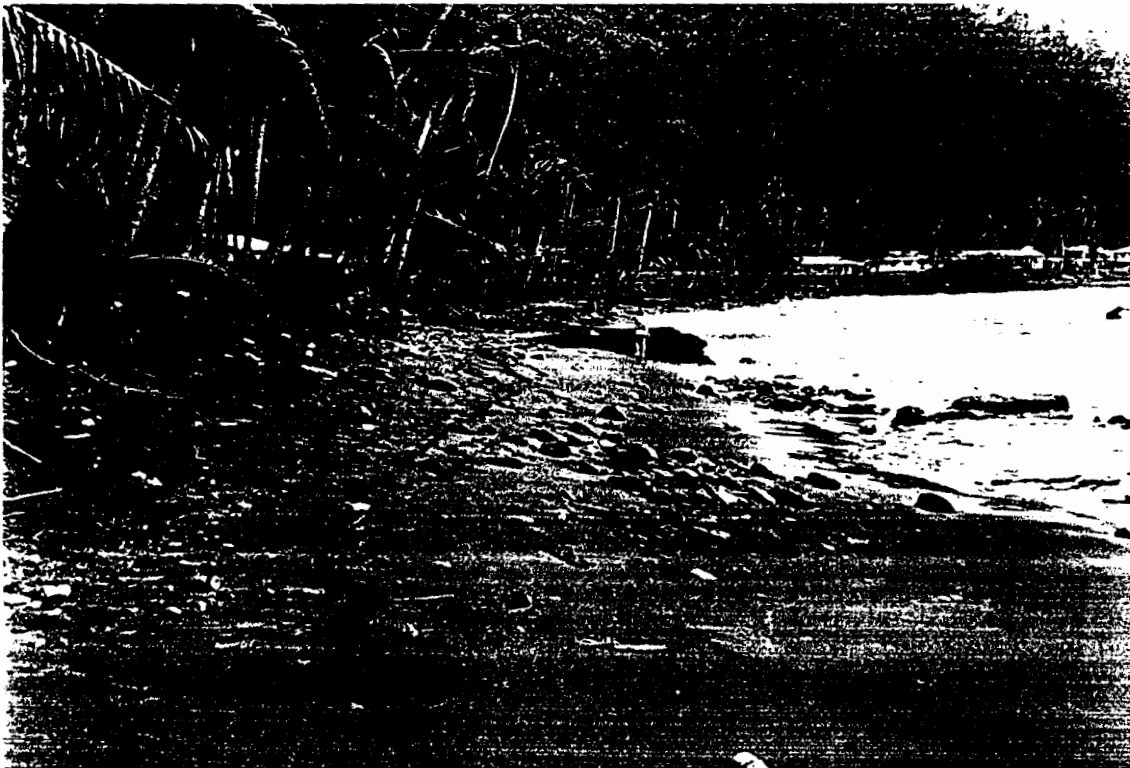
Remarks: In general, the terrigenous component of the beach sand decreases away from the stream mouths.

Plate A29. The beach at Utumea showing a high amount of terrigenous beach sand as indicated by the dark color. A basalt bench is outcropping in the center of the photograph.

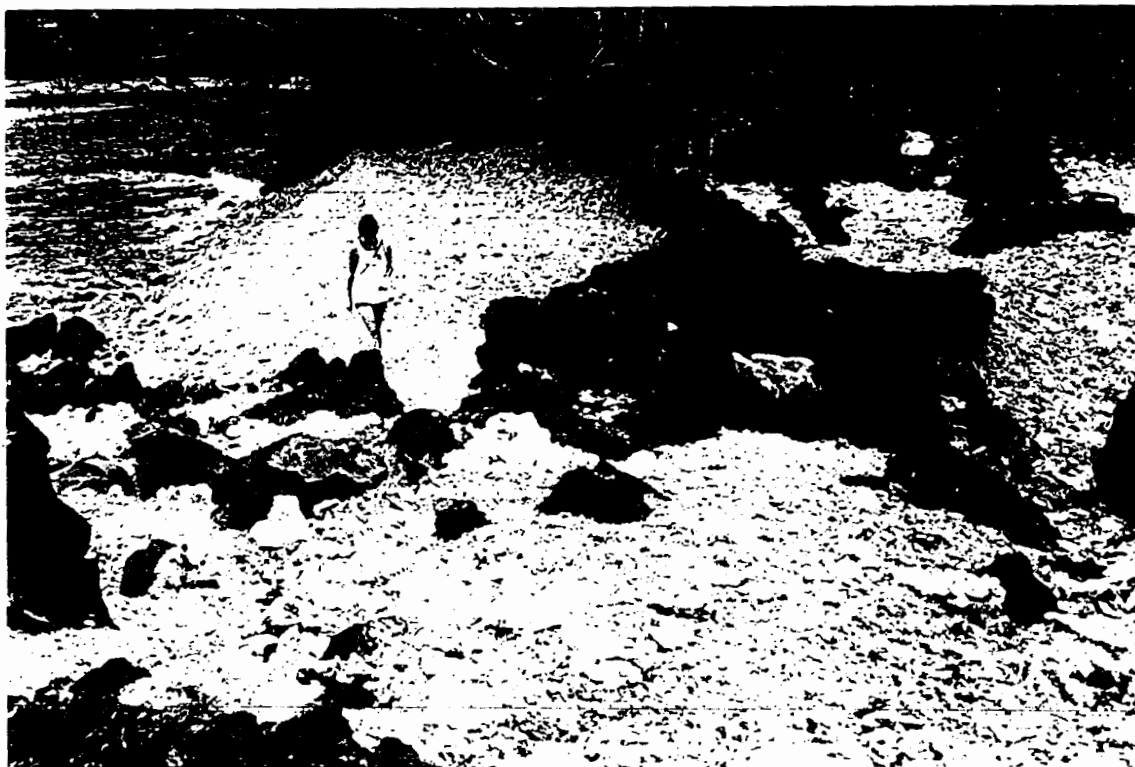
Plate A31. Storm beach of coral rubble resting on basalt at Asili Point.

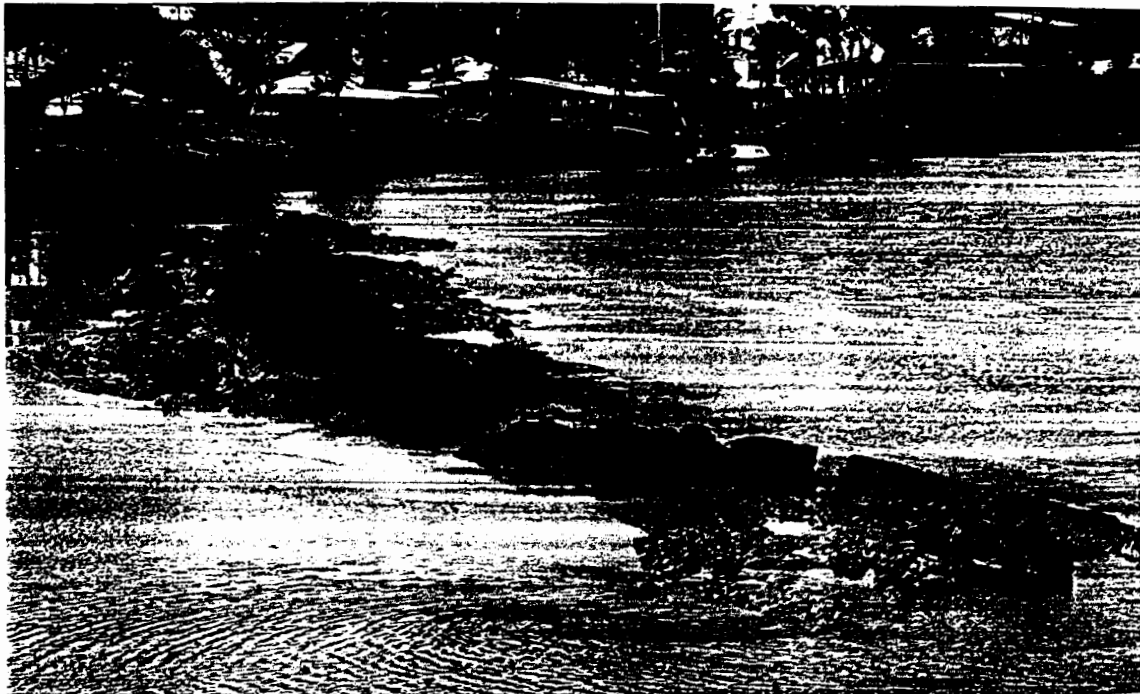
Plate A32. Beachrock denoting the former shoreline position of the barrier spit at the entrance to Pala Lagoon at Leone. View towards the east. The dark color of the beach is from the terrigenous component of the sand.

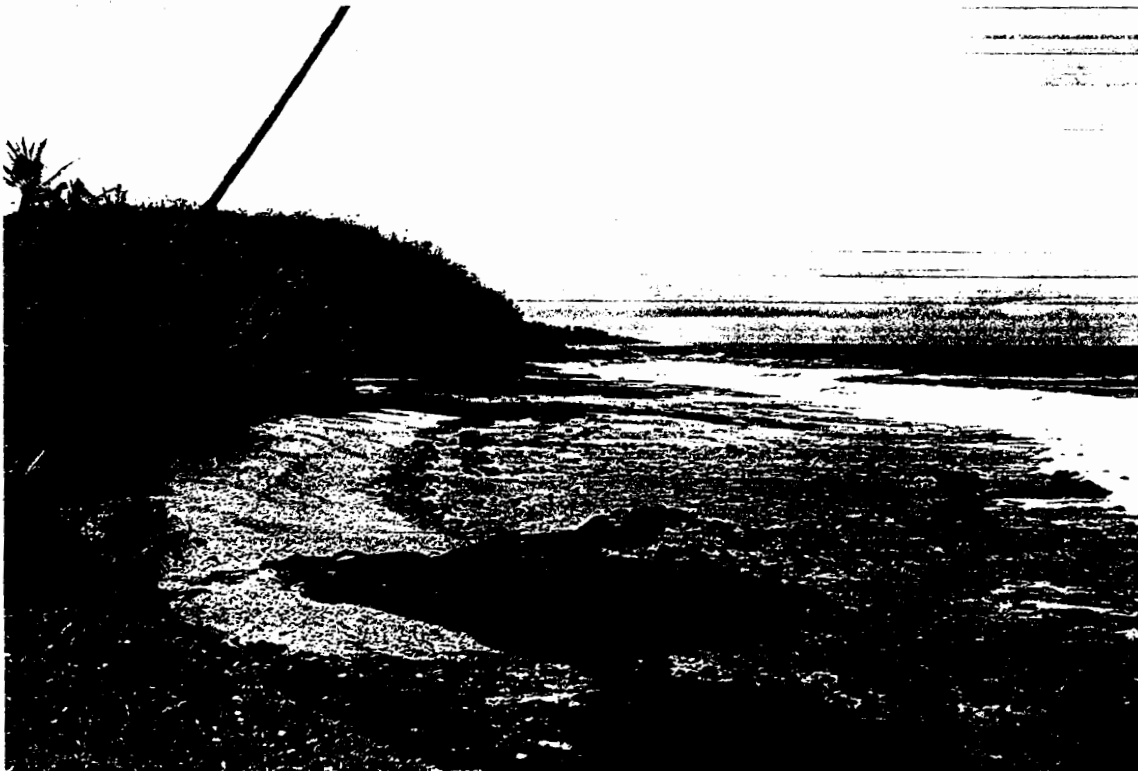
Plate A34. View towards the west of the coastline near Avaloa Pt. showing the narrow fringing reef, basalt benches, and small pocket beaches of coral rubble.

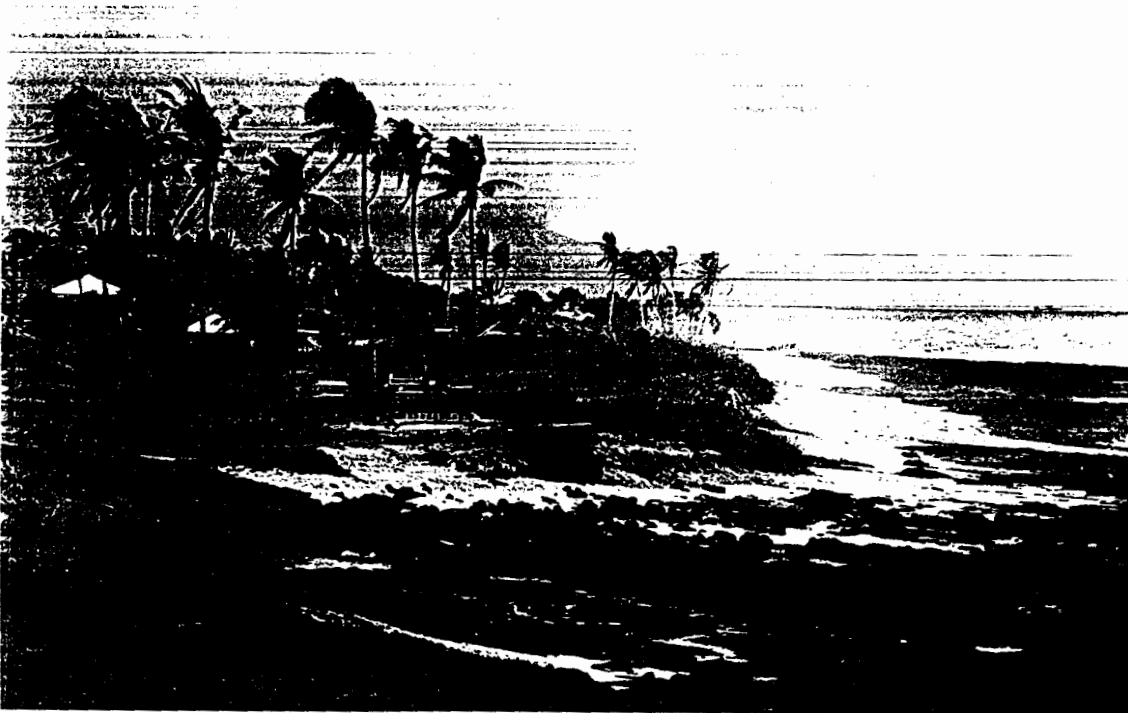
Engineering Structures and Coastal Stability: No major engineering structures were observed. Low (< 2 m) scarps in the beach face were observed and recent undermining of backbeach concrete (gravesite) structures has occurred. The erosion appears to be event related and not representative of a chronic problem.

Plate A37. View of the Vaitogi shoreline showing the carbonate sand beach and backbeach deposits perched on a basalt bench. View towards the northeast. The low basalt bench forms the shoreline. Note the lack of fringing reef development.

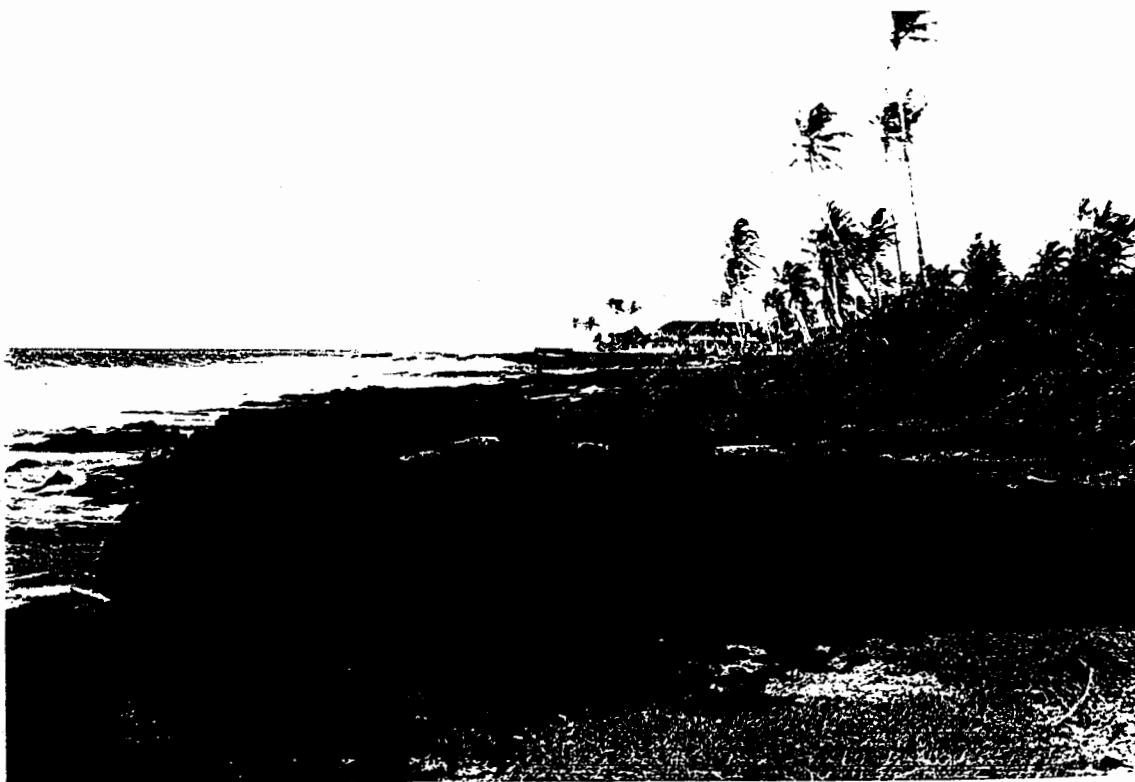
Engineering Structures and Coastal Stability: No engineering structures were observed and the basalt shoreline appeared stable.

Plate A38. View to the south at Fogagogo showing the low basalt cliffs and bench at the shoreline. Storm deposits in the foreground are composed of coral rubble.

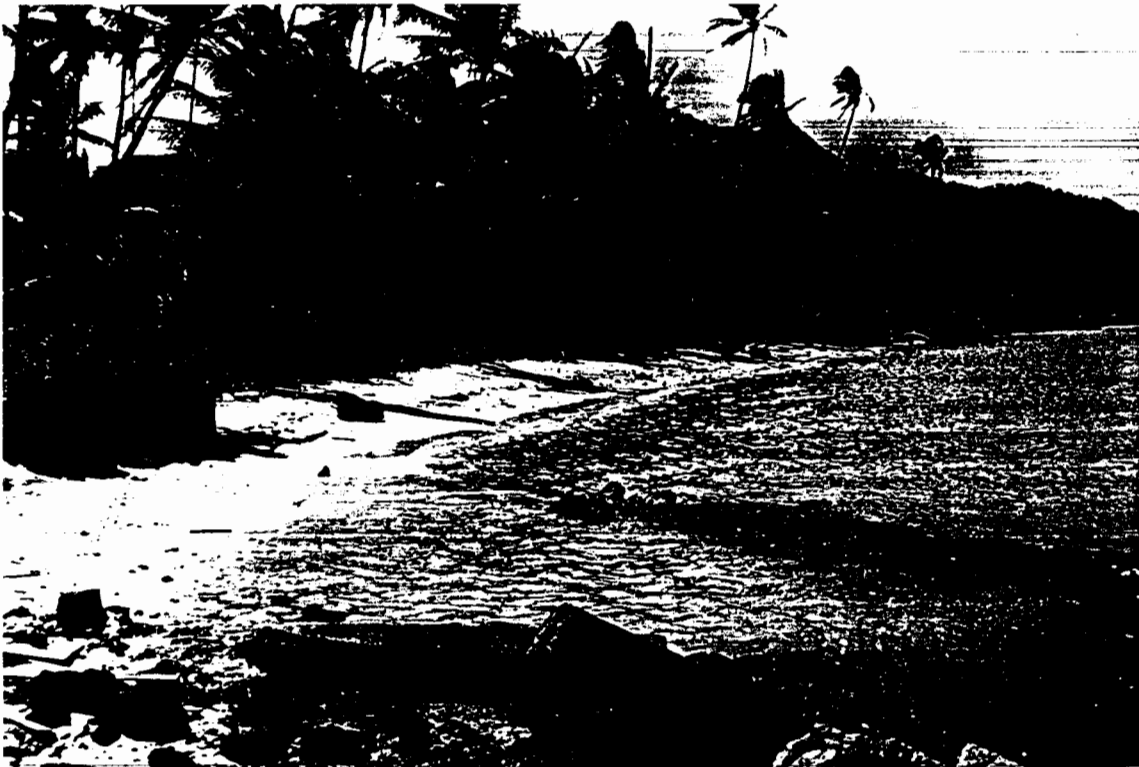
Engineering Structures and Coastal Stability: Loosely placed basalt boulders forming crude seawalls have been constructed along the seaward margin of the spit to impede the erosion, which is estimated to range from 1 - 1.5 m/yr in the south to 0.5 m/yr in the north (U.S. Army Corps of Engineers, 1980, 1989).

Plate A40. View north along the barrier spit showing the narrow beach with concrete bunkers and rip-rap in foreground and undermined coconut palms in the background.

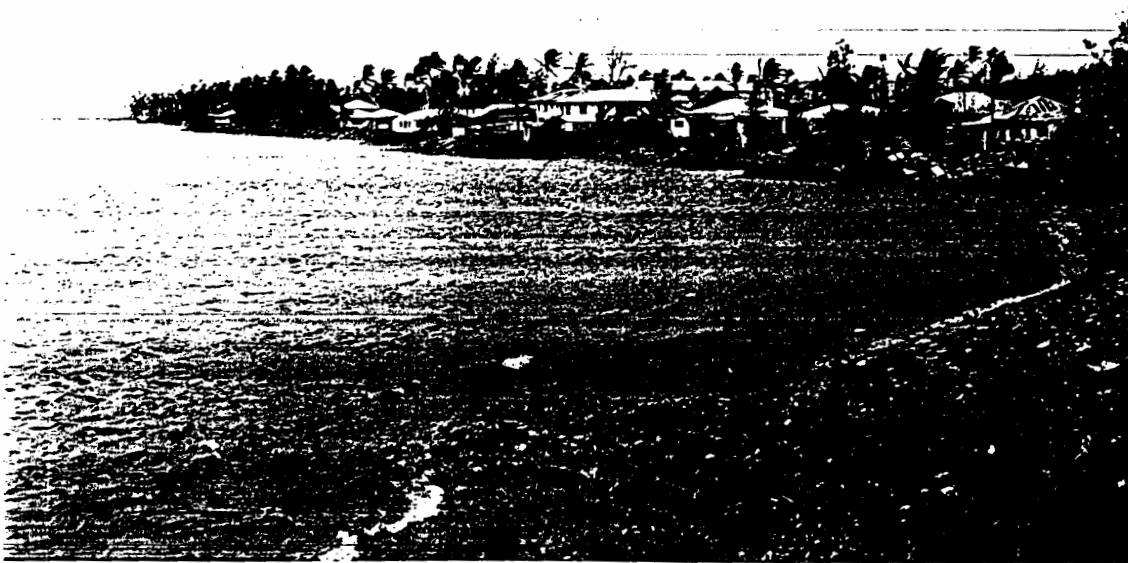
Plate A41. Shoreline at the intersection of the barrier spit with the mainland. A small flood-delta has formed at the mouth of Amaile Stream in the foreground.

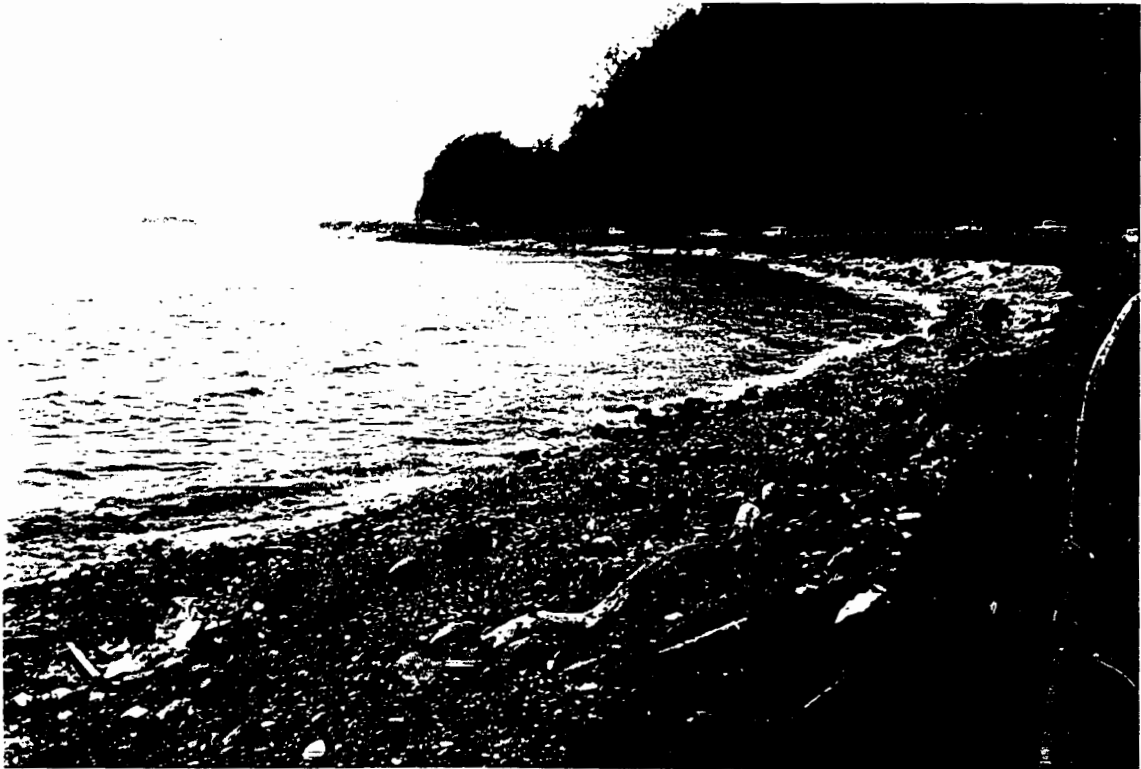
Remarks: Exposed area to southeast tradewinds. Little natural shoreline remains.

Plate A42. View from the roadway towards the southwest with Fatu'uli Rock in the background.

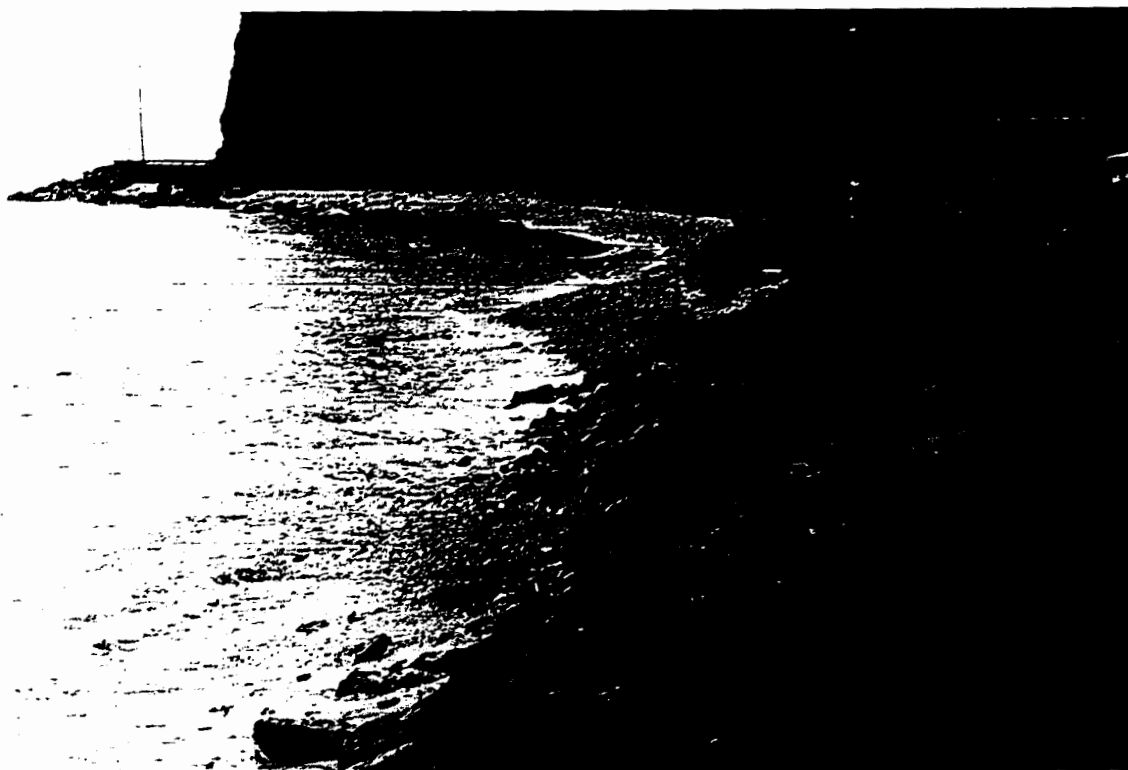
Plate A43. Basalt revetment protecting the coastal road along the shoreline near Matu'u.
View towards the southwest.

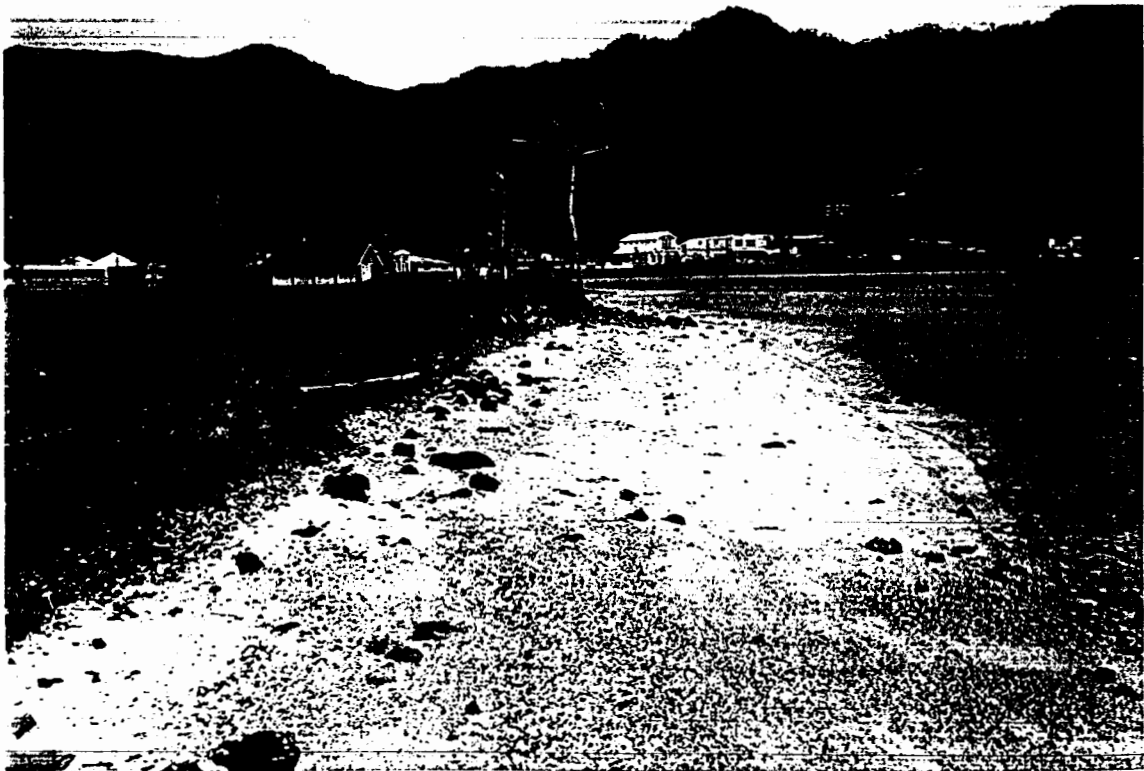
Plate A46. Shoreline of the reclaimed land area at Punaoa. Note the small scarp along the backbeach. View towards the northwest.
