*Archaeological Survey and Inventory of  
Submerged Cultural Resources in the Lagoon  
of Kwajalein Atoll:*

SITES ON THE SOUTH AND EASTERN SIDES OF KWAJALEIN ATOLL

Matthew B. Holly

HPO Report 2000/02

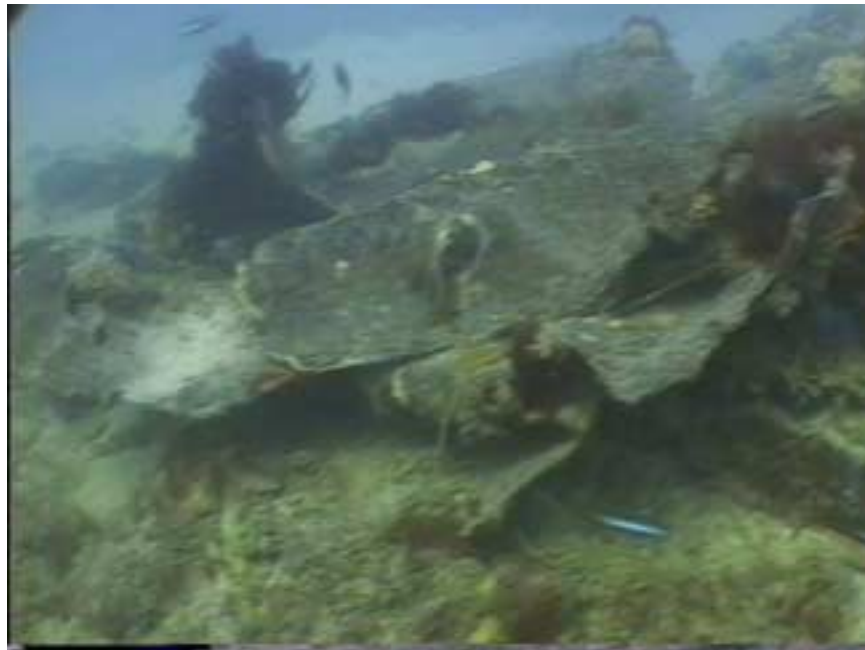
Photo KS1-1. Large Metal debris of unknown type in the north end of the debris field.

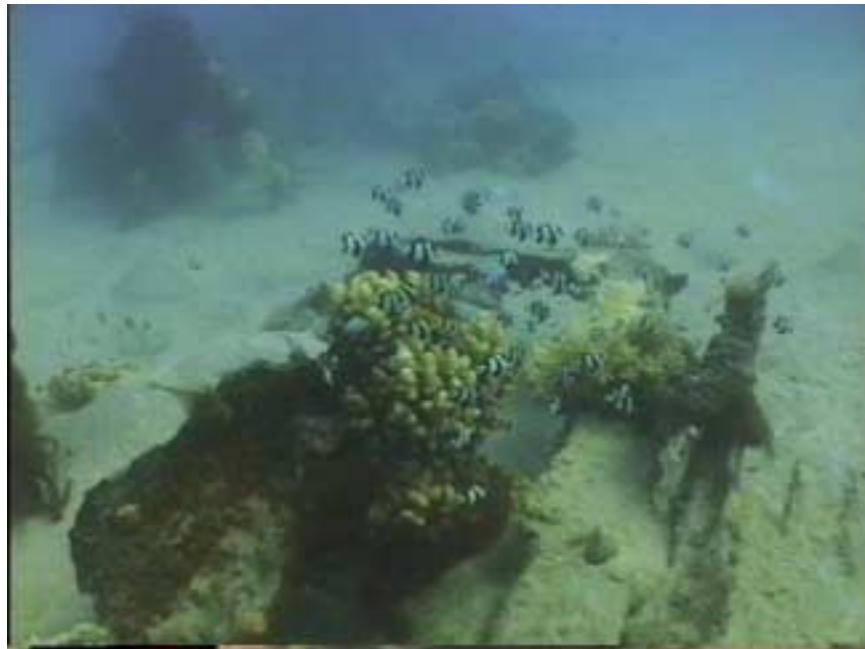
Photo KS1-3 Large Metal debris of unknown type in the south end of the debris field.

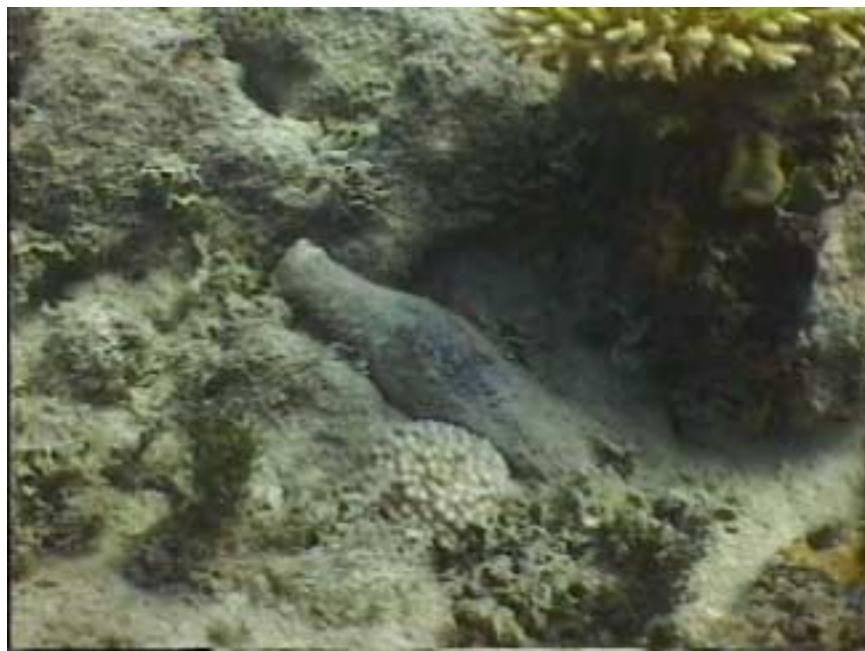
Additionally, riveted metal sections, if not hull or boilerplate, could have come from the many worn-out war era utility barges of either Japanese or American type, possibly also destroyed to make a clear path to the Gugegwe dock. This theory is re-enforced by the discovery of a large US type large anchor, over 3,000 pounds, which was well buried among the debris (Photo KS1-4). Thus, many wrecks of many types may be in the site. Numerous Coca-Cola bottles from the war years were also located underwater nearby; indicating US servicemen had frequented the pier area and tossed them into the lagoon (Photo KS1-5).

Photo KS1-5 Coca-Cola Bottle in the debris field area of the North Gugegwe Pier Wreck. Over 50 were seen in the area.

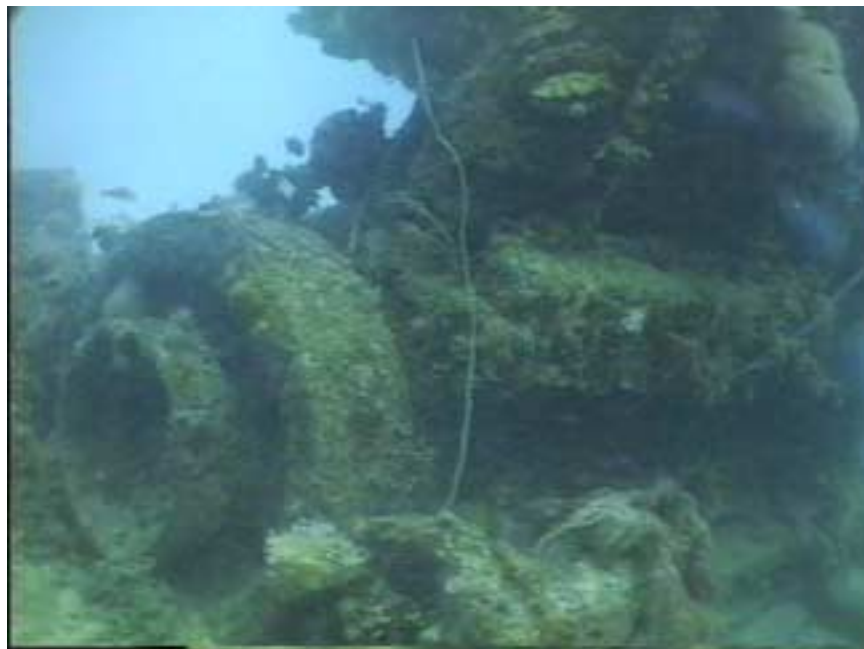
Photo KS2-1 is the vessels main engine viewed from the port side forward.

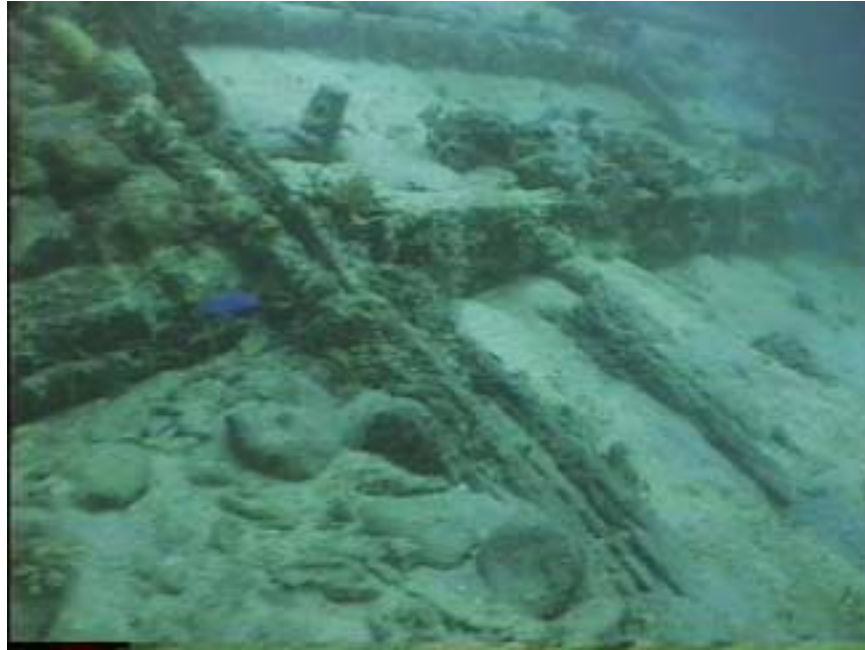
The vessel was likely not a fishing vessel, as no fishing gear, support equipment, or fishing layout was observed. The bottom of the wooden hull of the vessel (Photo KS2-2) sits partially buried in the sandy bottom on the edge of the lagoon-side drop off. Ballast stones lay in the hull bottom between the frames and ribs, from bow to amidships (Photo KS2-3). The main keel strike, frames, ribs, and assorted fittings are visible, but little else remains above the chines. Little also remains of the bow except metal fasteners, chain, and possibly a windlass with fittings among a pile of debris. The main engine is host to an assortment of coral life (Photo KS2-4).

Photo KS2-2 shows the wooden keel section amidships looking towards the stern.

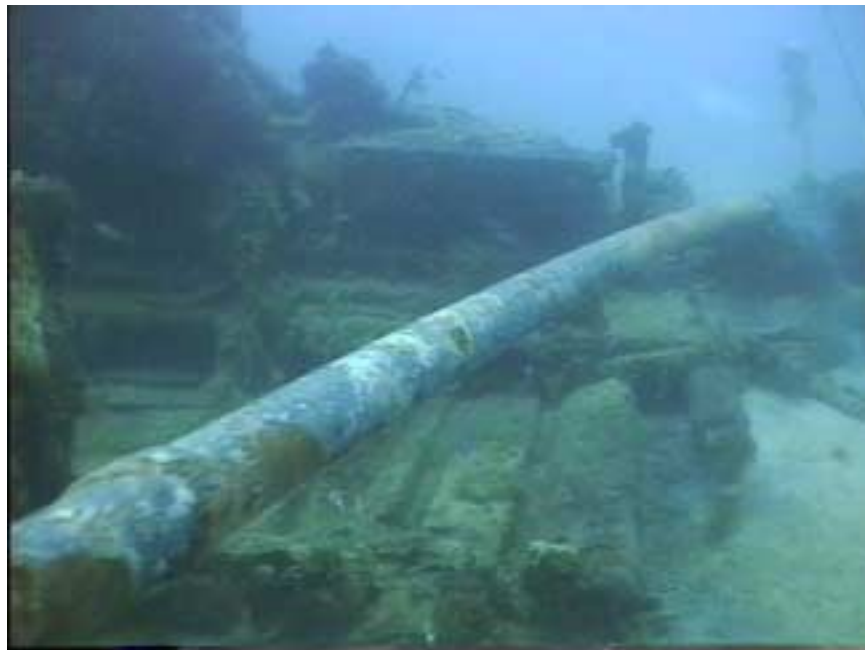
This site is a prime example of what determined collectors' can do to a site without any rules to protect it or means to enforce them. The site had been described (Miller, 1991: 92) 8 years ago with detailed cargo and artifacts, and now I couldn't find a single object worthy of any collection. The airlift and the divers searching the remains have truly stripped the site, leaving only the hull, heavy machinery and debris. The airlift proves the Kwajalein divers have been there and gone. The site is still an interesting dive, but has not much to offer besides the knowledge you are diving on a Japanese WW2 wreck.

Photo KS2-5 shows the remains of an airlift used to search the vessel and surrounding area for artifacts.

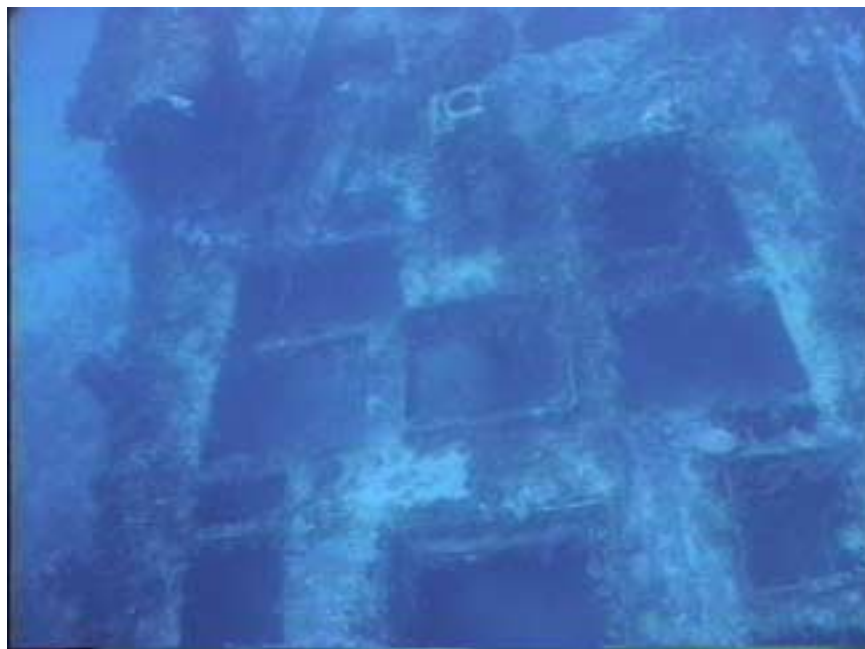
Photo KS3-3 Main deck of Shell Island Wreck. Note mainmast circular boss in top of photo, and inner-connecting forward holds from the visible inner lighting.

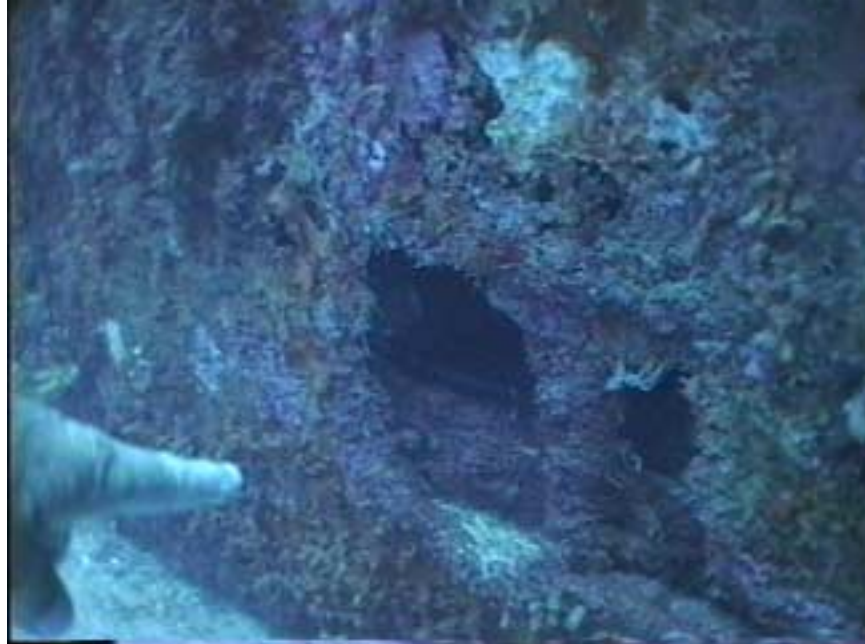
Photo KS3-5 A hole located on the starboard side below the waterline.

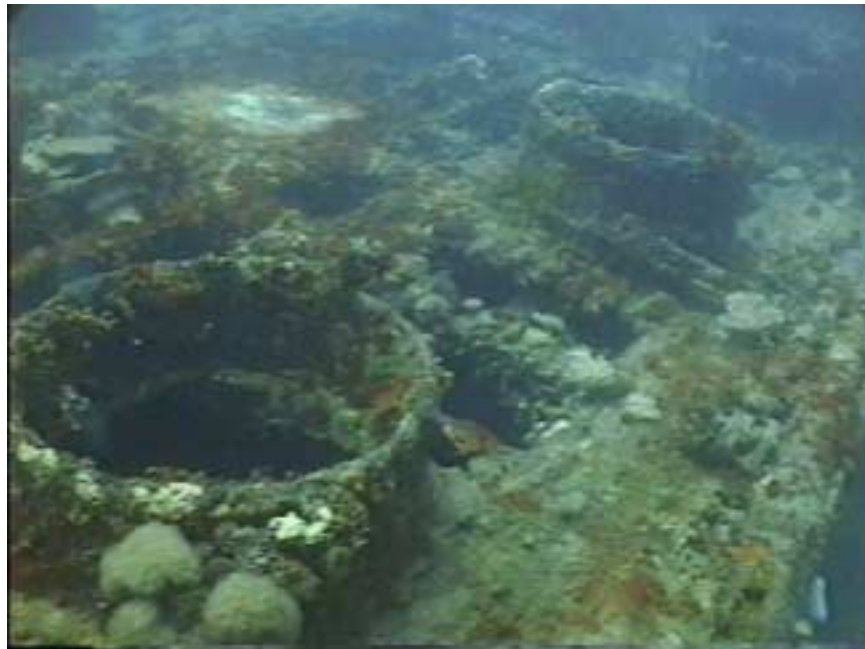
Photo KS4-3 Typical round and raised bait tank combings of a fishing vessel.

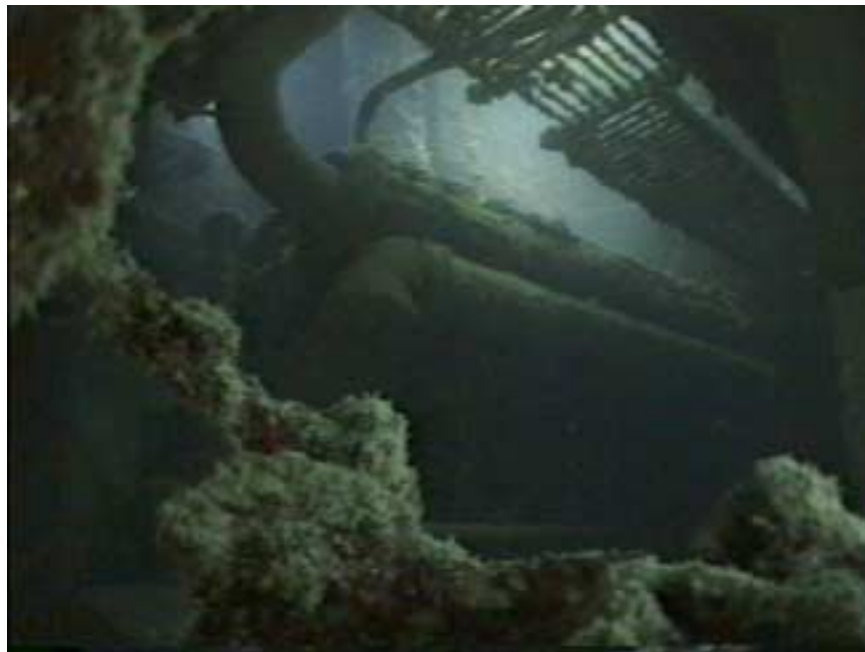
KS4-8) to look for additional artifacts. Holes in the starboard sheeting allowed me to photograph the main engine and engine room (Photo KS4-9). No personal artifacts were found, all that remains is machinery and some spare parts such as cables and hoses in the forward compartment (Photo KS4-10).

Photo KS4-9 Engine room of North Lot wreck viewed from a hole in the hull starboard.

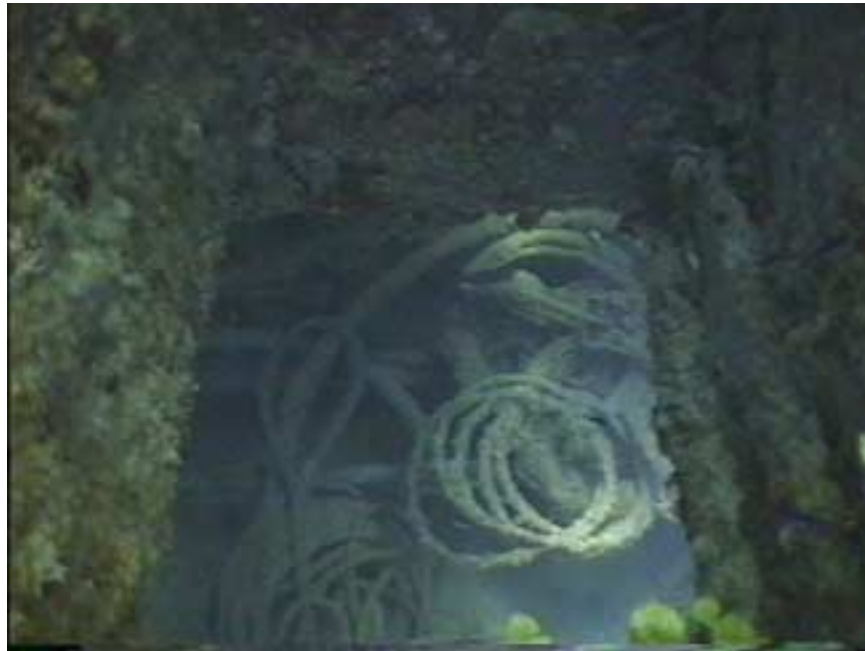
Photo KS4-10 Remaining spare cable and hose in bow of North Loi wreck.

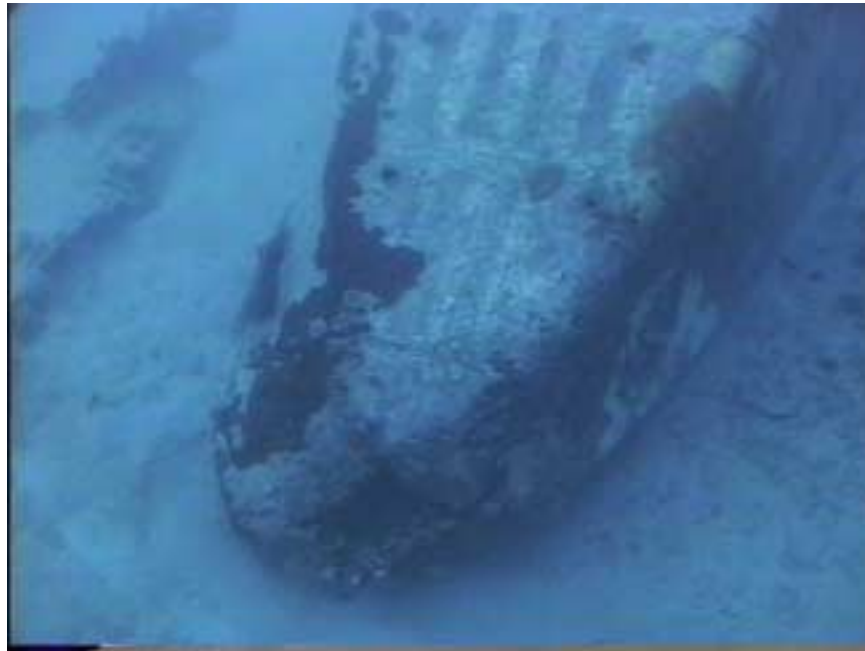
Photo KS5-2 Bottom of the nose of Northern "Mavis" Kawanishi H6K4 Model Flying-Boat in 70 feet of water off the Ebeye Seaplane ramp.

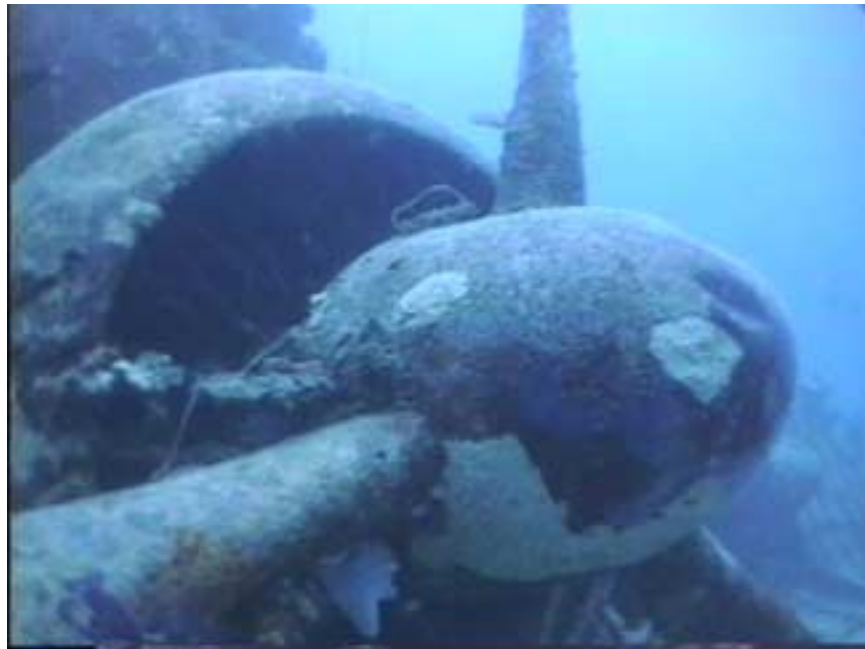
Photo KS5-3 The only engine still attached to a wing section on the North Mavis Flying-Boat wreck. Note 3 bladed propeller.

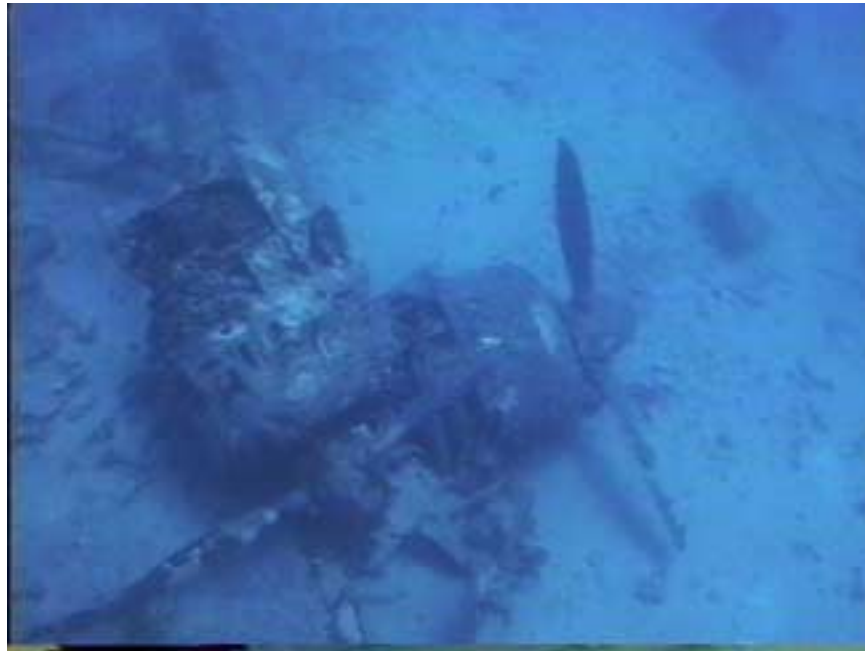
Photo KS5-4 Two engines of the North Mavis Flying-Boat with part of a wing section underneath.

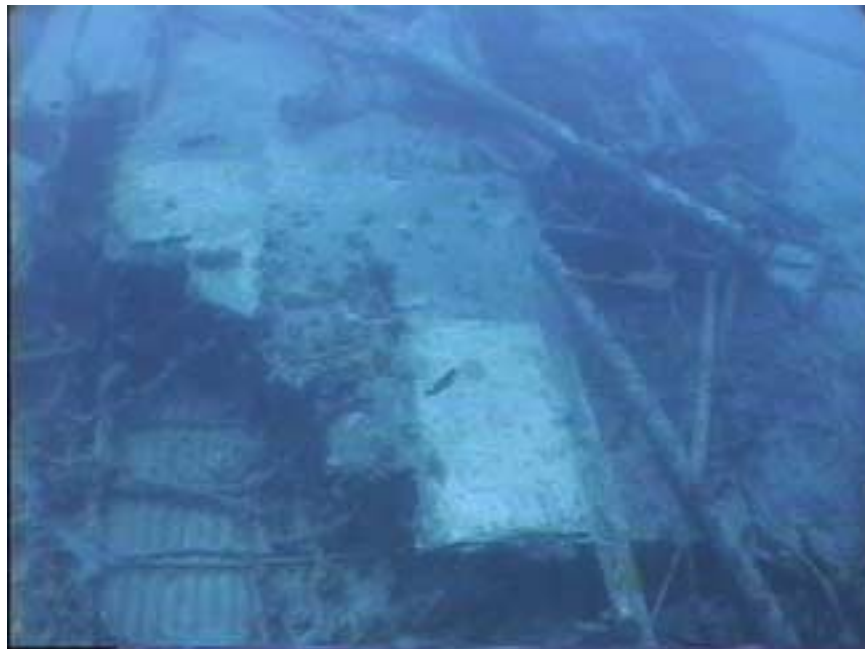
Photo KS5-5 North Mavis Flying-Boat wing section, with outer parasol supports visible in right side of photo.

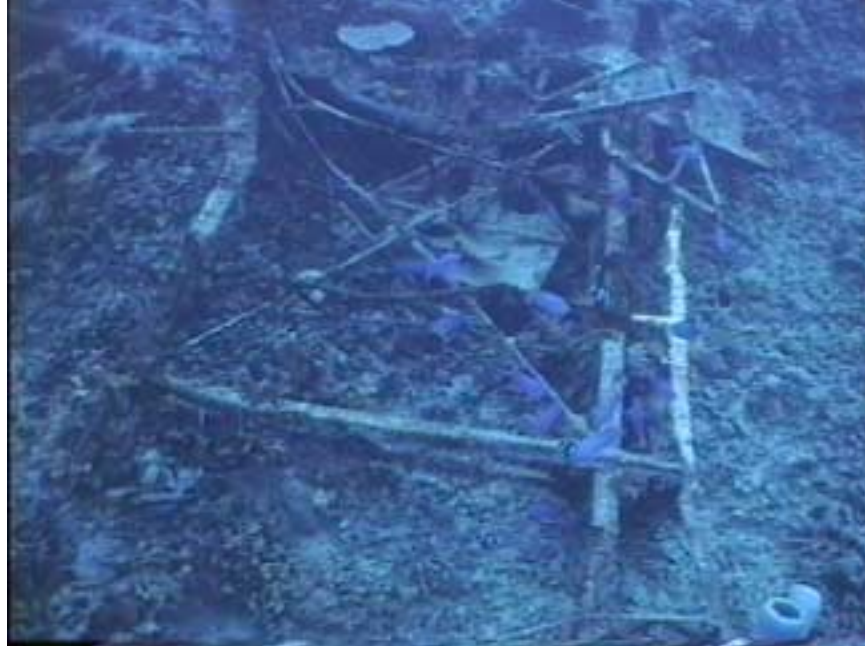
Photo KS5-6 North Mavis Flying-Boat bracing for pontoon.

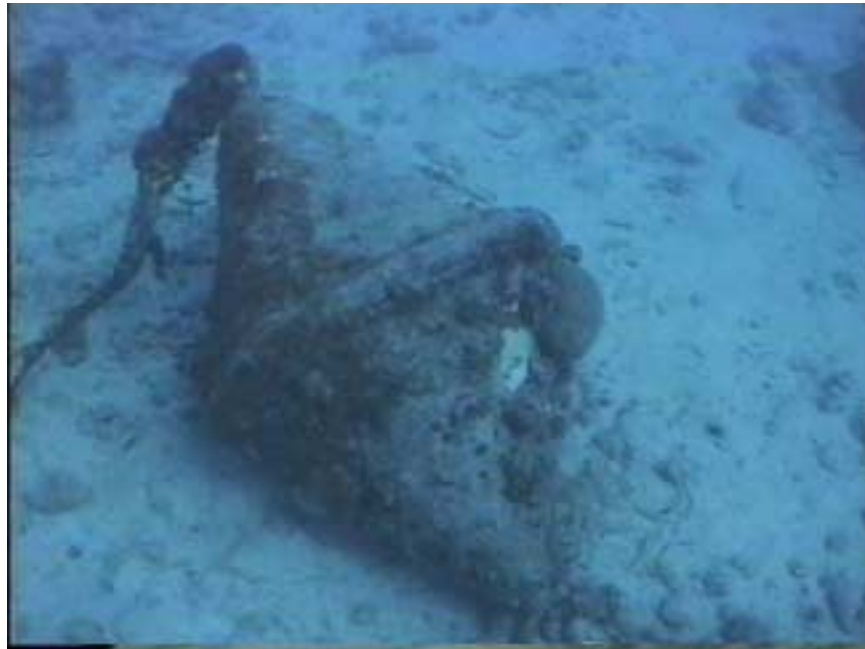
dives (Photo KS5-7). One of these is a mooring buoy used to tie up the flying-boat or other offshore visitors, seen in the KS5-8 photo, also seen by the author in Jaluit for the Kawanishi H8K models. Nothing of collectable value was seen during the survey, indicating divers and time had worn out the site, but one anemone stood out on the wreckage (Photo KS5-9).

Photo KS5-8 A Japanese type mooring buoy used throughout the Marshall Islands to secure both flying-boats, seaplanes, and other floatplanes while at anchor.

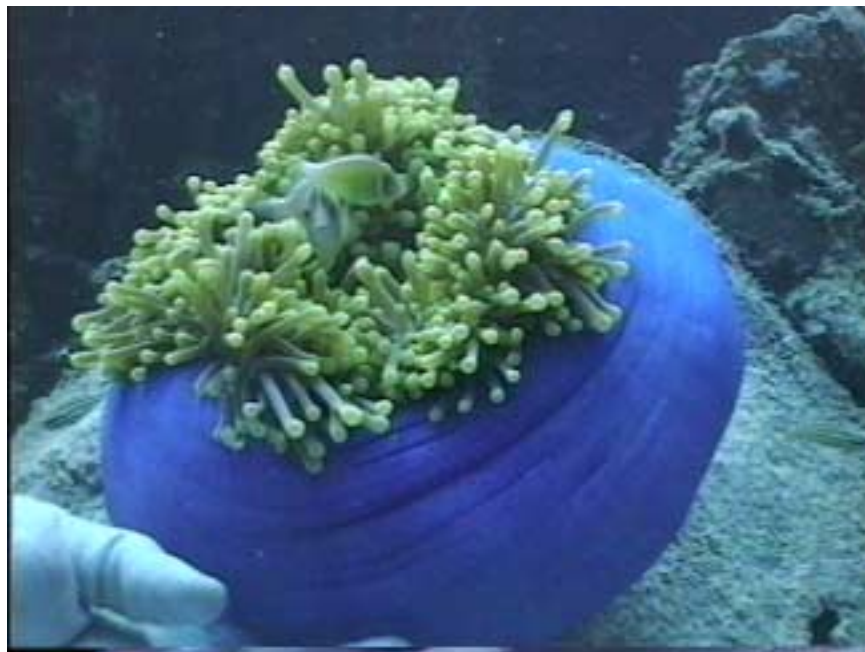
Photo KS5-9 An anemone with cinnamon clownfish growing on the wreckage of the North Mavis Flying-Boat.

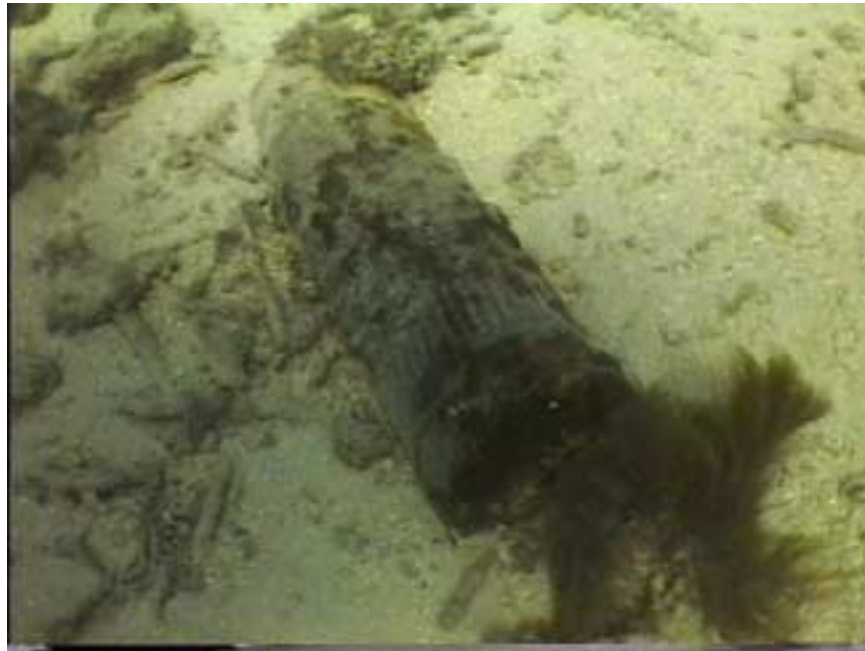
Photo KS6-2 Photo of unexploded artillery round near Ebeye Seaplane Ramp.

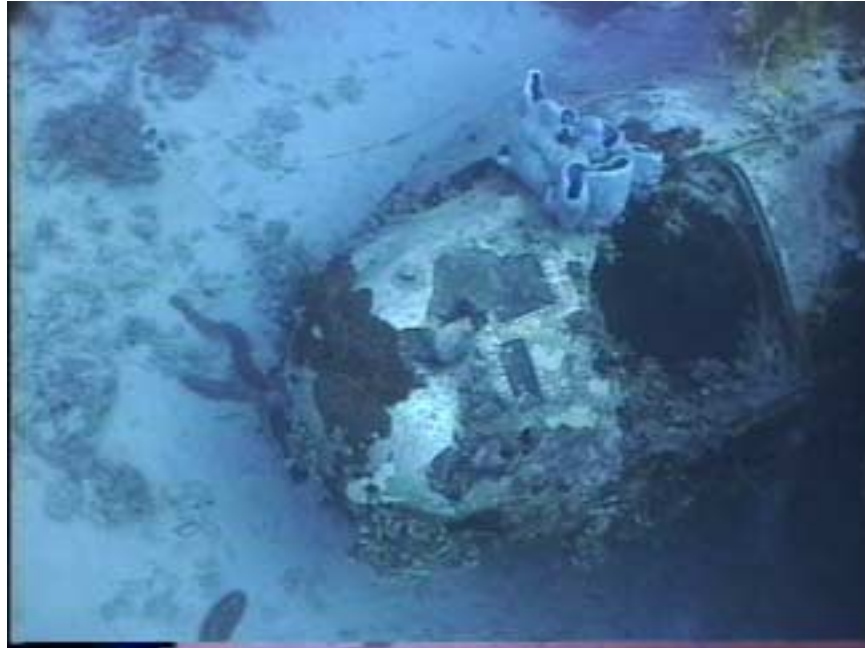
Photo KS7-2 is the top of nose of "Mavis" H6K4 Flying-Boat, with open gun position and still has glass ports intact.

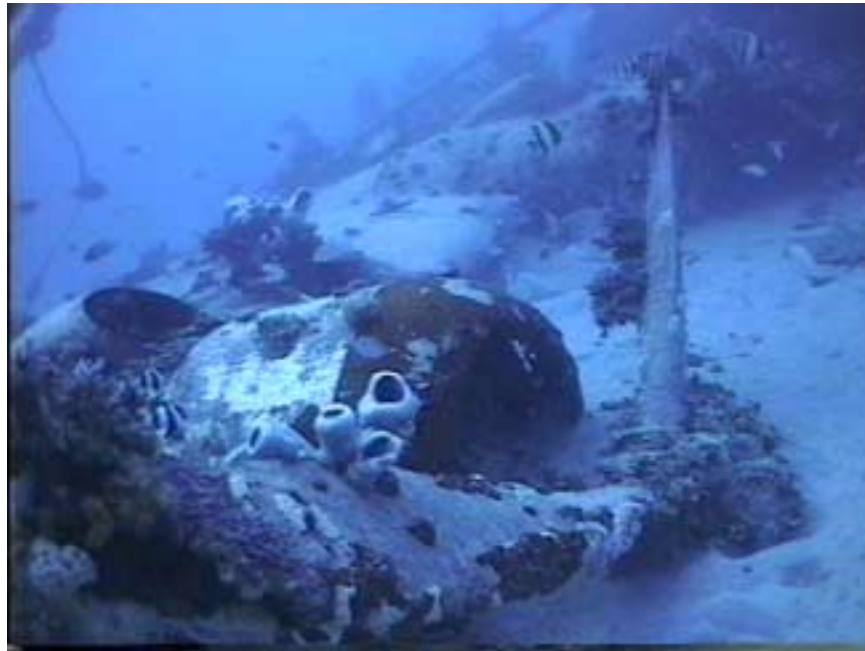
KS7-6 Photo of the number 1 engine of the Central H6K4 Mavis Flying-Boat.

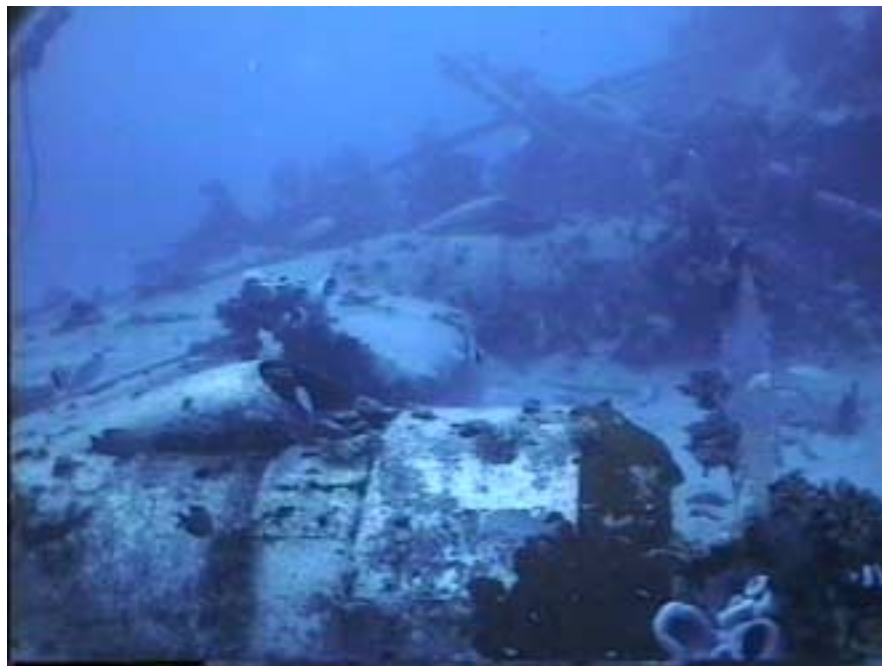
KS7-7 Photo of the number 1 and 2 engines of the Central H6K4 Mavis Flying-Boat. Fuselage debris is center and right in the photo, including parasol wing braces.

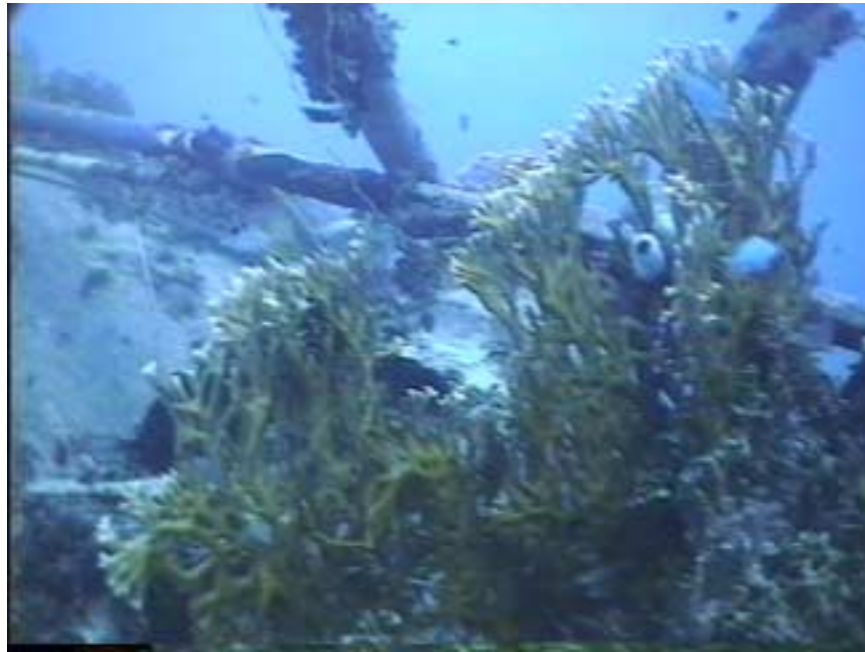
The Central Mavis Flying-Boat is also a well worn dive site, but an interesting one to visit due to the marine life and excellent photo opportunities, due to the coral growth on the wreckage (Photos KS7-8 and 9). The major aircraft parts are recognizable and interesting to study, and the site is an easy swim from the dock.

Photo KS7-8 shows some incredible coral growth on the wreckage, in this case behind the torn off number 3 engine.

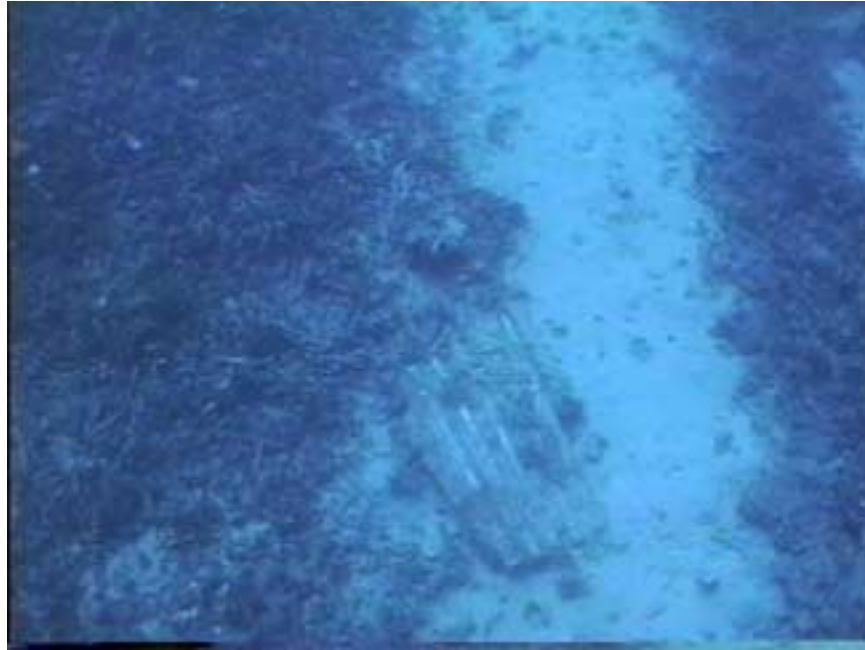
The site also has additional risks indicated by a fresh nearby anchor drag mark from a large modern ship (Photos KS7-10 and 11) that has carved a large track in the bottom rubble. A piece of aircraft aluminum was in photo 10, possibly from the deck flooring of this Mavis aircraft. This indicates the site is also being attacked from unknown and unsuspecting ships from the surface, and makes the marking, buoying and education of these sites important for their future preservation.

Photo KS7-10 Fresh anchor drag mark through coral rubble with aluminum aircraft piece in its path.

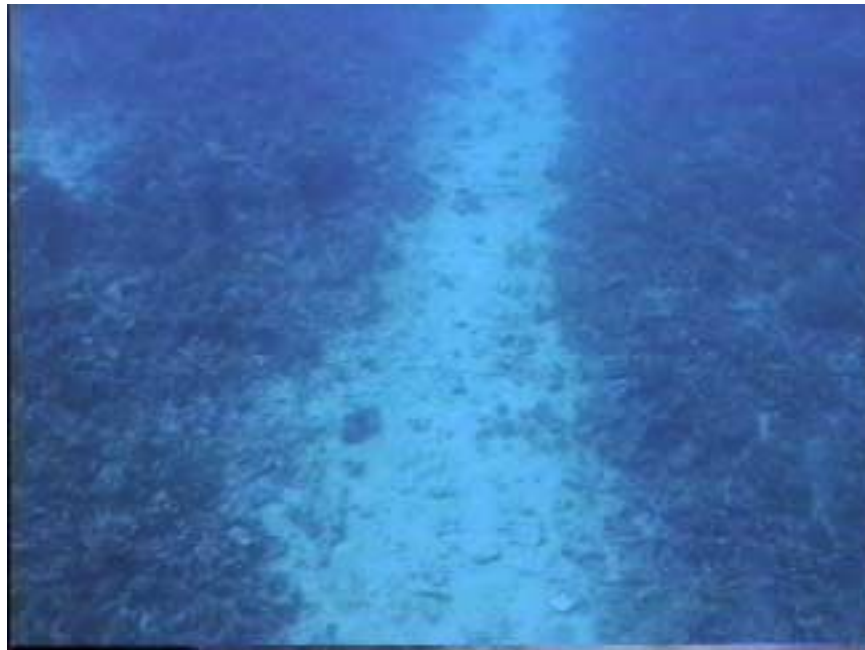
Photo KS7-11 Fresh anchor drag mark continues into the deep, easily over 150 feet long.

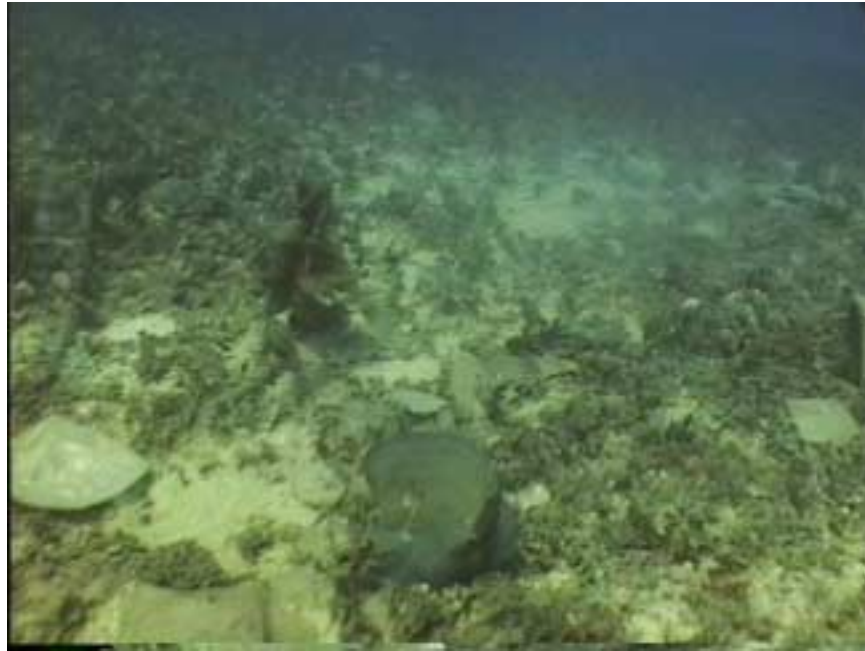
old dock was partially damaged in the 1980s probably lead to an accelerated construction process, with ignorance of this asset. The site is gone.

Photo KS8-2 Rubble at the location of the Japanese Floatplane site.

This site of a sunken Japanese floatplane is now forever lost simply because no one knew it existed, or inquired of anyone if there was an asset to protect. This is another reason why additional surveys and permits to the appropriate offices should be required to save future sites as development continues.

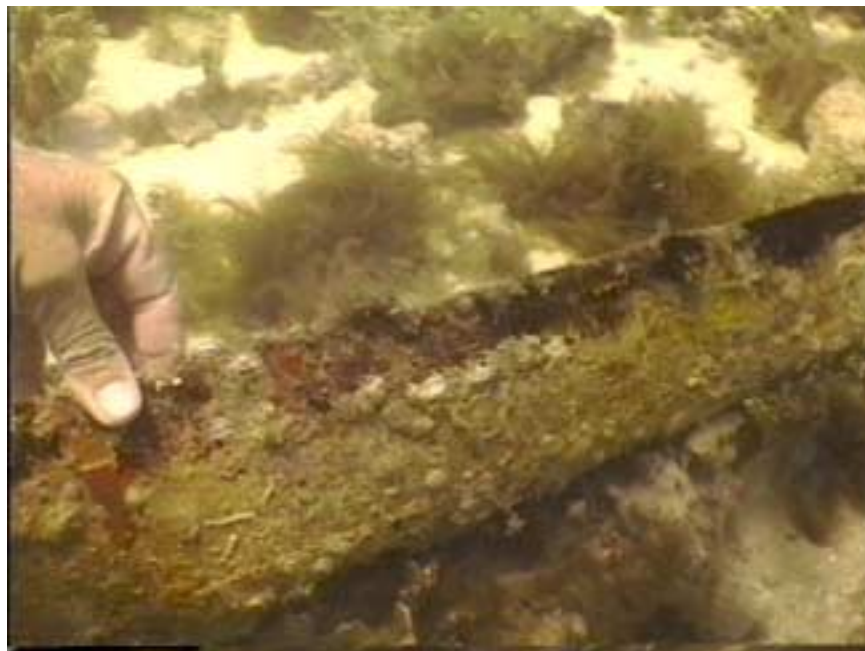
Photo KS8-3 Aluminum strut piece near Japanese Floatplane site is possibly all that remains of the aircraft today.

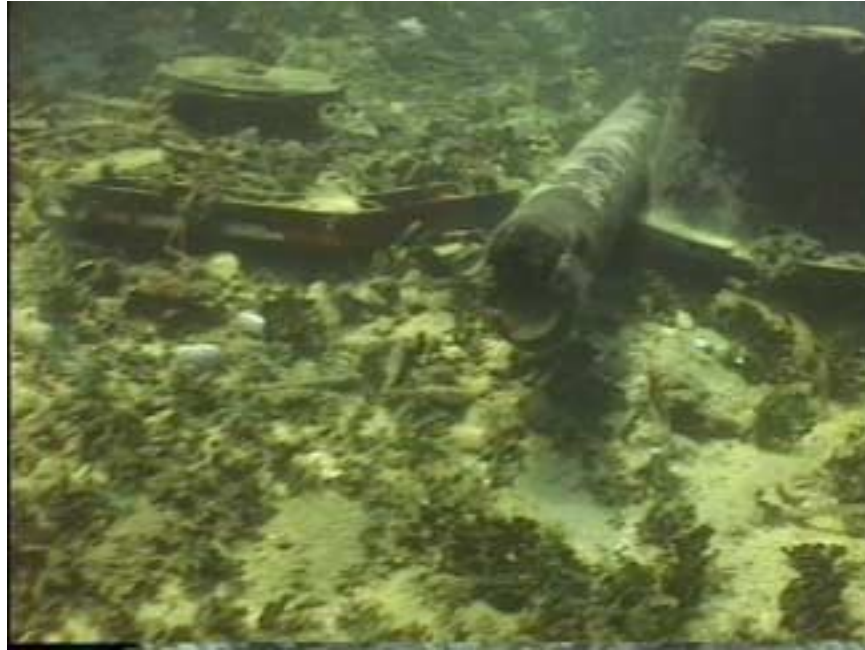
Photo KS8-4 New Ebeye Dock debris at old Japanese floatplane site. Debris is primarily large rubber fenders that have been torn off the dock face.

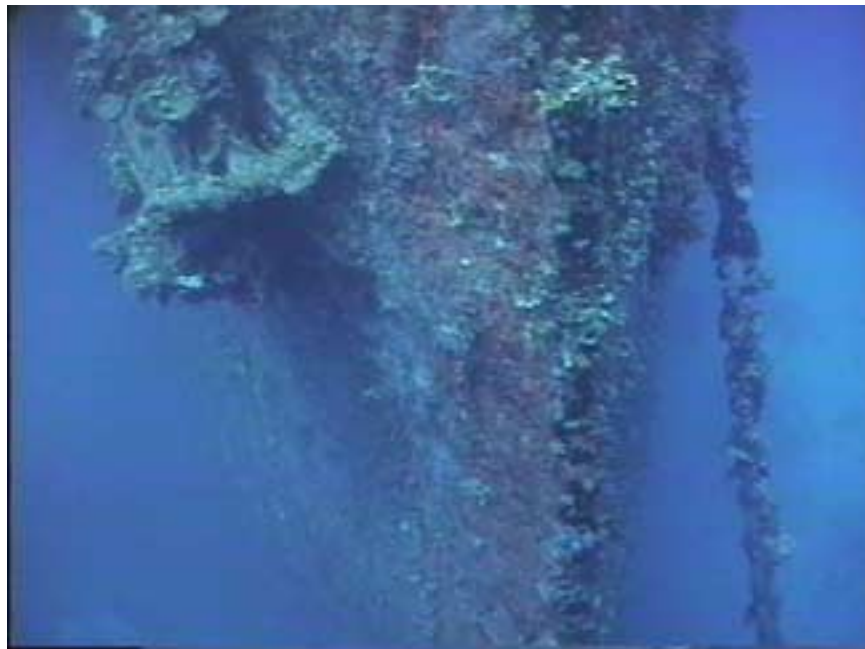
The bow showed the portside anchor away (Photo KS10-2), at 120 feet. The excellent visibility also allowed a submarine cable to be seen on the bottom running north-south between Kwajalein and northern islands just forward of the ship. Spotted Eagle rays also "flew" over the bow, which had supported a 75mm deck gun, now missing (Photo KS10-3). Ammunition ready boxes stand open with a few remaining shells (Photo KS10-4).

Photo KS10-2 Bow of Akibasan Maru, with port side anchor played out.

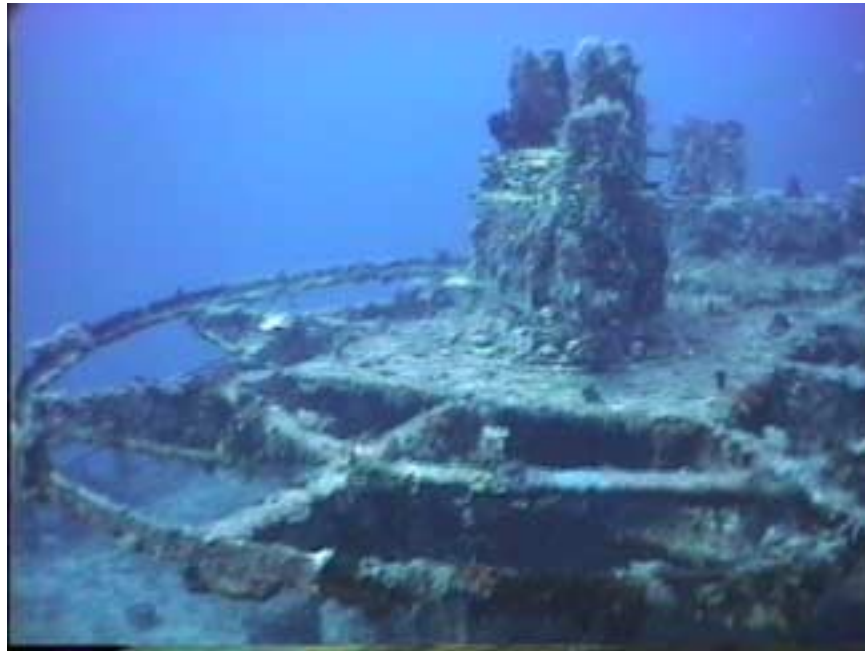
Photo KS10-3 Empty gun mount on bow of Akibasan Maru. Gun was a 75mm model.

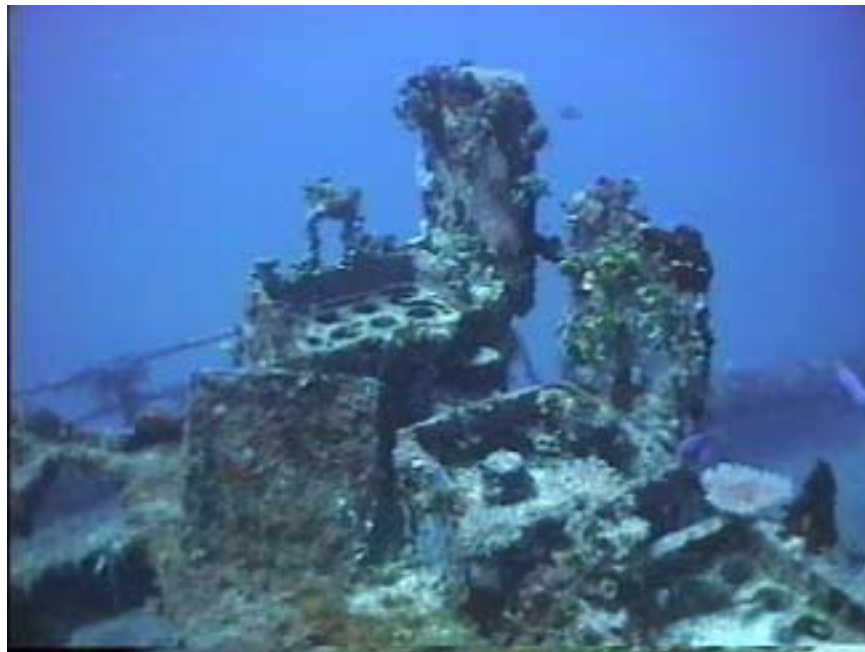
Photo KS10-4 Ready ammo boxes for forward gun mount with a few remaining 75mm shells.

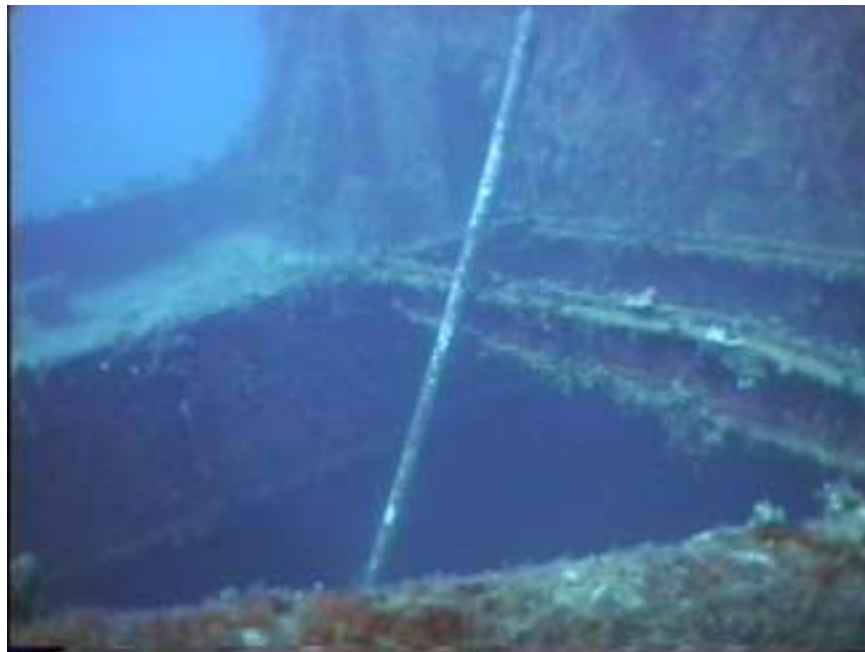
The discovery of the airlift further proves the stripping of the Kwajalein historic sites continues. The airlift was not that old, by the coral growth on the pipes. Besides this kind of activity being extremely dangerous, it destroys one of the only assets the Republic can develop, tourism. I can only recommend that KalGov, KADA, or the RMI Government Agencies responsible strive harder to control the destruction of their historic sites, as Kwajalein Lagoon and its' sites are truly world class.

Photo KS10-6 Airlift for artifact collection in Number 2 hold of Akibasan Maru.

I would recommend the Akibasan Maru be permanently marked with underwater and surface buoys, the airlift removed, and airlift equipment banned from Kwajalein. The Kwajalein SCUBA Club should be informed of this activity, the Kwajalein authorities additionally informed, and any further violations of the Historic Preservation Regulations be prosecuted to the fullest to set an example.

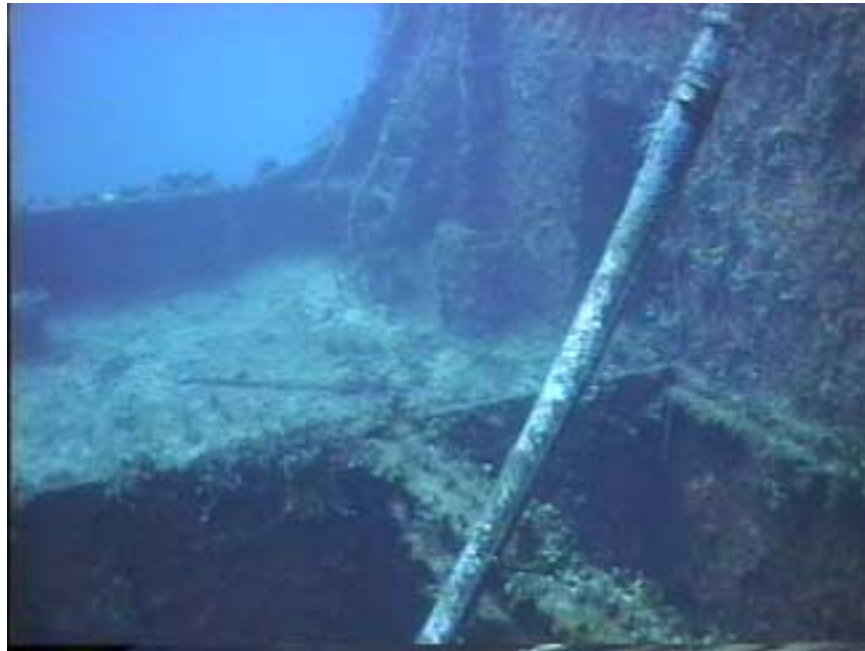
Photo KS10-7 Airlift showing aluminum piping, couplings, and back of number 2 hold on the Akibasan Maru.

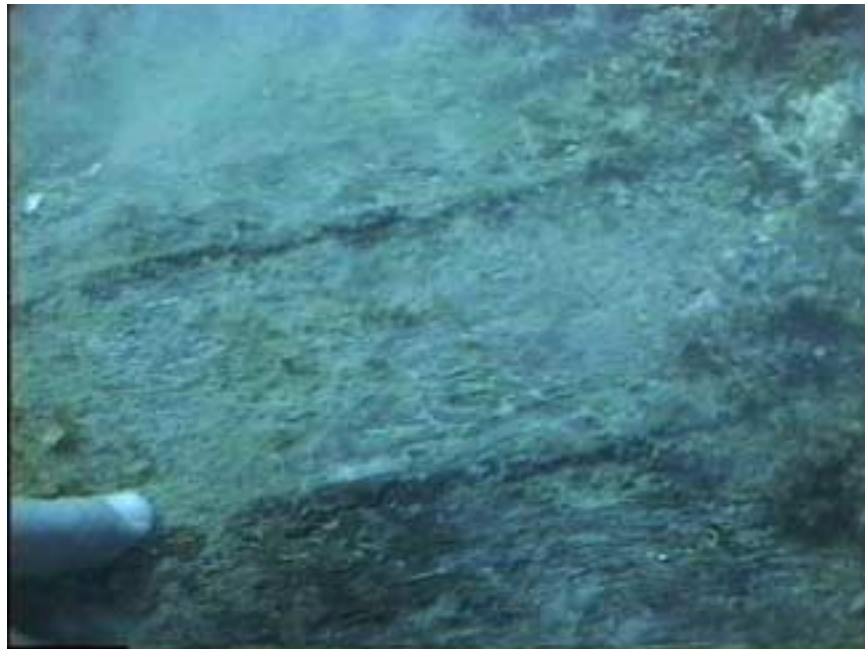
The number 4 hold was then inspected starboard side showing the damage which sank the vessel (Photo KS10-10), and up on the stern quarters (Photo KS10-11) which even had a teak deck surviving with caulking between the lumber planks (Photo KS10-12).

Photo KS10-12 Wood deck, probably teak, with caulking, still surviving after over 50 years of underwater exposure.

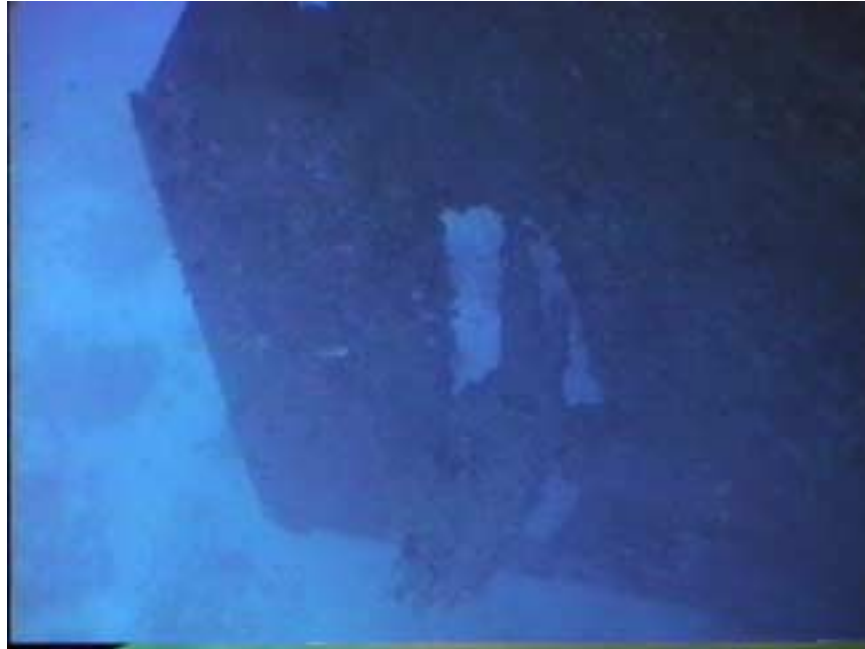
Photo KS10-13 The massive rudder and propeller of Akibasan Maru sitting on a 150-foot bottom. A US Navy LST style anchor also sits on the sand nearly below me at this point in the photograph.

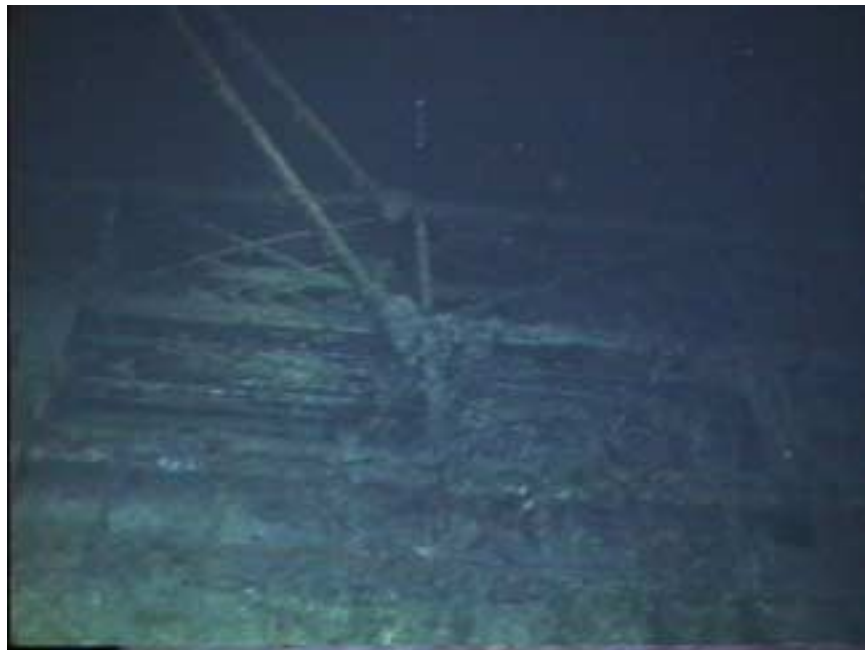
Photo KS10-14 Aircraft parts in the port side of the number 5 hold are probably for the Kawanishi H6K4 model Mavis Flying-Boats used in the Marshall Islands.
