*Archaeological Survey and Inventory of  
Submerged Cultural Resources in the Lagoon  
of Kwajalein Atoll:*

SITES ON THE SOUTH AND EASTERN SIDES OF KWAJALEIN ATOLL

Matthew B. Holly

HPO Report 2000/02

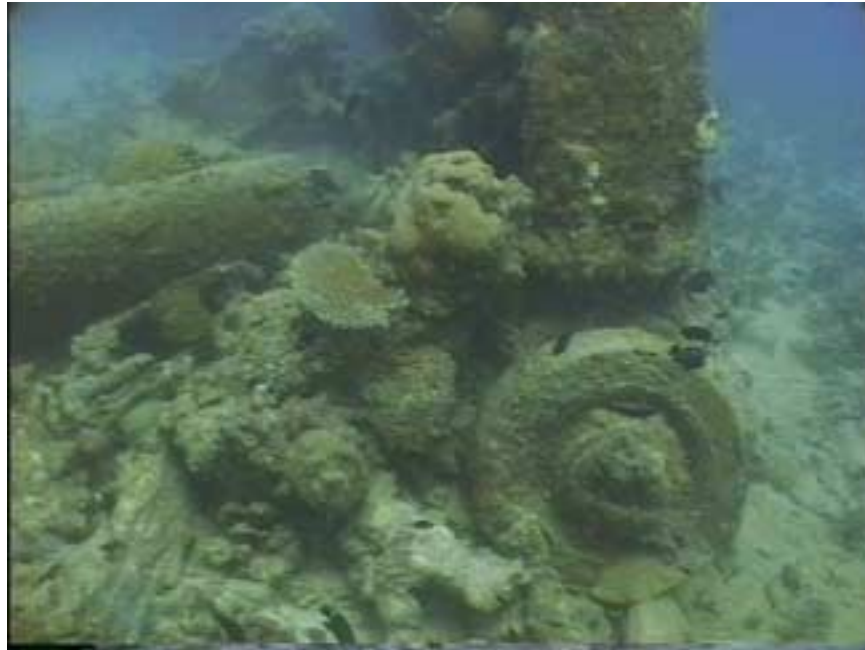
This site, as virtually all of the Kwajalein Ski Area Wrecks, have deteriorated seriously due to the effects of the shallow water and storms, dredging, and divers collecting artifacts. I was hoping when I choose these sites I would find more protected wrecks due to the restrictions on diving at the ski area. Instead, thousands of dives have been made in this area in the last 30 years, and virtually every nook and cranny has been looked into for collectable items. Dredging has physically removed some of the inshore sites at the ski area, and removed 2 additional sites within the current harbor, south of the Ski Area. These sites are hard to protect, and little hope for them exists in the future as Kwajalein keeps developing. I would only suggest they be marked and buoyed to avoid accident damage from anchors and un-educated development.

Photo KS11-1 Flywheel side of main engine on Ski Area Wreck No. 1.

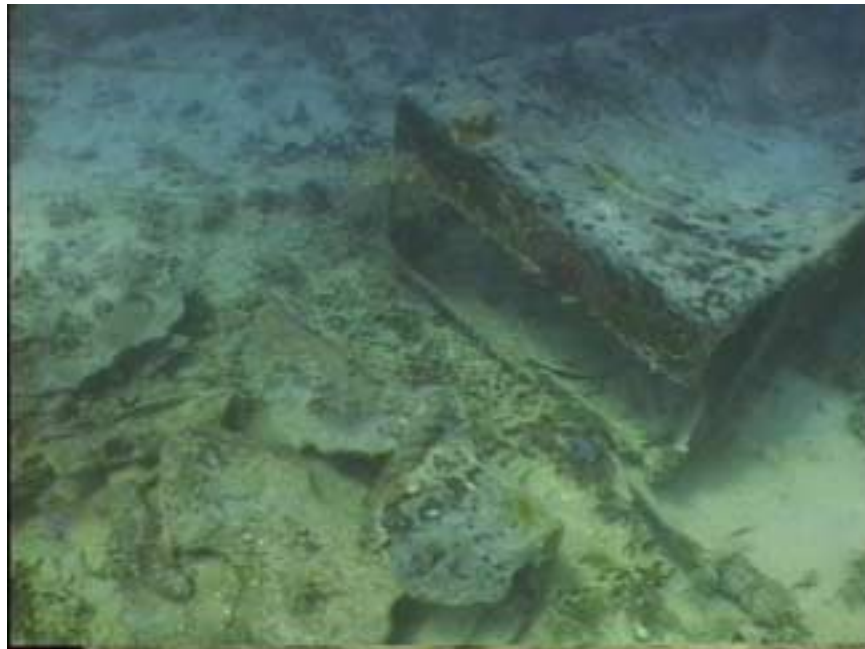
Photo KS11-4 Fuel tank of Ski Area Wreck No. 1.

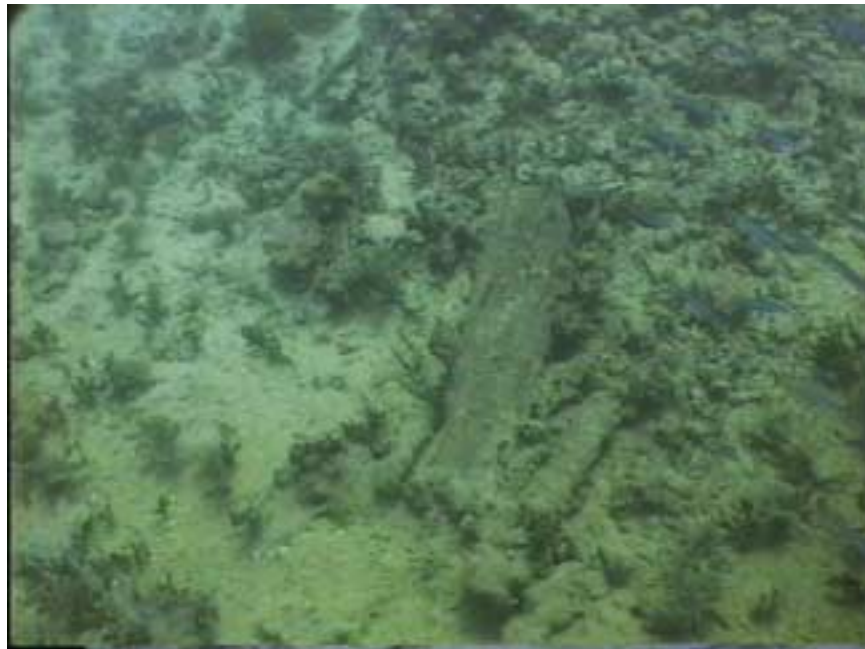
Photo KS12-2 Wood from hull of Ski Area Workboat.

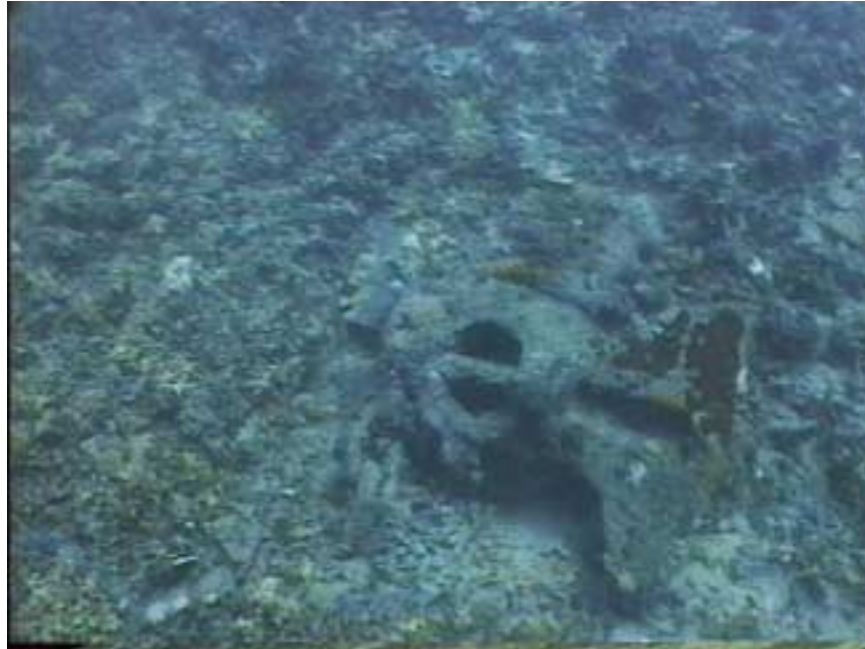
Additionally, an US naval anchor (Photo KS12-3) was also located nearby, as were 2 additional anchors and hundreds of feet of ships anchor chain throughout the area. These have been used by USAKA. The entire area is a mix of old and new, and I doubt if anyone has knowledge of all the details of the entire Ski Area site.

Photo KS12-3 Anchor imbedded in the rubble nearby the Ski Area Work-Boat debris.

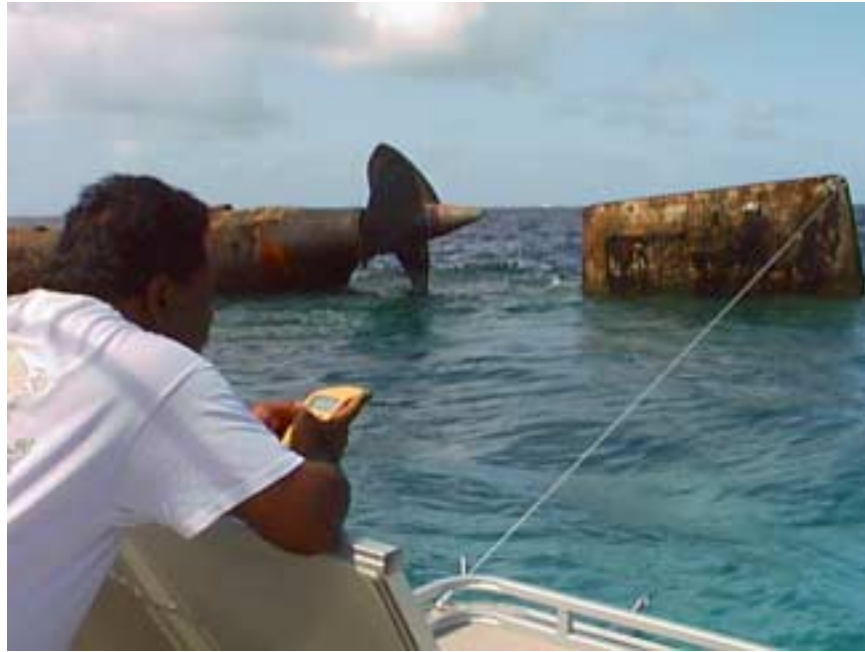
Photo KS13-1 Stern of Prinz Eugen wreck showing rudder and center propeller above the waterline with RMIHPO diver Hemley Benjamin plotting GPS coordinates for this report.

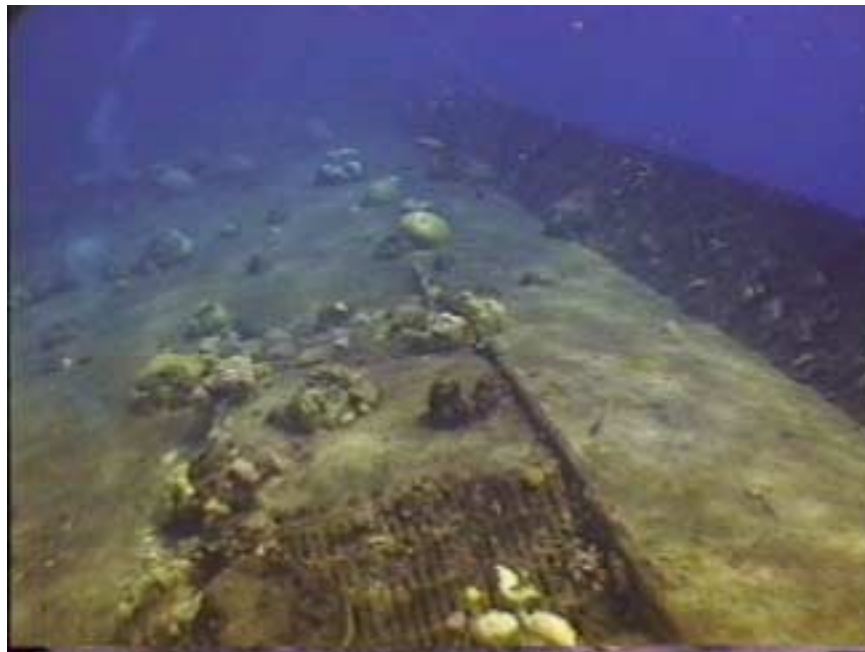
Photo KS13-2 Bottom hull of Prinz Eugen showing port side bilge keel on right of photo and sea chest intake in bottom of photo.

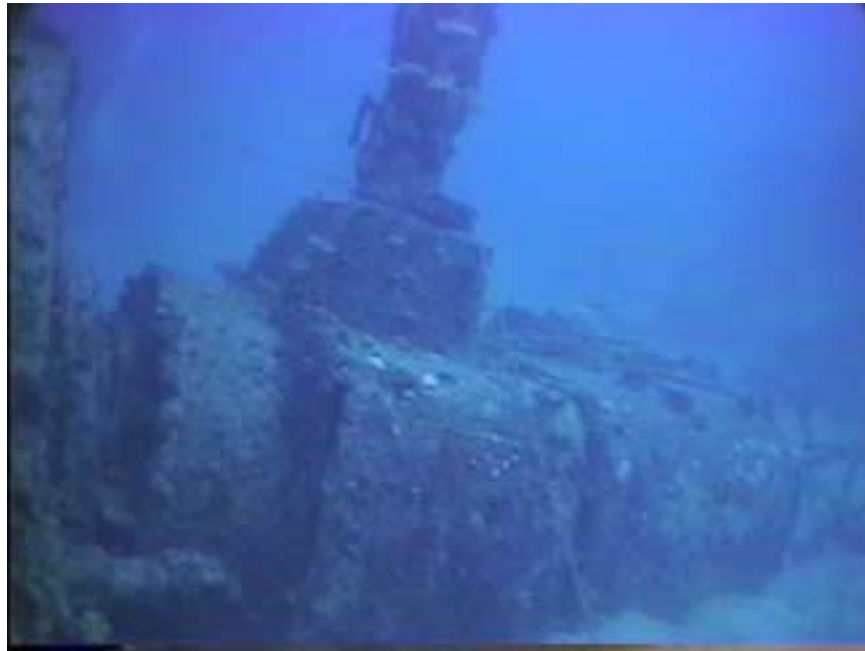
Photo KS13-9 The rear of the fighting bridge at approximately 80 feet. It was crushed over flat against the bottom by the capsizing of the vessel. A large coral mountain rises up to the right of the photo, and a lost anchor and line are visible in the photo.

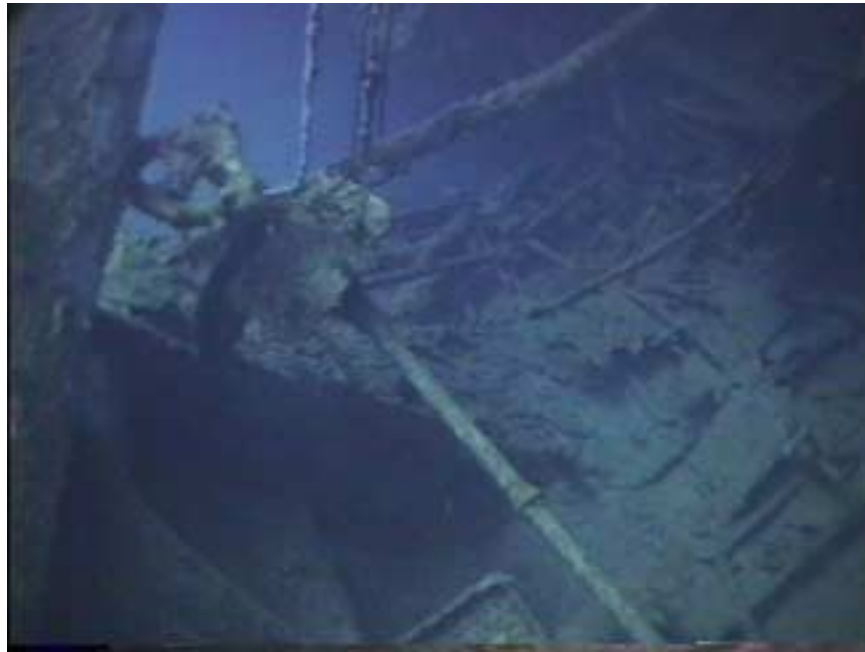
Photo KS13-11 Airplane hold with remains of lifeboat still hanging in its' davits.

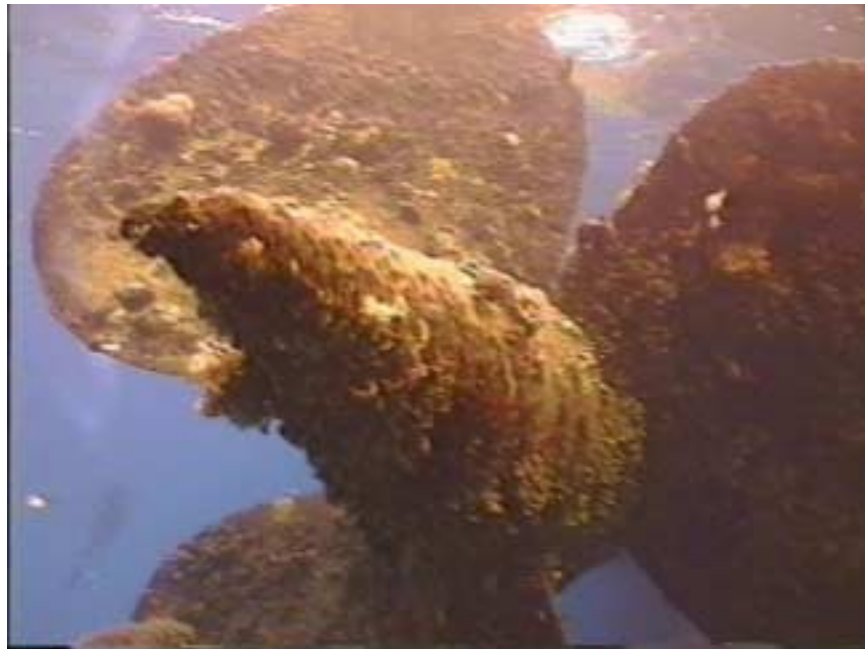
Photo KS13-14 Close up of starboard propeller.
