*Archaeological Survey and Inventory of Submerged
Cultural Resources in the Lagoon of Wotje Atoll*

Matthew B. Holly

HPO Report 2000/03

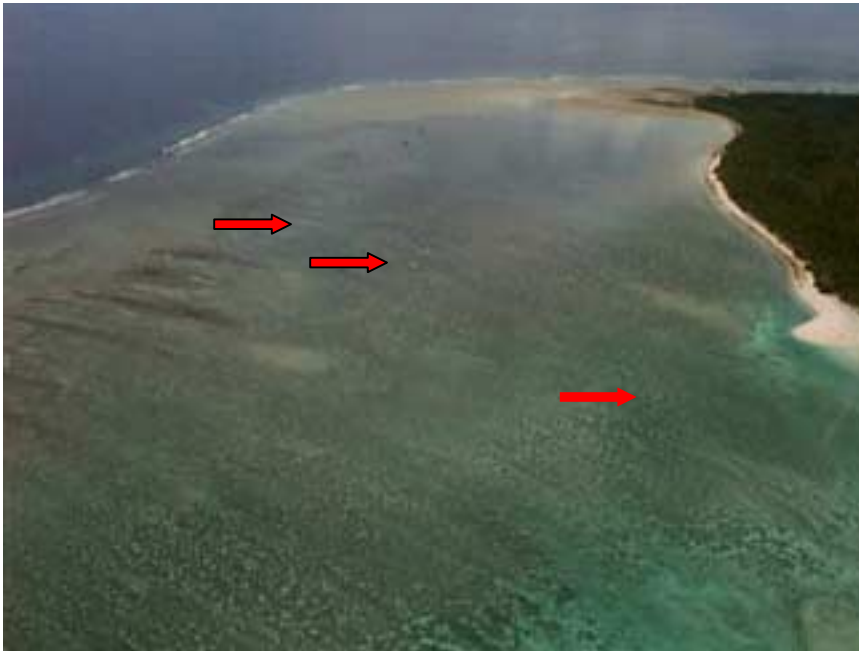
Photo WT1-3. Aerial Photograph of the Oceanside and reef of Northwestern Ormed Island. Red arrows show positions of large pieces of the SB2C wreckage; left arrow, engine; center arrow, right wing; right arrow, left wing and fuselage. WT2 site debris is in the background.

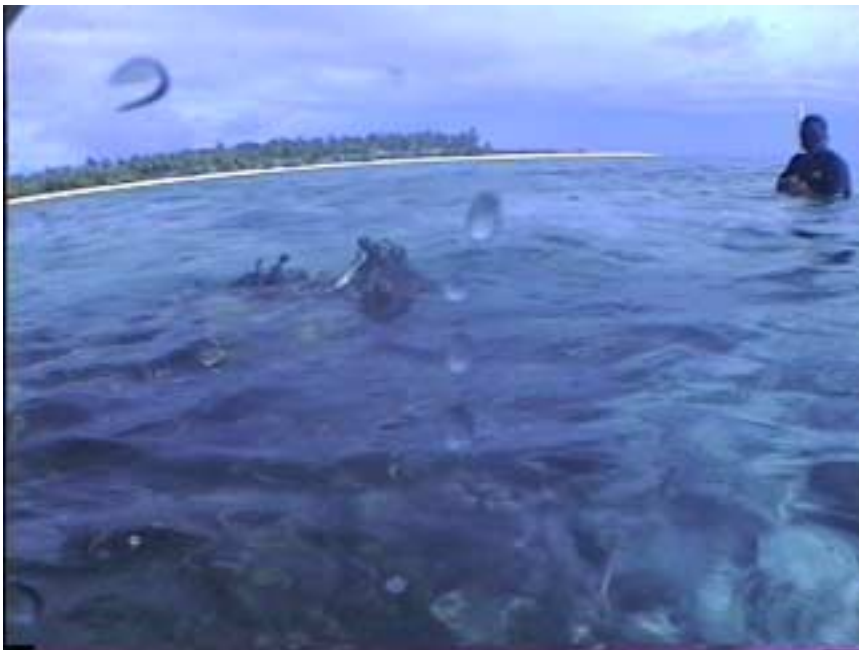
The aircraft engine is the farthest major piece from shore, and is barely exposed at low water (Photo WT1-4). The engine, Photo WT1-5, is basically intact, missing a few cylinders and the propeller. Conspicuous were the stainless steel exhaust manifolds, still shining, and significantly different than the Japanese versions that turn black with age and exposure to the elements. A close-up of the engine (Photo-WT1-6) shows the double row of cylinders which totaled 14, the correct amount for a SD2C engine (which was a Wright Cyclone model R2600).

Photo WT1-4. Photo with top of engine exposed with Ormed Island in the background on a 150 degree magnetic compass course. Diver is Mr. Aki Mike.

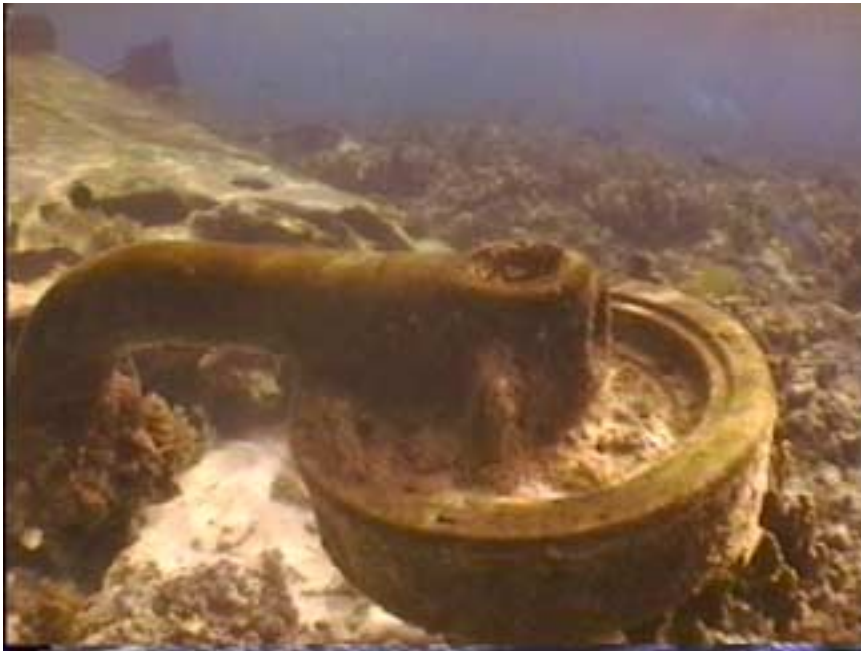
Photo WT1-7. Landing Gear Hub at the end of the severed right wing

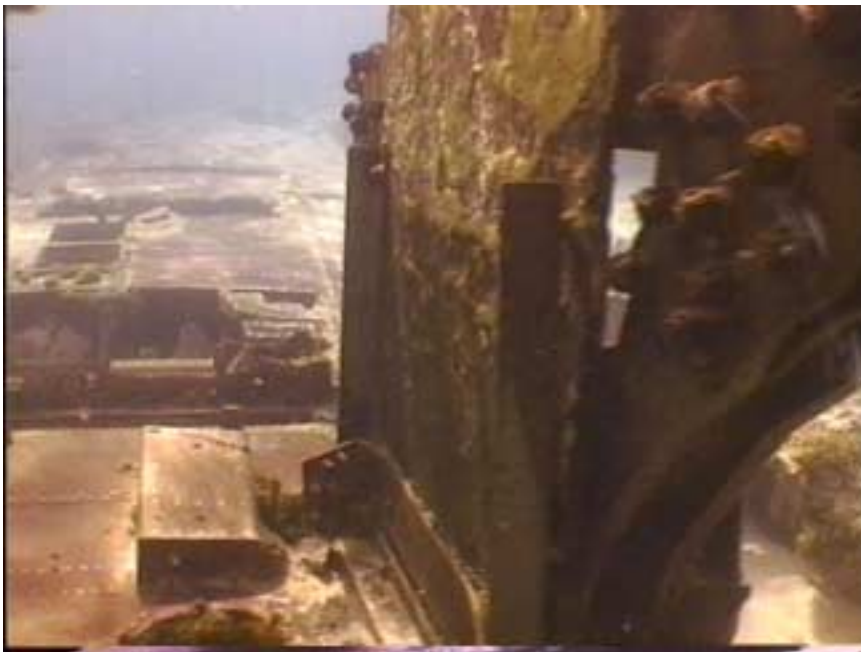
Photo WT1-8. Pilot area with structure and armor to the right of the photo, with left wing extending to top of photo. Fuselage ends at right of photo, but continues to the left for apx. another 8 to 10 feet.

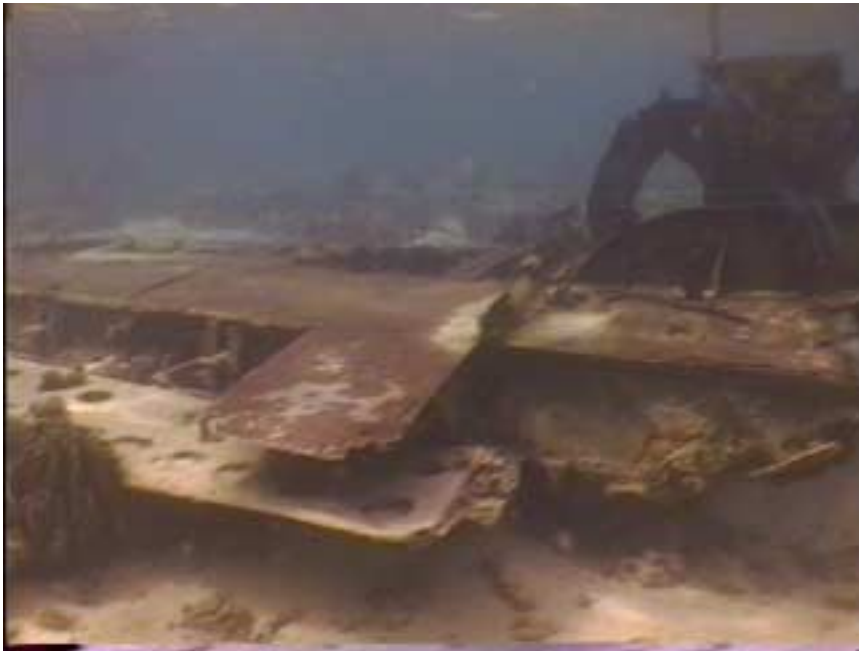
Photo WT1-9. Left wing section to the left of photo, with the remaining fuselage to the right. Note air brakes retracted in left wing assembly.

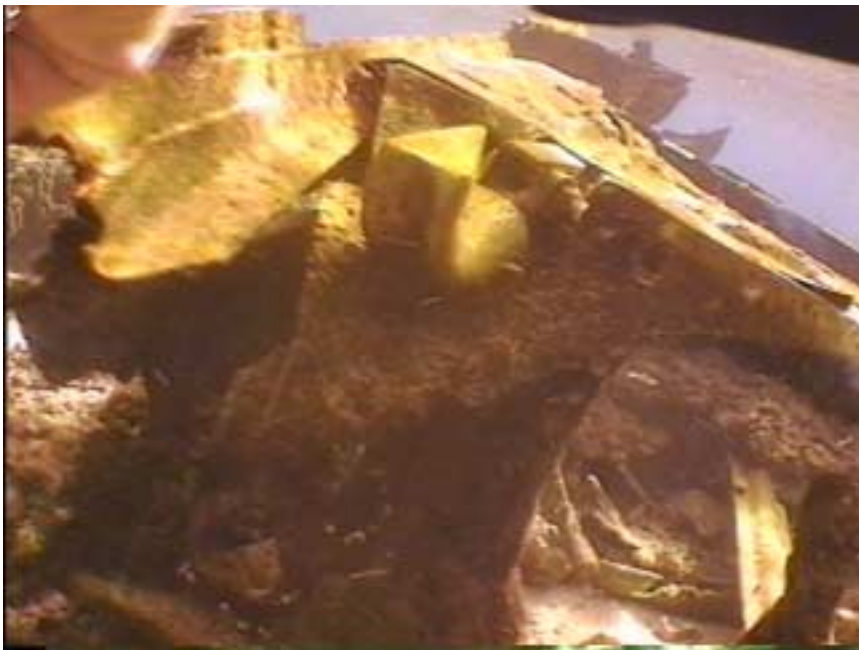
Photo WT1-14. Presumed tie down point of aircraft located on wing directly next to the fuselage. Fuel tank was locally removed from the compartment visible in the lower right, taken through the opening above chiseled through the top of the wing.

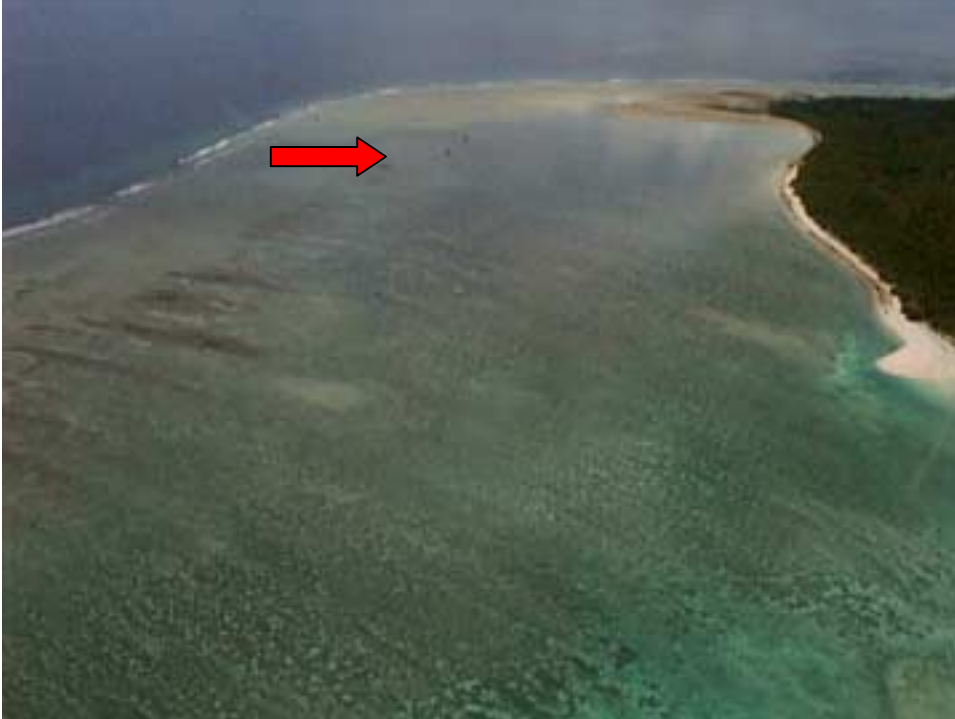
Basic inspection showed it was a steam boiler driven vessel, as a large boiler has rolled up on and across part of the reef. The propeller and shaft were visible and typical for an apx. 300 foot long, 2,000 to 3,000 ton vessel. The vessels hull was riveted steel plate, with no indication of welding or stainless steel, dating the construction as probably after 1920 but before 1930. Shards of hull metal and heavily rusted bits and pieces litter the reef. A closer inspection and cleaning of the propeller may shed some light on the age, manufacturer, or name of the vessel.

Photo WT2-1. Red arrow shows location of large debris from Ormed Oceanside Wreck, visible at low tide on the exposed reef of this aerial photo. The largest item is a round boiler, rolled up onto the reef, which is the item directly off the point of the arrow.

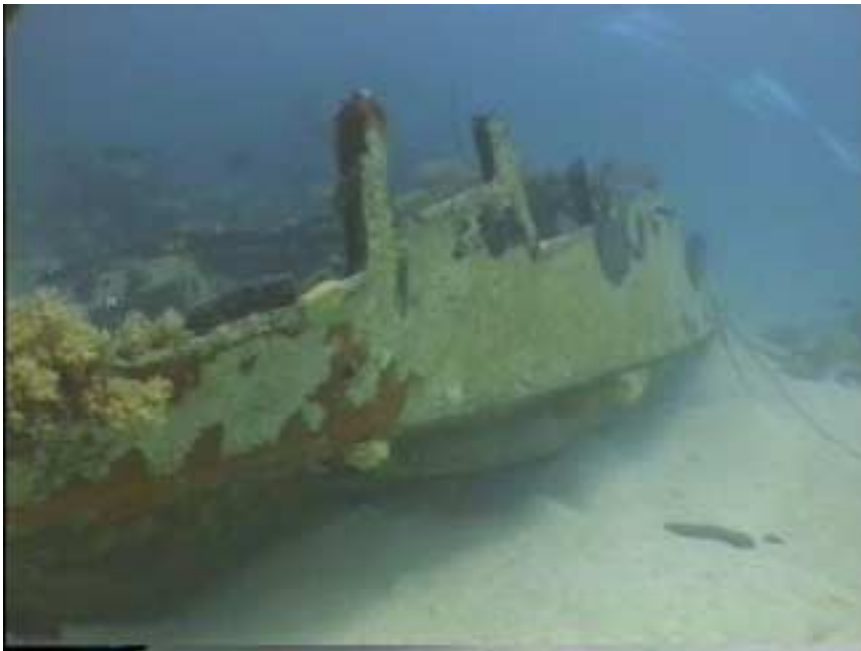
Photo WT5-3. Bow section of the Kawanishi H8K2 at the site. Note the lower window frames visible in the photo.

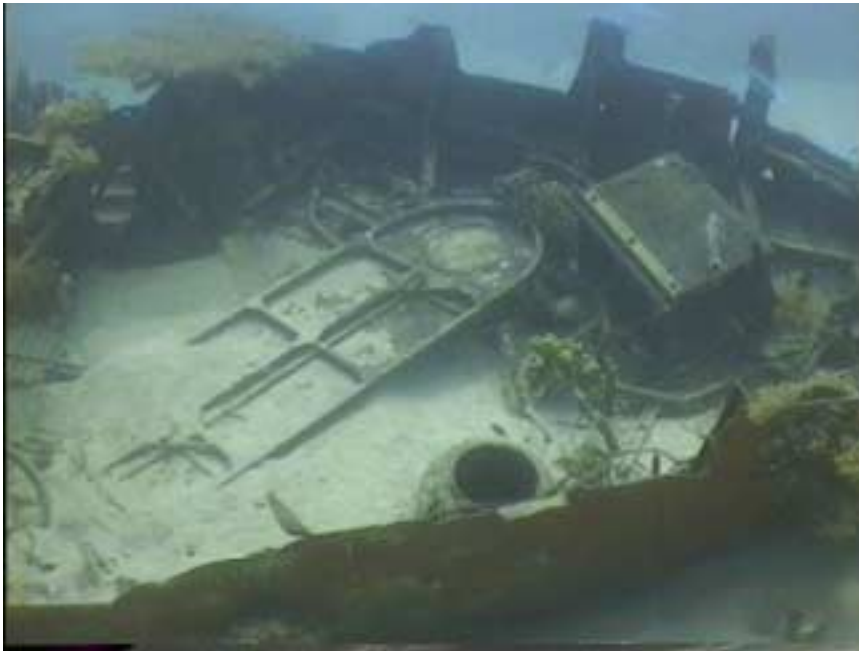
Photo WT5-4. Remains in the bow section of the flying-boat. Note the forward hatch door, a storage compartment box, and an engine cylinder in the photo.

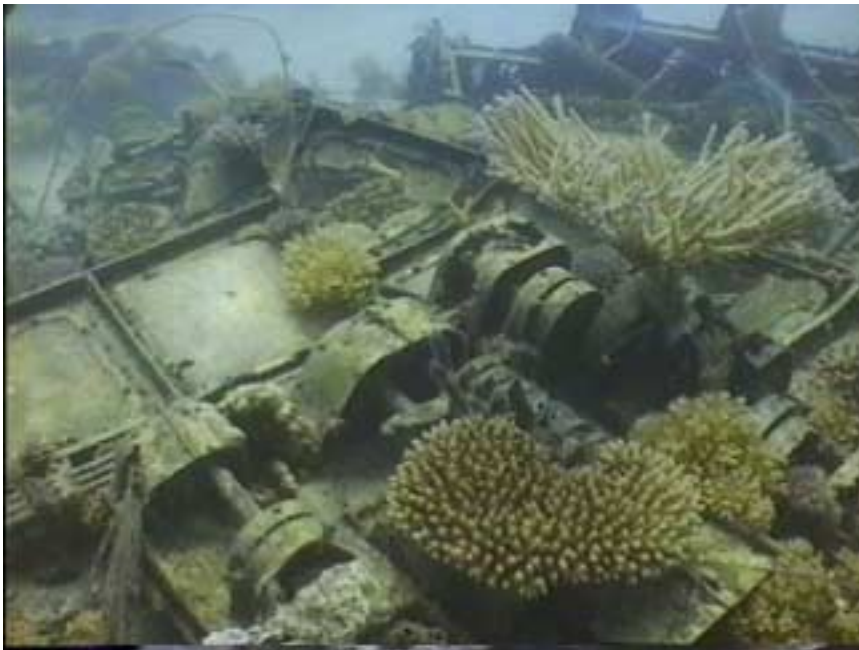
Photo WT5-5. Flight deck controls of the Kawanishi H8K with coral growth.

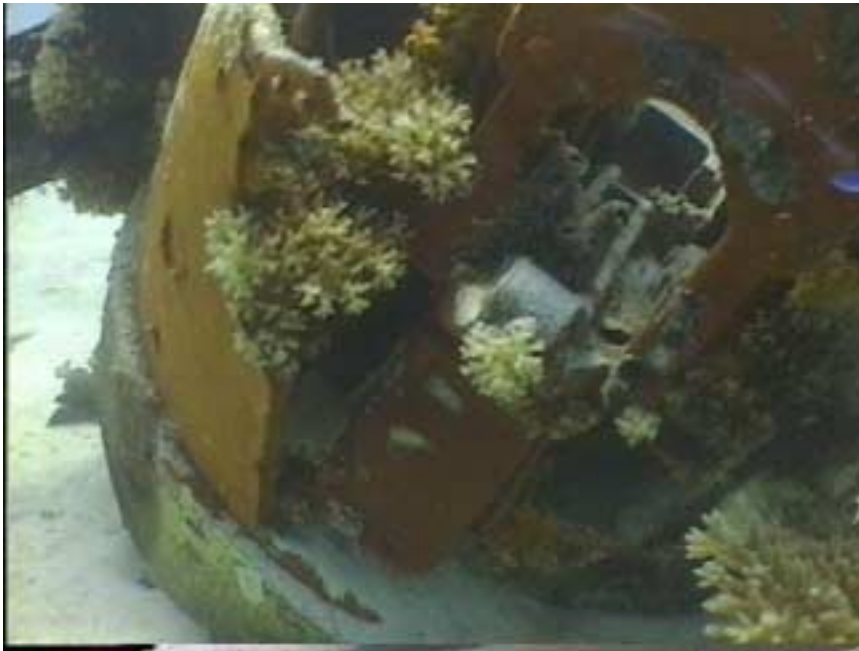
Photo WT5-8. Tail turret assembly without the 20mm cannon, showing the attached curved armor plate at the left of the photo covered in an orange algae

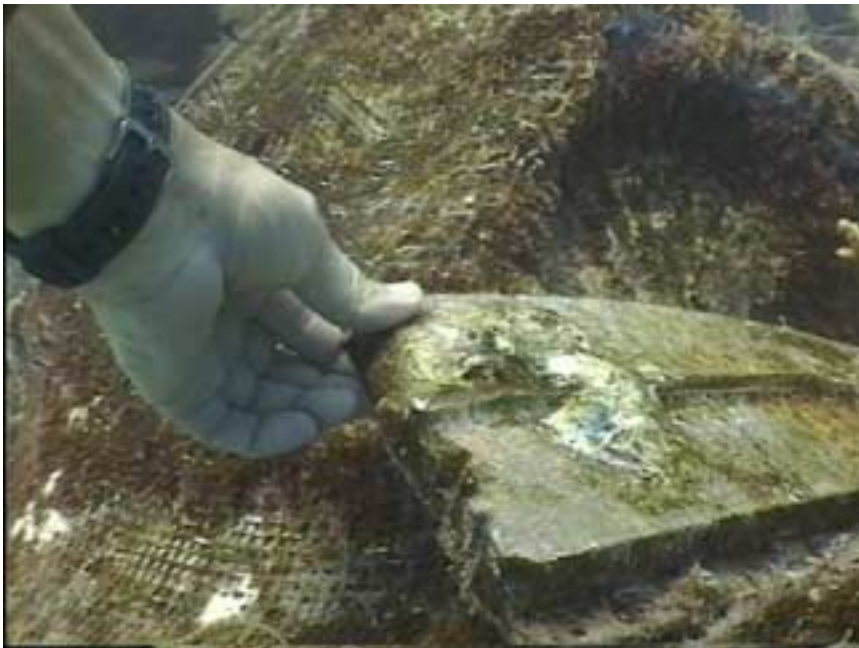
Photo WT5-9. Heavy metal structure of the aircraft, laying over an internal fuel tank.

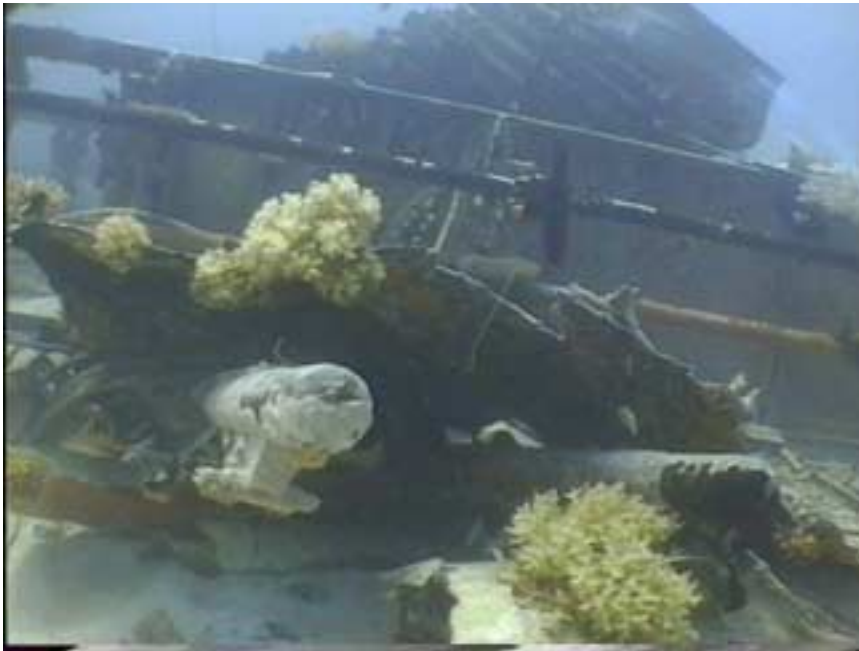
Photo WT5-12. Mounts for aerial torpedoes, left one covered in white growth.

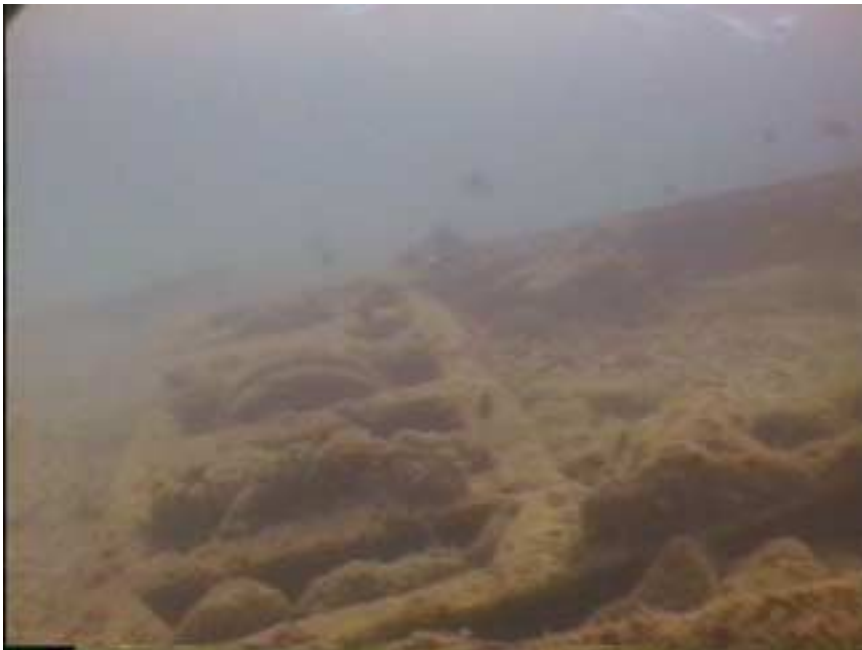
Photo WT6-3. Top of Crane section underwater off end of Main Service Dock.

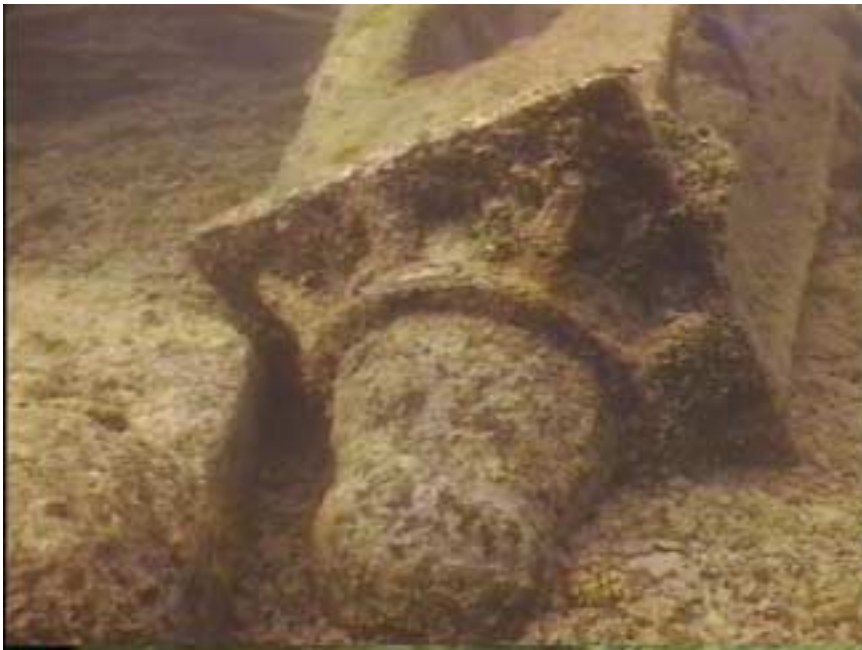
Photo WT6-5. Ships service tie up bollards at the end of the Main Service Dock.

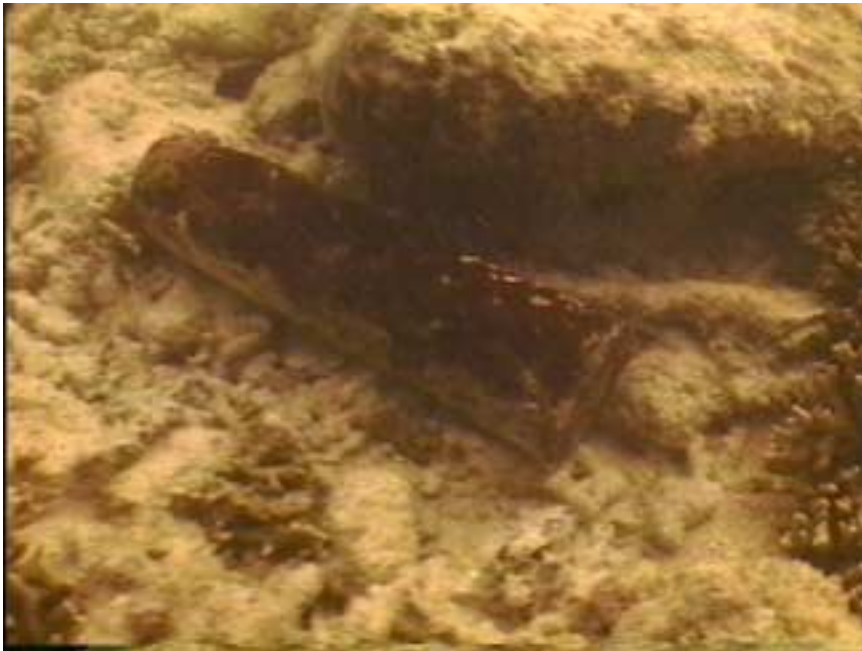
Photo WT6-6. A 75mm artillery round lies on the lagoon bottom, possibly from the anti-aircraft position on the end of the dock.

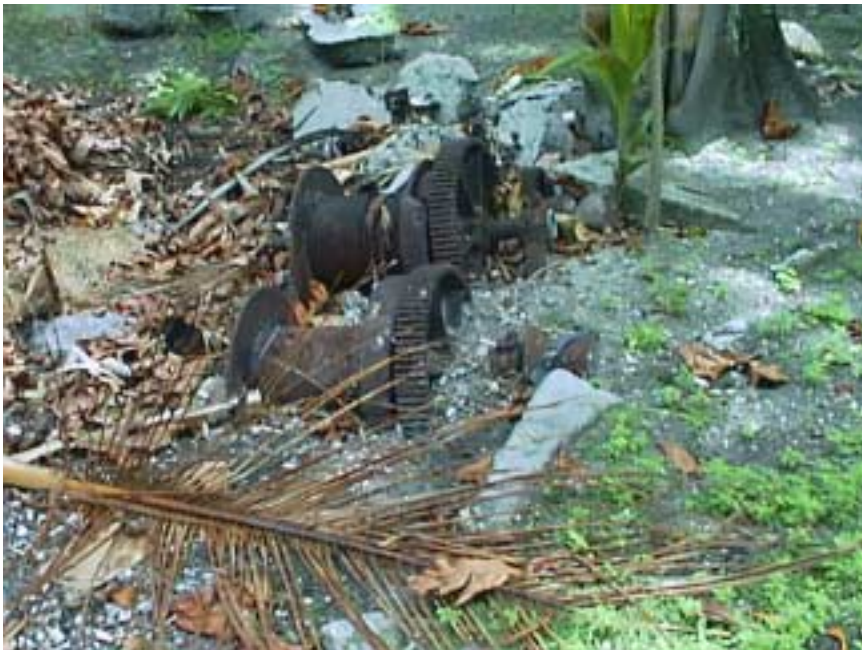
Photo WT6-7. A winch was set up inshore to haul boats ashore to the small dock.

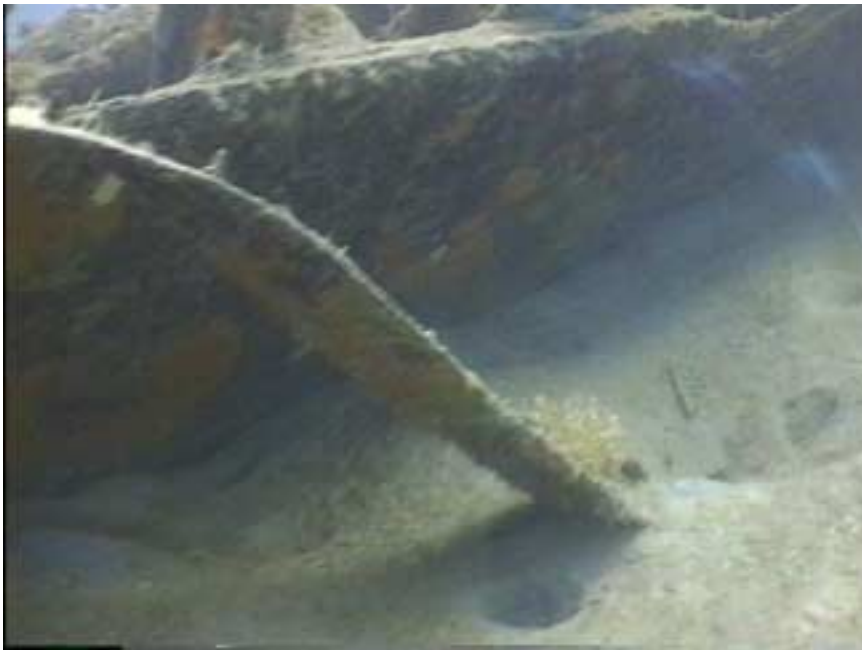
Photo WT7-3. Copper sheeting on the port side of the Central Vessel Wreckage.

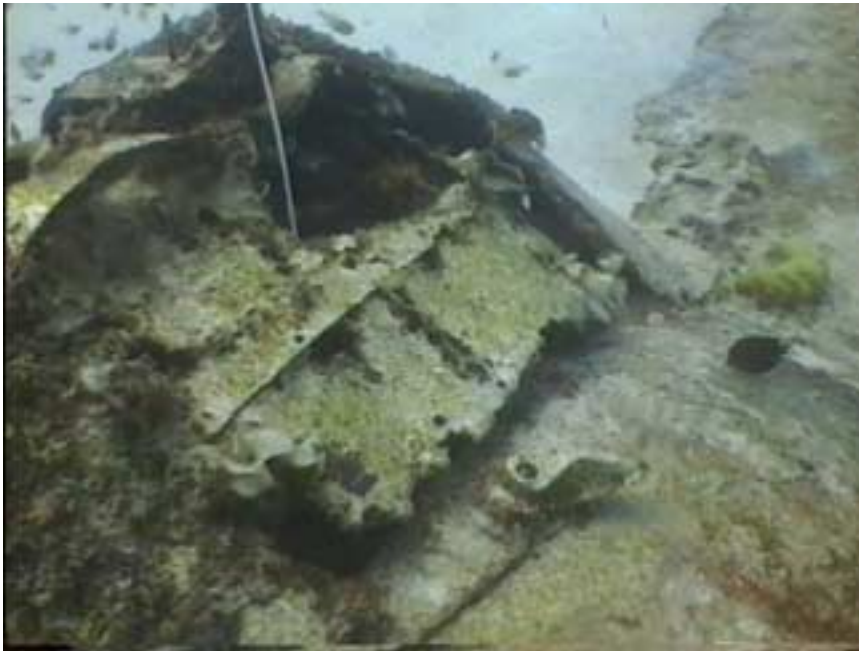
Photo WT8-3. Part of the engine mounting area on the wing section.

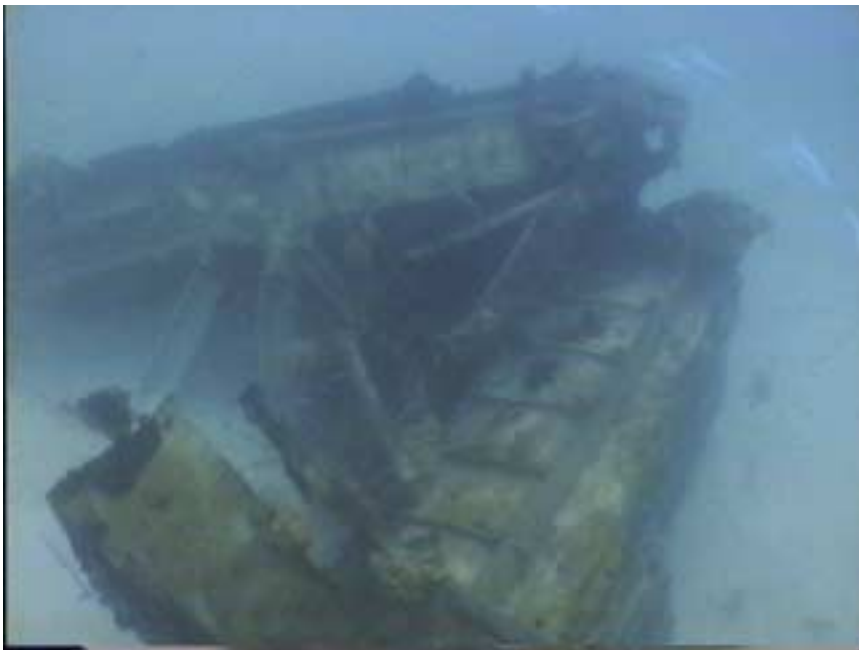
Photo WT8-4. Two more wing sections at the site, with stub inboard wing section on lower left of photo.

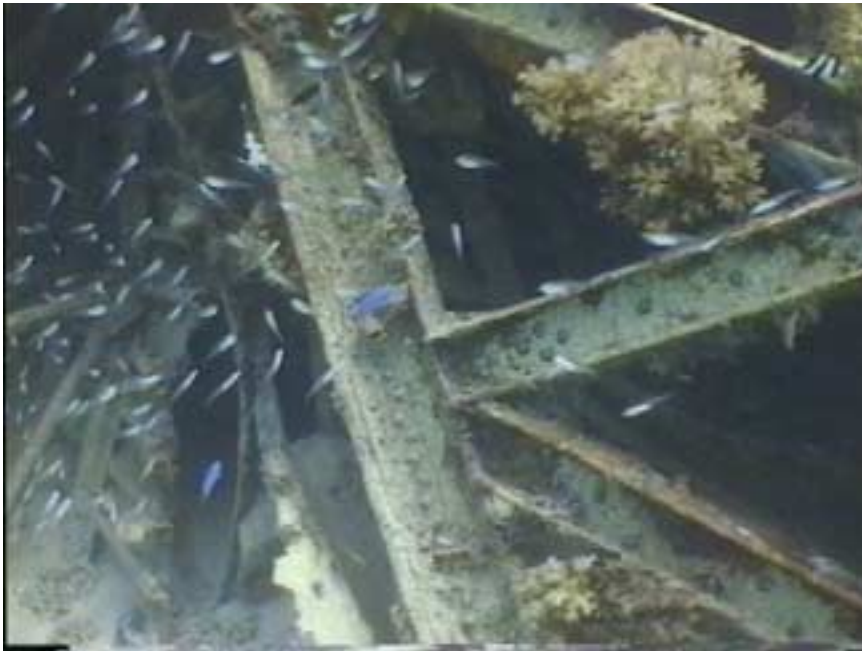
Photo WT8-5. Inside the exposed edge of the large wing section.

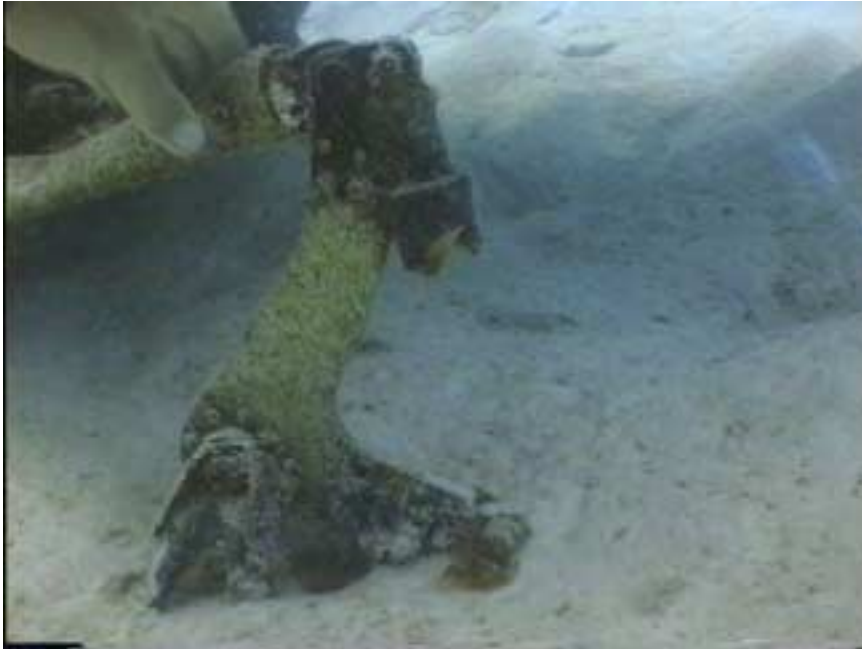
Photo WT8-9. A control arm stuck in the sand, very similar to a control arm for the ailerons for a Mitsubishi G4M "Betty" bomber.

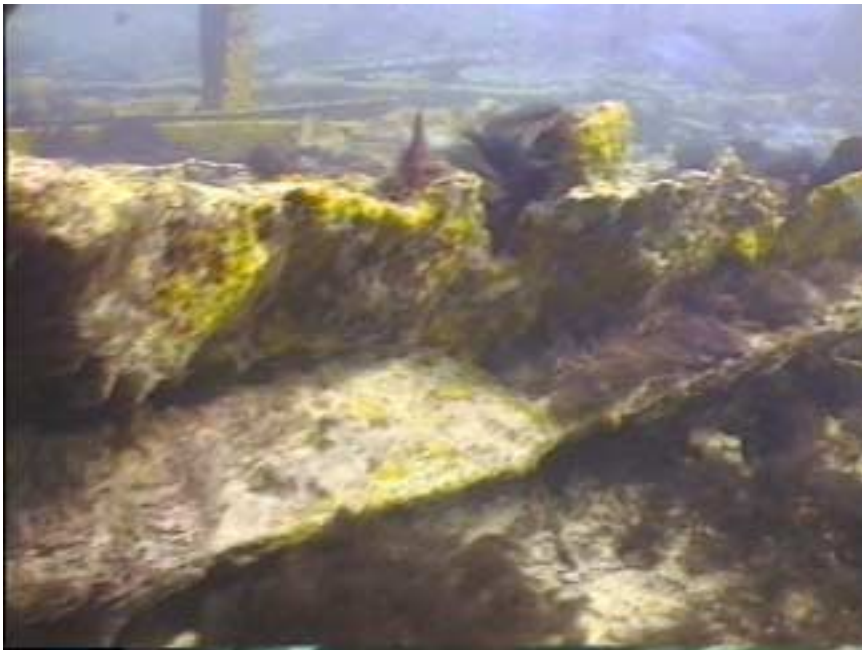
The bow is shown in Photo WT9-2, with 2 anchor tubes. The vessel had an attached bilge keel, with the port side shown in Photo WT9-3. The vessels windlass is in Photo WT9-4, and a steel mast post base in Photo WT9-5. If an original photo of each of the Wotje vessels could be found, it could more easily identified.

Photo WT9-3. Bilge keel on remaining hull section on port side bow.

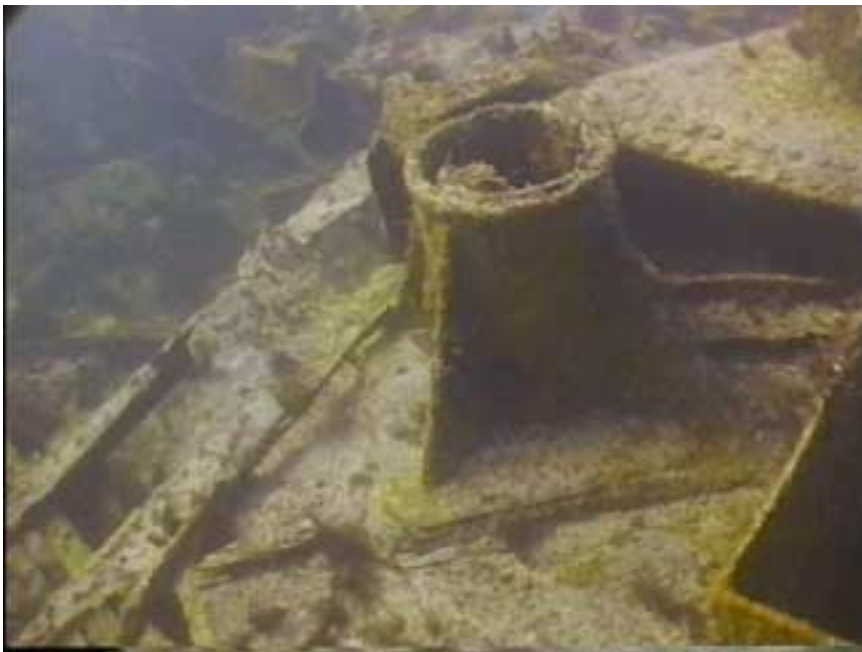
Photo WT9-5. Main mast post from forward area of vessel.

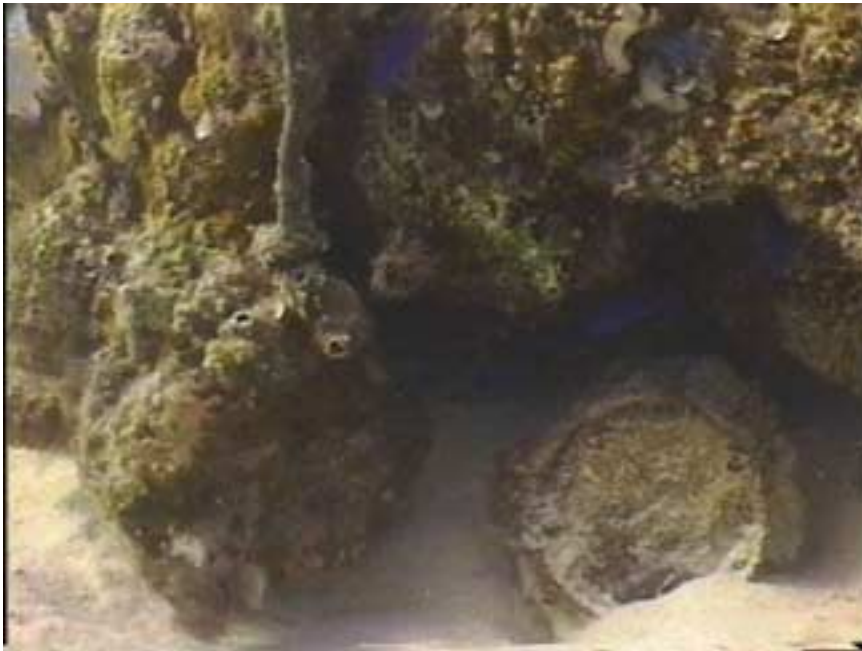
The engine is hardly recognizable from some angles, being overgrown with coral (Photo WT10-1) One cylinder head was missing, allowing the measurement of the cylinder bore, 140mm diameter, in Photo WT10-2. This measurement is typical of a smaller engine, such as belonging in a fighter, rather than engines in Japanese bombers or flying-boats. The rear of the engine is seen in Photo WT10-3, and a close up of the secondary gears, possibly used for timing the machine guns firing through the propeller of a fighter aircraft, is shown in Photo WT10-4.

Photo WT10-2. Double row of cylinders, 140mm diameter, in heavily encrusted coral.

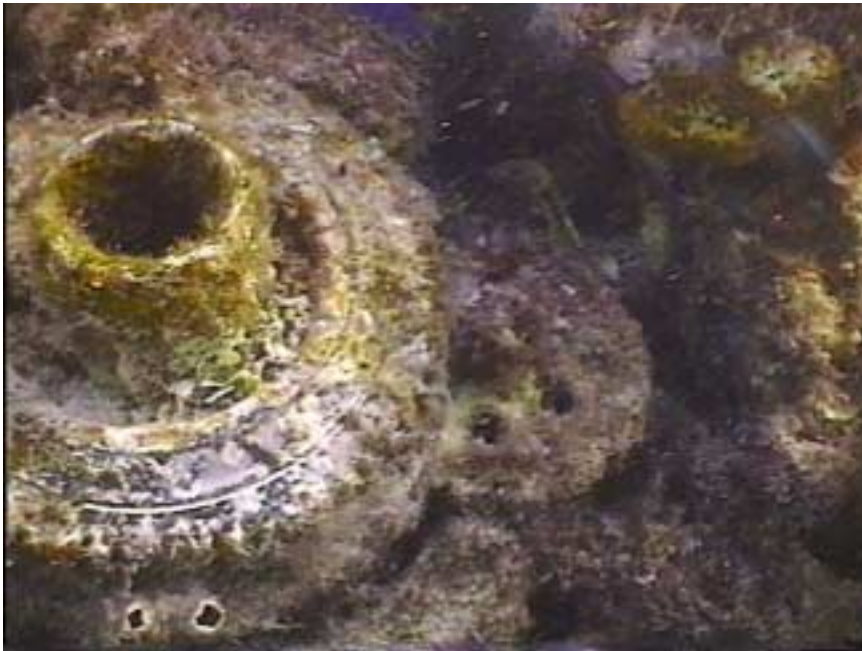
Photo WT10-4. Close up of rear of engine. Note secondary drive gear.

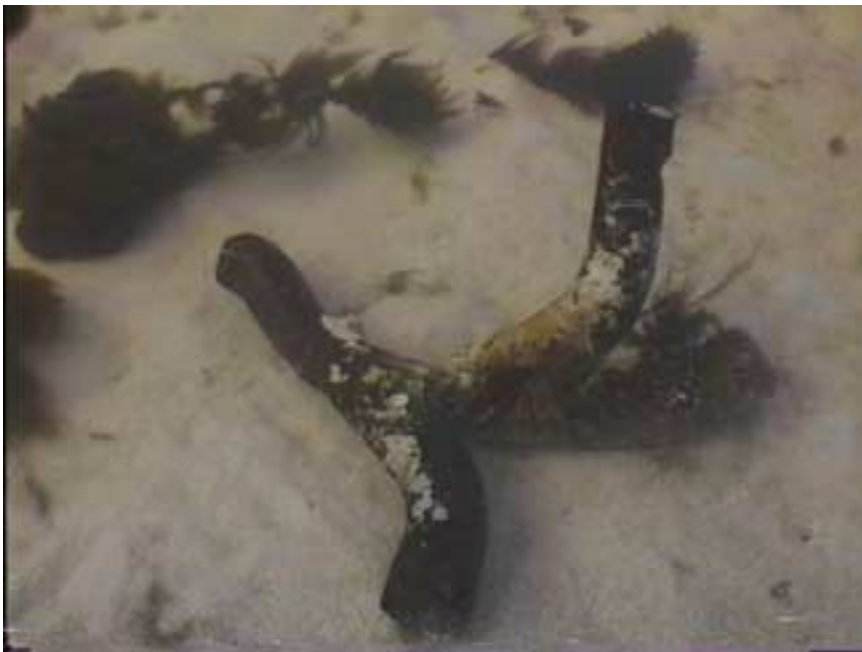
Photo WT10-7. Engine exhaust manifold.

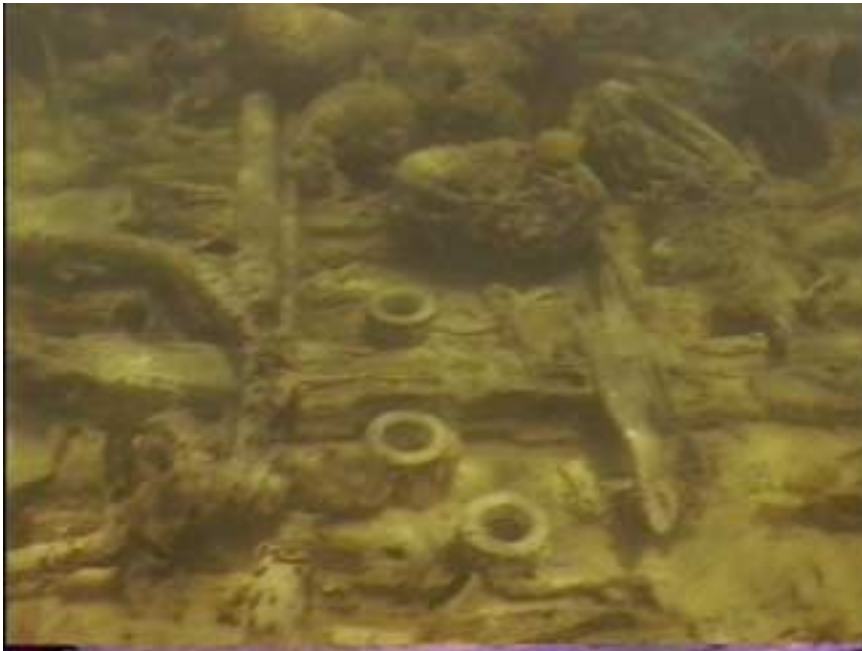
Photo WT11-3. Hull bottom with thru hull fittings.

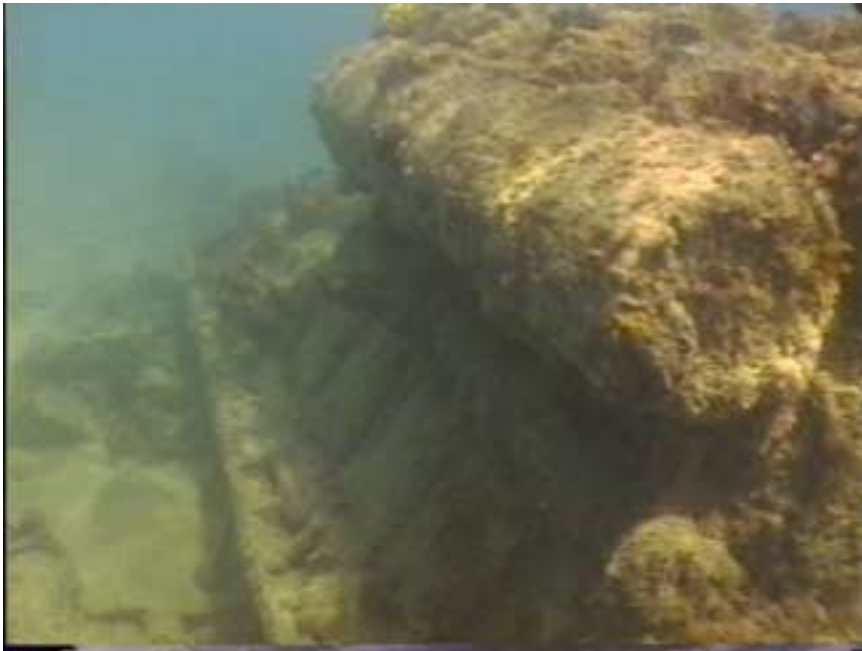
The main engine was a typical 6 cylinder unit, but was more modern than other units surveyed (Photo WT11-4). The engine and generator were air started, and air storage bottles were found near the main engine (Photo WT11-5). The gearbox and main shaft were attached to the main engine, but the propeller had already been removed. The stern items remaining were the kitchen stove nearby (Photo WT11-6), and the fuel tanks and steering gear. Small broken shards of dishes and bottles were also found in the area. A spare anchor, probably stowed on the stern, also rested on the bottom at the stern of the vessel (WT11-7).

Photo WT11-4. Main engine on starboard side facing the stern.

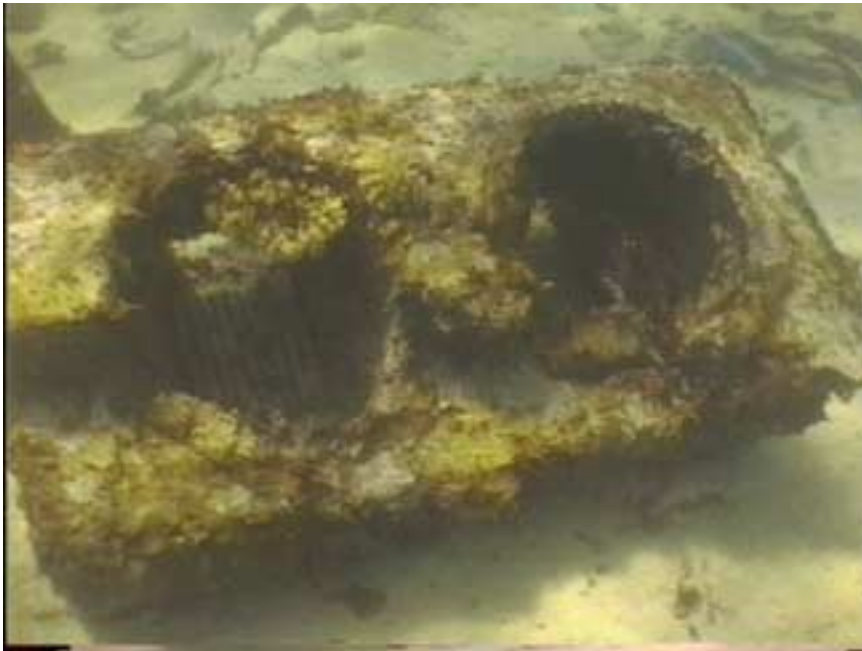
Photo WT11-6. Kitchen stove near stern of vessel.

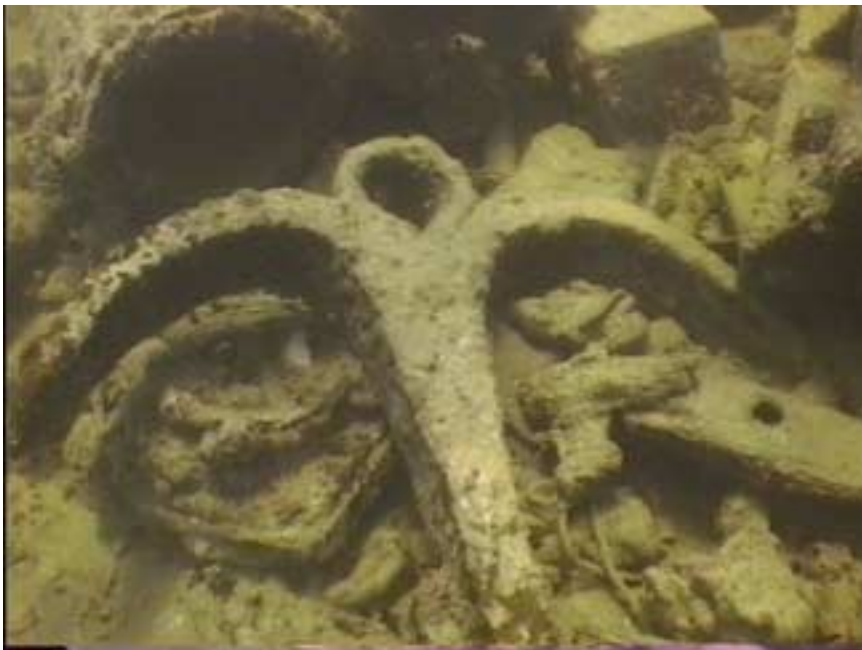
Photo WT11-7. Emergency anchor at stern area of vessel, port side.

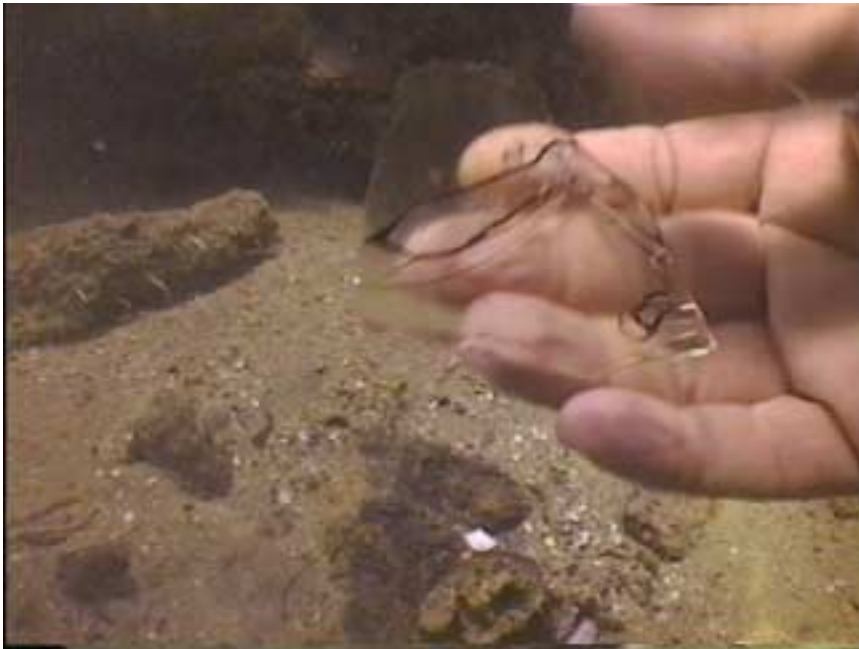
The vessel did not have any serious structural damage, indicating it was not directly struck by a bomb or artillery shell. It was probably sunk by near misses of bombs or artillery fire, possibly strafed, and through whatever means, caught fire and sank at

anchor. Shards of glass were found with burn indications (Photo WT11-8), and the remaining hull wood and surrounding sand showed indications of fire (Photo WT11-9).

Photo WT11-8. Glass shard with burn indications, probably from running lights, found on port side near the bow.

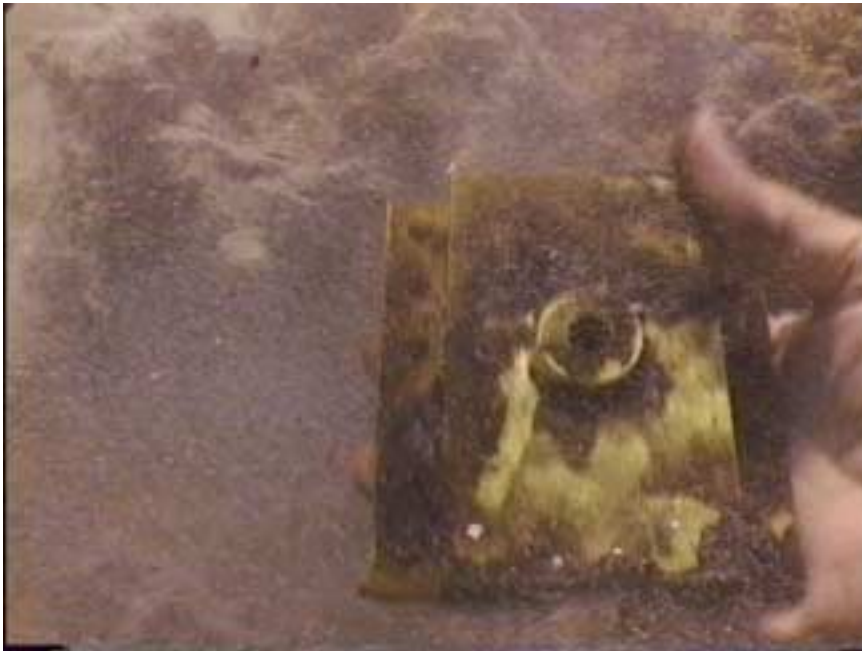
Photo WT11-10. Brass lock found in sand and debris on port side mid-ship.

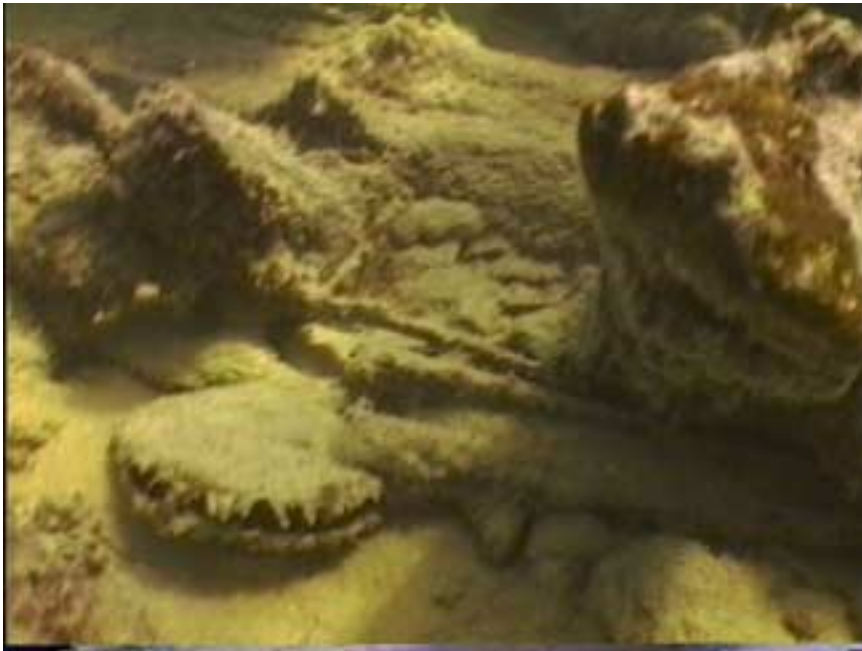
Photo WT11-12. Marine life was limited, this black lip pearl oyster surviving near the main engine.

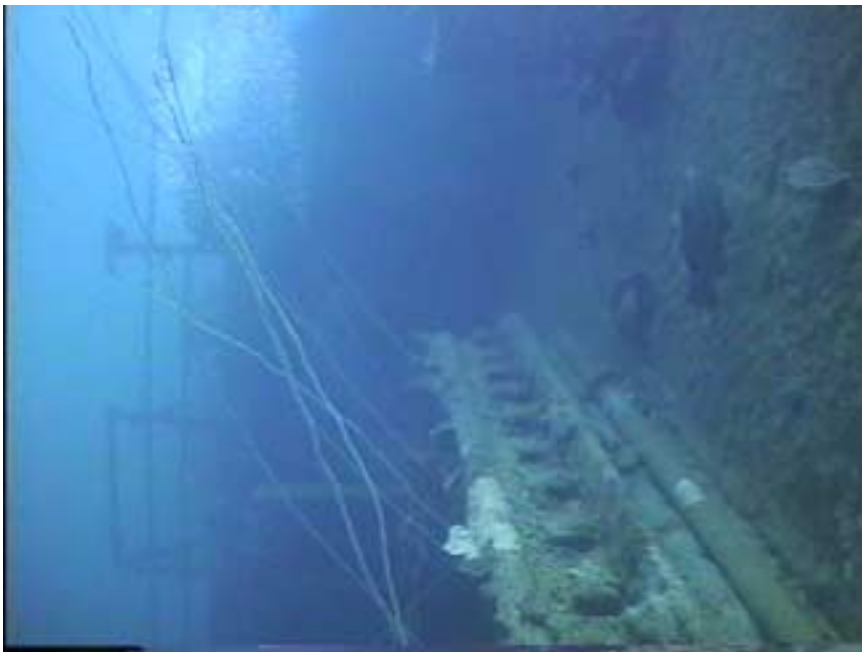
Photo WT12-7. Towards the bow on the main deck, with the number 1 hold to the left of the photo.

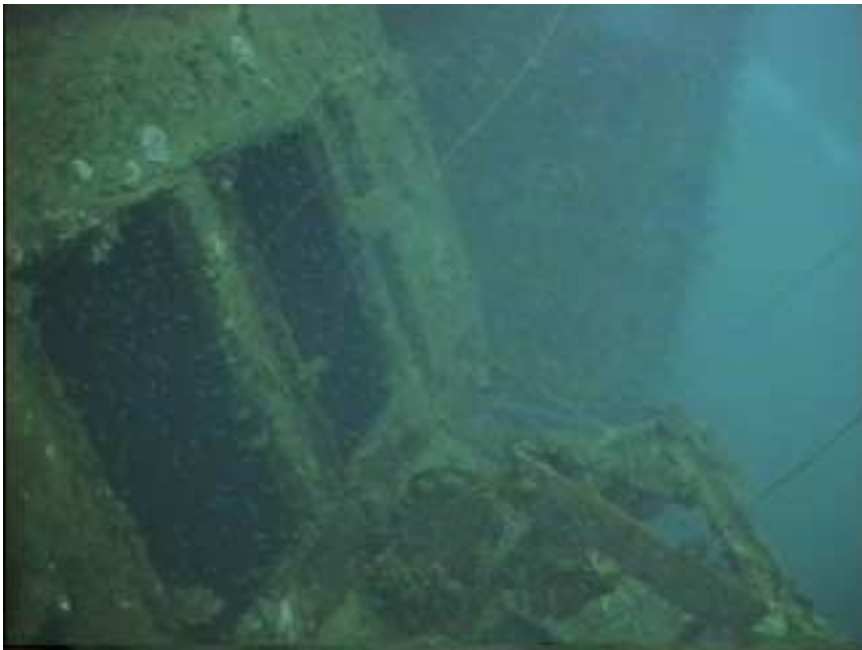
Photo WT12-13. Open engine room skylights.

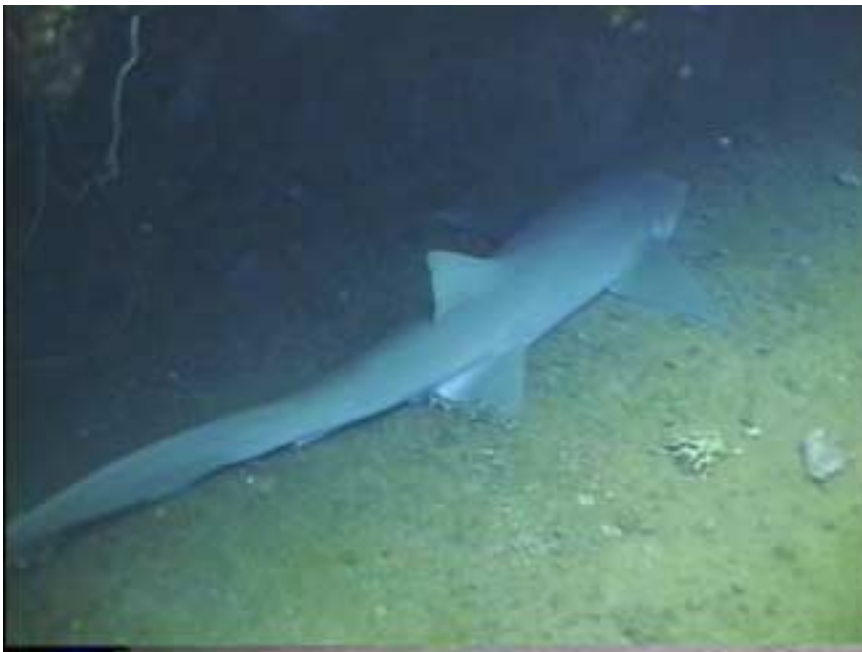
Photo WT12-15. Nurse shark resting near the engine room spaces on the main deck area.
