*Archaeological Survey and Inventory of Submerged
Cultural Resources in the Lagoon of Wotje Atoll*

Matthew B. Holly

HPO Report 2000/03

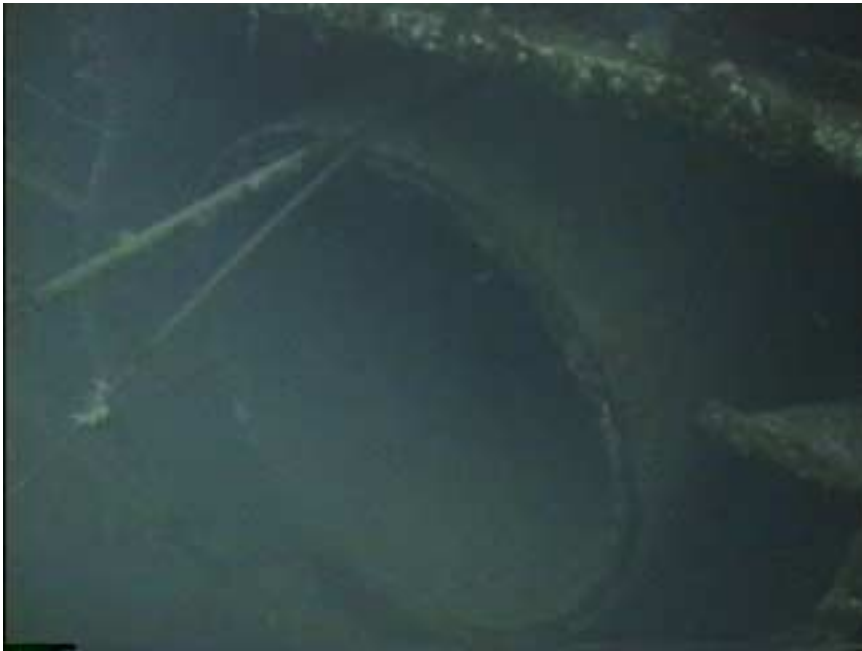
Photo WT12-16. Funnel base; funnel had fallen off and crushed itself.

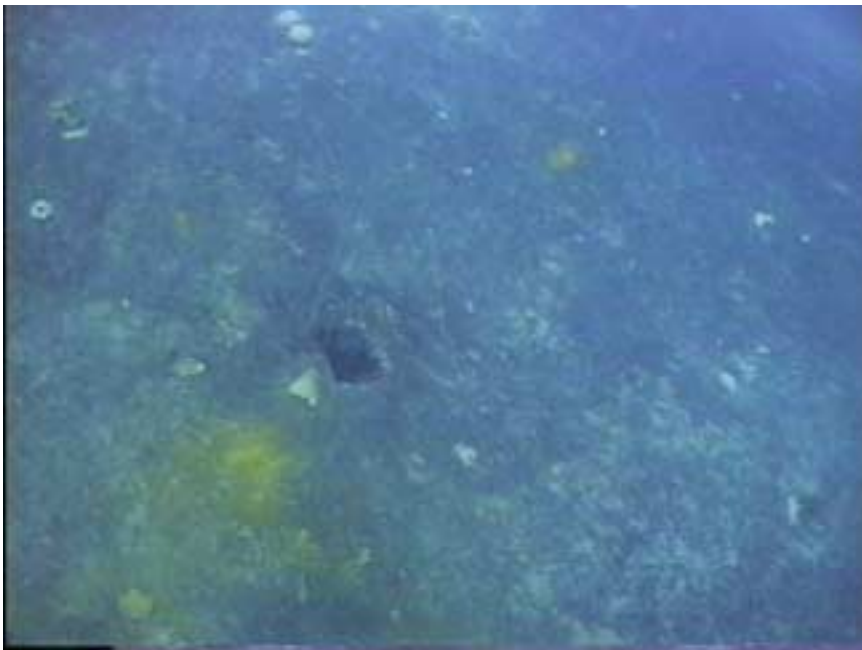
Photo WT12-17. Small hole in stern on starboard side, probably from Naval artillery shell.

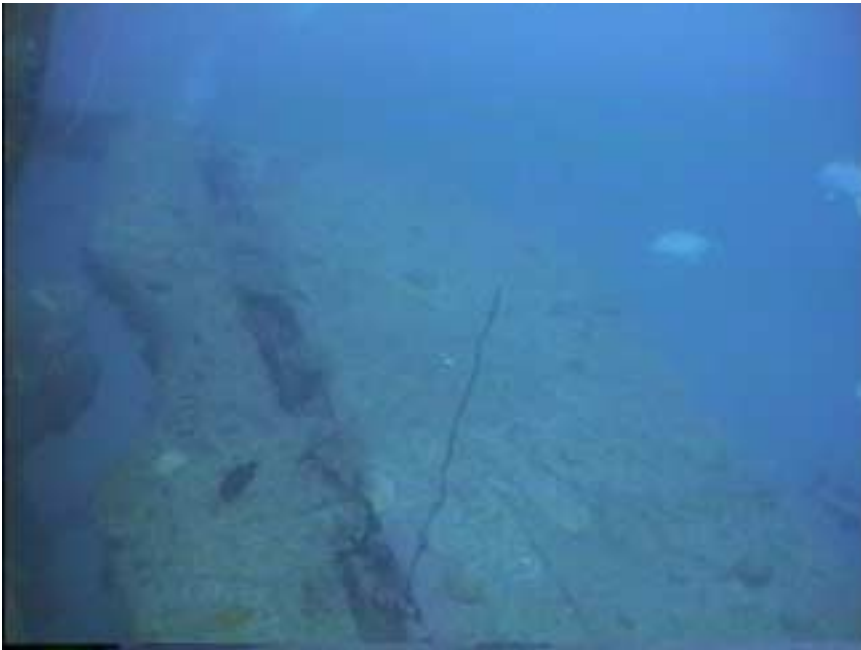
Photo WT12-19. Massive rudder of Borudou Maru.

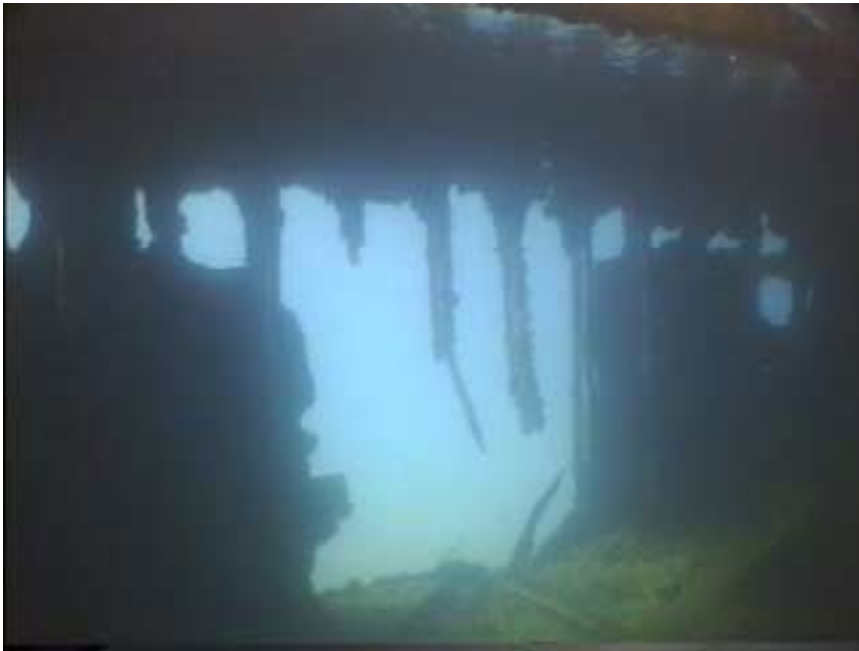
Photo WT13-5. Hole in port side of bow from probable near bomb miss.

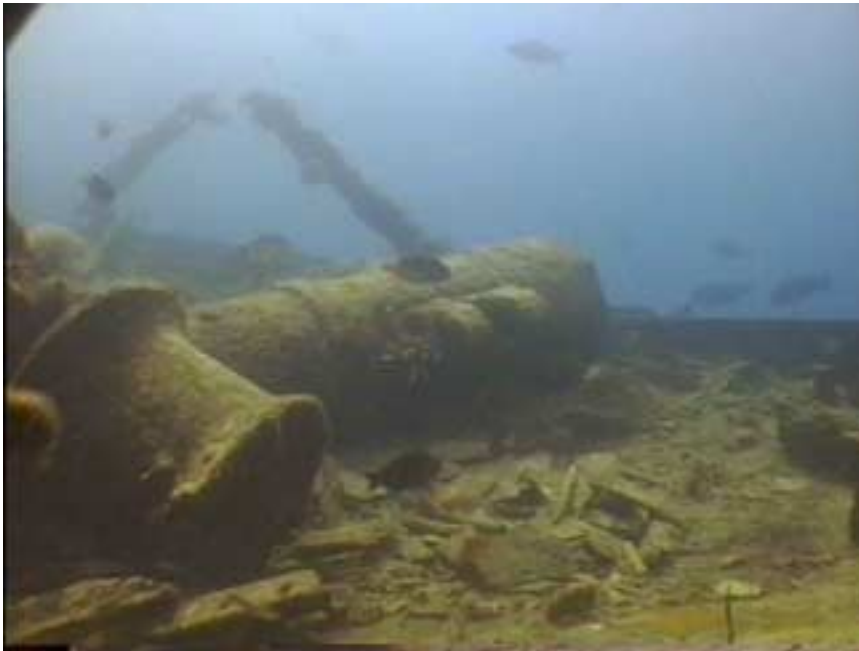
Unfortunately, the vessel was probably struck at this site in the stern by large bomb(s), as from behind the engine room, including the last 2 holds, is a pile of steel debris. Repeated and/or large bomb blasts have shredded the vessel to its keel. Photos WT13-9 and Photos WT13-10 show this damage. The final portion of the vessel has a segment of hull still attached from the keel to the underside of the stern, supporting the rudder, which is still attached, and actually a danger to passing boats.

Photo WT13-9. Stern debris, with winch and king-post lying on remains of a section of the port side deck.

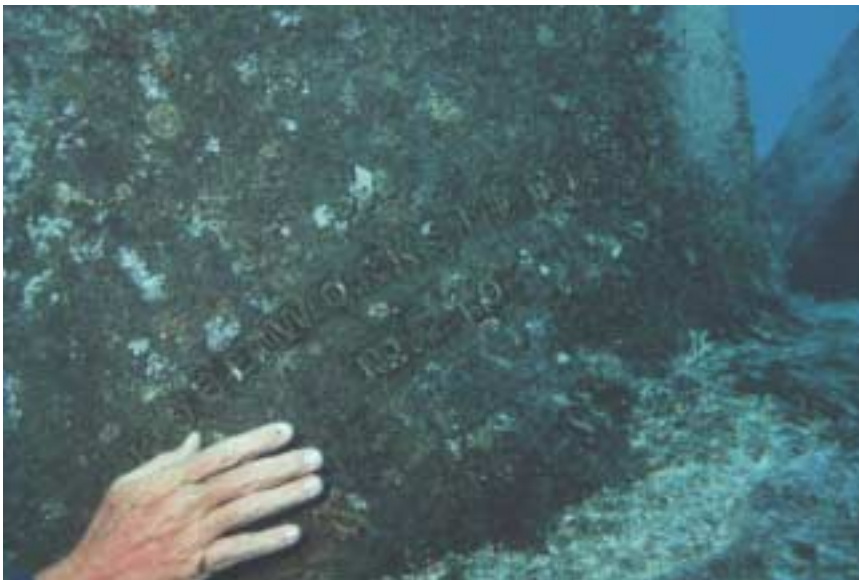
Photo WT13-12. Propeller manufacture cast into individual blades. This casting has Mitsubishi "3 Diamond" emblem and reads "KOBE WORKS MAY 1937, No. 210" Smaller ID reads "DIA 4.000m by PITCH 4.638m (not clear) ". Also on ID was numbers 12-3-22, indicated Japanese 12th Year of Showa, meaning 1937, March 22nd.
