The Impact of a Ship Grounding and Associated Fuel Spill at Rose Atoll National Wildlife Refuge, American Samoa

U.S. Fish and Wildlife Service Pacific Islands Ecoregion Honolulu, Hawaii

September 1997

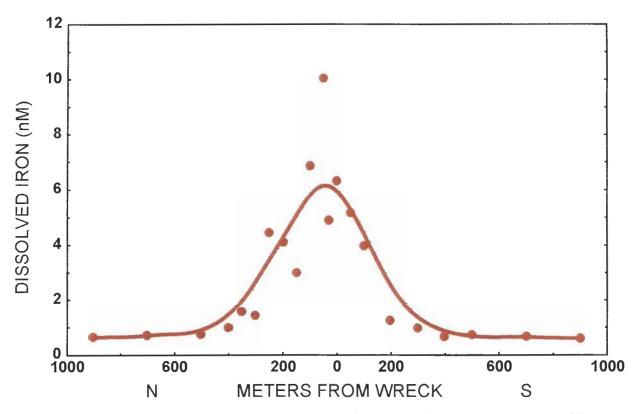
A clear peak in iron concentration was found on the outer reef flat at the wreck site (Fig. 16). Given water circulation patterns on the atoll (see *Study Area*), the source of the iron is most likely the large amount of submerged wreckage on the outer reef slope. Limited sampling suggests that a plume of iron-rich water, approximately 500 m wide, flows across the reef from the outer reef slope to the lagoon and that the debris on the reef flat contributes relatively little iron to the plume (J. Burgett unpubl. data). By comparison, low background iron levels found away from the plume (< 1 nM: Fig. 16) are typical of oceanic waters in which iron is the limiting nutrient.

Figure 16 Iron (Fe) concentrations (and least squares curve) on the outer reef flat on the southwest arm of Rose Atoll in January 1997.

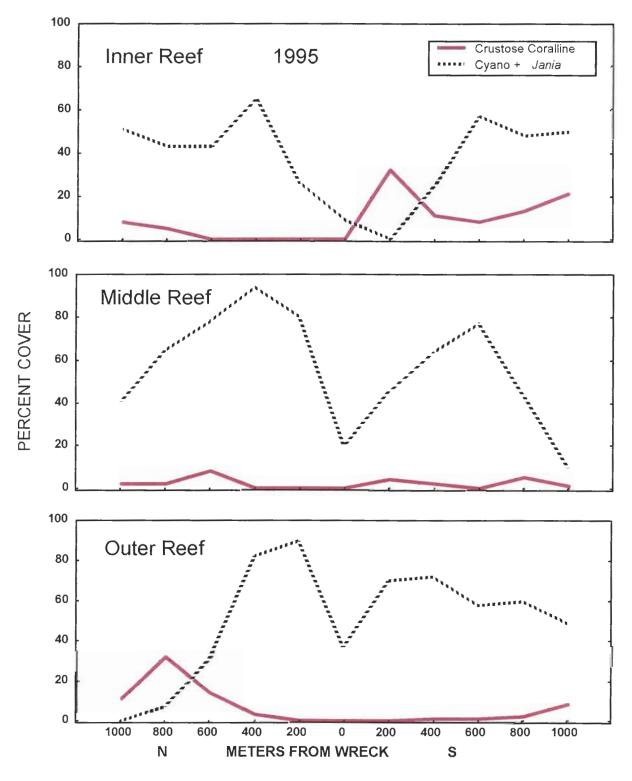
The algal communities on the southwest arm have changed dramatically as a result of the grounding. By 1995, it was apparent that the previously dominant crustose coralline algae were no longer abundant on this arm (0-35% cover: Fig. 21), and that they had been replaced by opportunistic species. At that time, the dominant algae on the southwest arm were a mixed community of cyanobacteria species and a finely branched, turf-forming coralline alga, *Jania adherens*, which together accounted for up to 90% of the cover (Fig. 21). The *Jania*, like cyanobacteria, is usually rare on the atoll, and became abundant on the southwest arm sometime between March 1994 and August 1995. As a result of this change in the algal communities the reef flat on the southwest arm had changed from pink, the color of healthy crustose coralline algae, to black, the color of the mixed cyanobacteria community (Figs. 19 & 22). This pattern was most pronounced on the outer reef flat (Figs. 22).

Figure 21 Abundance of crustose coralline algae and opportunistic algae (cyanobacteria and *Jania*) in a gradient away from the wreck site on the southwest arm of Rose Atoll two years after the grounding (1995). Data is presented for each of three zones across the reef flat: inner, middle, and outer (see Fig. 20).

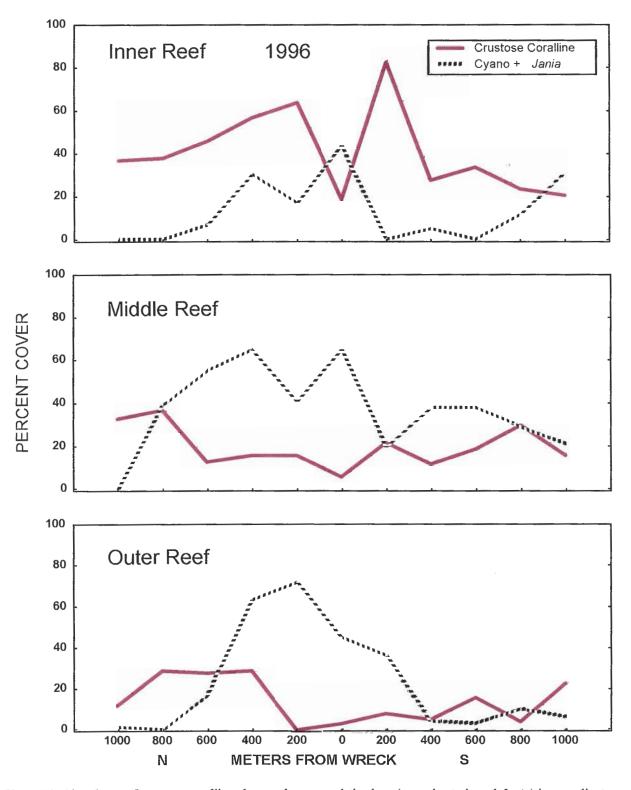
Figure 23 Abundance of crustose coralline algae and opportunistic algae (cyanobacteria and *Jania*) in a gradient away from the wreck site on the southwest arm of Rose Atoll almost three years after the grounding (1996). Data is presented for each of three zones across the reef flat: inner, middle, and outer (see Fig. 20).

The results of the survey in 1996 indicated that some reef recovery was underway on the southwest arm. Crustose coralline algae had recolonized the inner reef flat (Fig. 23). However, only minor recovery of crustose corallines had occurred on the middle and outer reef flat, and these areas were still dominated by cyanobacteria and *Jania* (Fig. 23). On the outer reef flat, the area of dominance by opportunistic *Jania* and cyanobacteria had become more restricted and centered north of the wreck (Figs. 21 & 23). Qualitative observations in January 1997 indicate that this is still the case (J. Burgett pers. obs.).

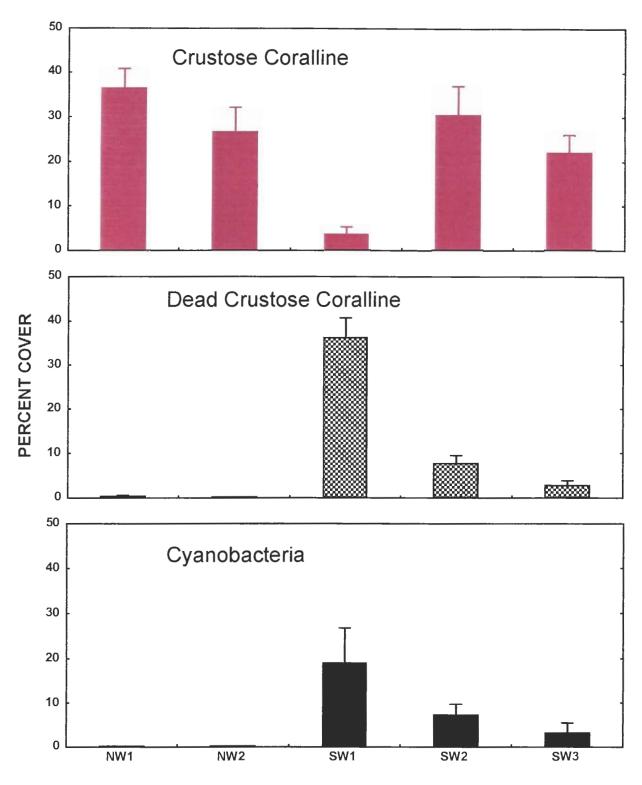
This study showed that there were some dramatic differences in the algal communities on the reef slope at Rose Atoll one to two years after the grounding (Fig. 24). Live crustose coralline algae was the dominant substratum type at all sites, except the wreck site. Similarly, qualitative observations of the reef slope on the southeast arm revealed that it was also dominated by a lush growth of live crustose coralline algae (A. Green pers. obs.). In contrast, the algal communities at the wreck site were dominated by dead crustose coralline algae and cyanobacteria. Dead, crustose coralline algae and cyanobacteria were also recorded in low abundance on the other two sites on the southwest arm but were not recorded on the northwest arm. These results suggest that there has been a die-off of crustose coralline algae at the wreck site as a result of the grounding, and that the area has become dominated by opportunistic algae species.

Figure 24 Abundance of live and dead crustose coralline algae and cyanobacteria on the outer reef slope at three sites on the southwest arm and two sites on the northwest arm of Rose Atoll approximately one year after the ship grounding. Where SW1 is the wreck site (see Fig. 2)

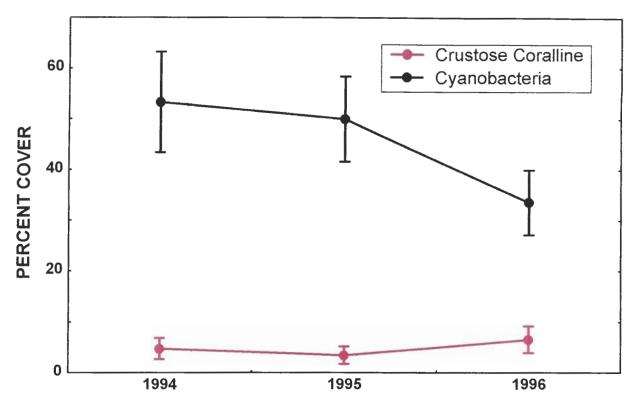
In order to determine how the algal communities changed over time, the survey of the wreck site was conducted on three occasions: October 1994, August 1995, and August 1996. The results of these surveys show that the algal communities at the wreck site do not appear to have recovered from the effects of the grounding (Fig. 25). The area is still dominated by cyanobacteria and the cover of crustose coralline algae has not increased.

Figure 25 Abundance of live crustose coralline algae and cyanobacteria on the outer reef slope at the wreck site approximately one, two and three years after the grounding (1994, 1995, 1996 respectively).

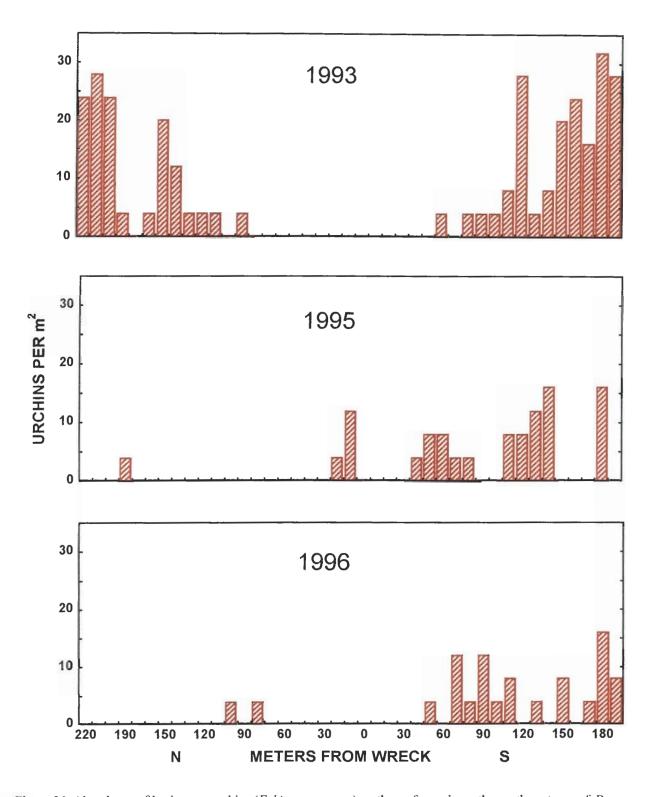
Figure 26 Abundance of boring sea urchins (*Echinometra* spp.) on the reef margin on the southwest arm of Rose Atoll on three occasions: two weeks, two years and three years after the grounding (1994, 1995, 1996 respectively). Data are presented in a gradient away from the wreck site.

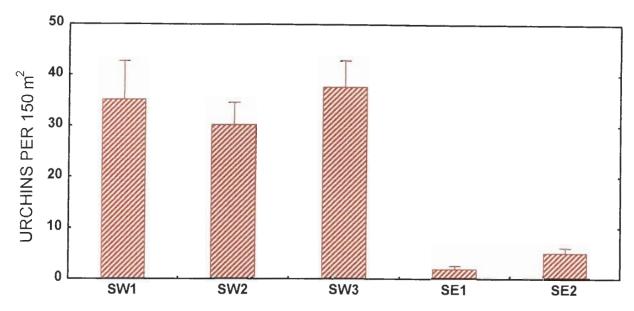
Figure 27 Mean density (and standard error) of sea urchins (*Diadema* spp.) on the reef flat at three sites on the southwest arm and two sites on the southeast arm of Rose Atoll two years after the grounding. Where SW1 is the wreck site (see Fig. 2)

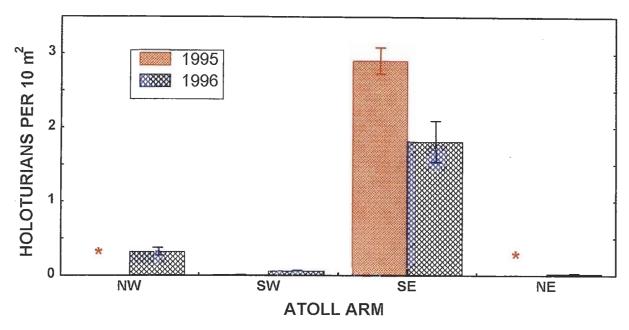
Early observations suggested that holothurian density was unusually low at the wreck site (M. Molina pers. comm.). To determine if this was true, sea cucumber surveys were done on the southwest and southeast arms of the atoll two years after the grounding. These surveys were repeated and expanded to include the other two arms one year later. Holothurian abundance was measured by five observers walking approximately 20 m apart across the reef flat in the center of the arm from the edge of the lagoon to the outer, seaward margin of the reef flat. Each observer counted the number of sea cucumbers observed within 1 m either side of the track. Holothurians were not recorded at the species level, but it was apparent that the dominant species was

Figure 28 Mean density (and standard error) of holothurians on each of the four arms of Rose Atoll two and three years after the grounding. Asterisks represent counts that were not done on the northwest and northeast arms in 1995.

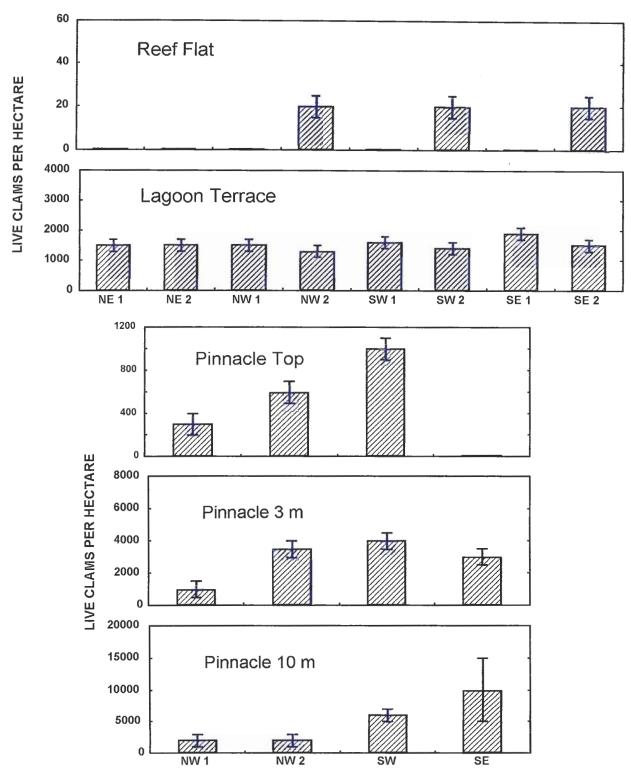
Figure 29 The abundance of giant clams on the reef flat, lagoon terrace, and three depths on the pinnacles, at a range of sites around Rose Atoll approximately one year after the grounding. Where SW1 is the wreck site (see Fig. 2).

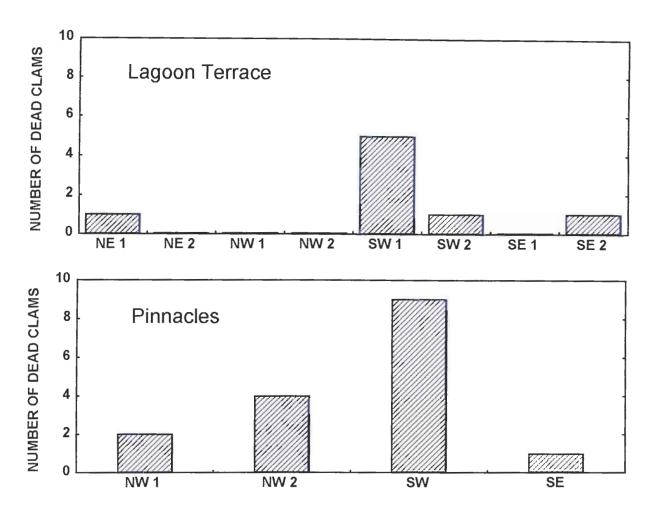
In contrast, the distribution and abundance of dead clams around the atoll indicates that there had been an impact on the clam population at the site of the grounding, which was still apparent 12 to 18 months after the event. The majority of the dead clams observed in each habitat type (63%, n=24) were recorded on the southwest arm of atoll (Fig. 30). However, this pattern should be interpreted cautiously because of the low number of individuals involved. No dead clams were recorded on the reef flat in this survey.

Figure 30 The number of dead clams recorded on the lagoon terrace and the pinnacles (at all three depths) in a range of sites around Rose Atoll approximately one year after the grounding. Where SW1 is the wreck site (see Fig. 2).

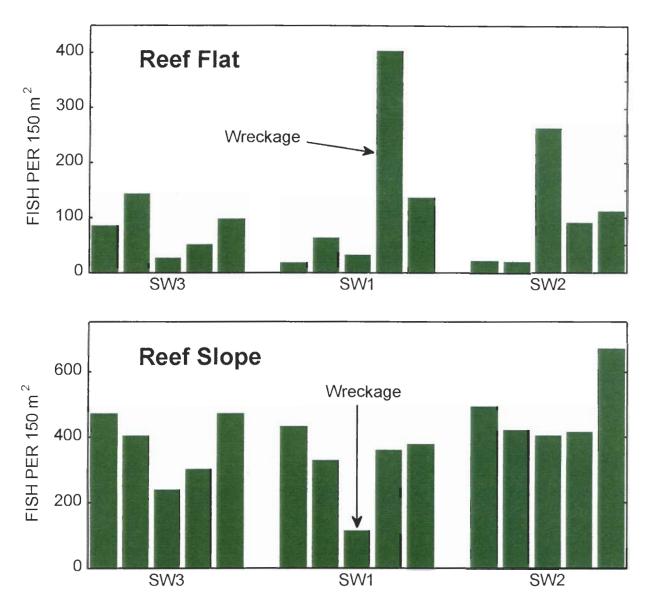
The results of this study show that the ship grounding appeared to have localized effects on the distribution of reef fishes on the southwest arm, although the effects were different in the two habitat types. On the reef flat, fish abundance was substantially higher around the wreckage at the wreck site than it was on any of the other transects on the southwest arm (Fig. 31). This was primarily due to the presence of large schools of herbivorous surgeonfishes (especially *Acanthurus triostegus*) and parrotfishes (especially *Scarus frontalis*), which appeared to be attracted to the site because of the algal bloom (see *Algae*) and the three-dimensional cover provided by the large pieces of wreckage (see Fig. 14).

In contrast, fish abundance on the outer reef slope was substantially lower around the wreckage at the wreck site than it was on any of the other transects on the southwest arm (Fig. 31). This was because some species usually associated with healthy reef slopes, such as butterflyfishes and the abundant damselfish *Chromis acares*, were less abundant around the wreckage than on the other transects. However, in a similar pattern to that described for the reef flat, the majority of fishes that were present at the wreckage were herbivorous surgeonfishes, mostly *Ctenochaetus striatus* and *Acanthurus triostegus* (Fig. 32), which were probably attracted to the area because of the algal bloom (see *Algae*) and the cover provided by the wreckage.

Figure 31 Abundance reef fishes on the reef flat and reef slope on each of the transects on the southwest arm of Rose Atoll one to two years after the grounding. Where SW1 is the wreck site (see Fig. 2) and the arrow shows the location of most of the wreckage.

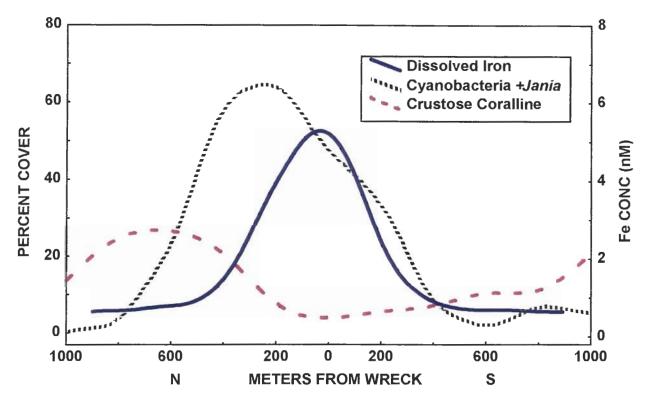
The factors responsible for maintaining the bloom of opportunistic algae at Rose Atoll are unclear. However, the bloom persists in the area that continues to receive high levels of dissolved iron coming off the wreckage on the reef slope (Fig. 33). Because iron has been shown to be the limiting nutrient for algae in oceanic environments (Martin & Fitzwater 1988), it is possible that the algal bloom is being maintained by the presence of this contaminant, and that the crustose coralline algae are unable to recolonize the area because they cannot compete with the opportunistic species. If this is true, it may be necessary to remove the wreckage to allow the reef to recover (see *Recommendations*). This hypothesis should be tested at Rose, because it has important implications for the future management of the Refuge, and for ship groundings on oceanic reefs worldwide.

Figure 33 Iron concentrations and the cover of crustose coralline algae and opportunistic algal species (cyanobacteria and *Jania*) along the outer reef flat on the southwest arm of Rose Atoll three years after the grounding.

For this reason, scientists and managers are often tempted to attempt to decrease recovery time by initiating coral reef restoration projects. It is recommended that the reef restoration at Rose be limited to the removal of the wreckage and ship debris that remains on the reef, especially the large metal objects on the reef slope that are continuing to release dissolved iron into the waters surrounding the reef. This may be important, since the iron may be impeding recovery of the
