Kosrae Shoreline Management Plan

Repositioning for resilience

NIWA Client Report No: HAM2013-133
Report date: November 2013
NIWA Project: DGI13201

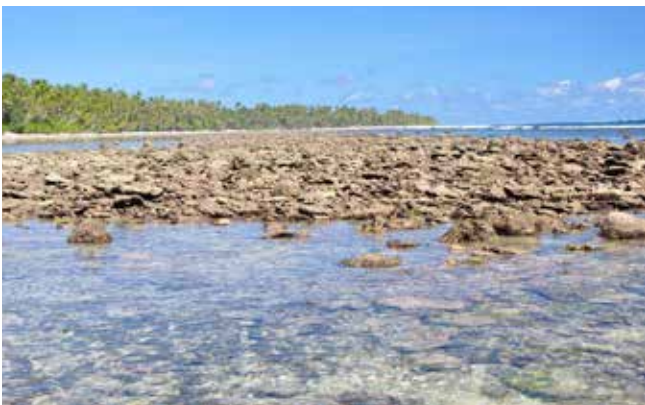
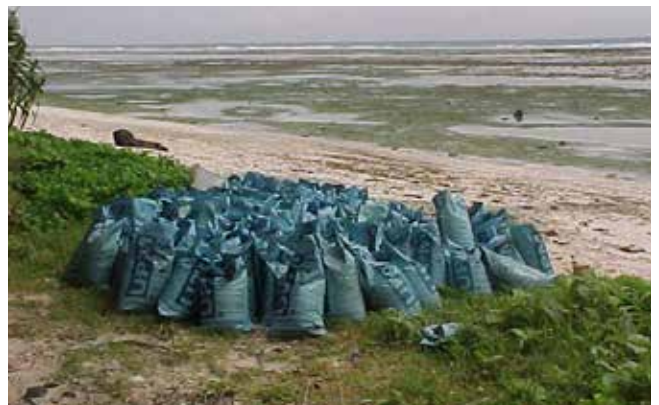
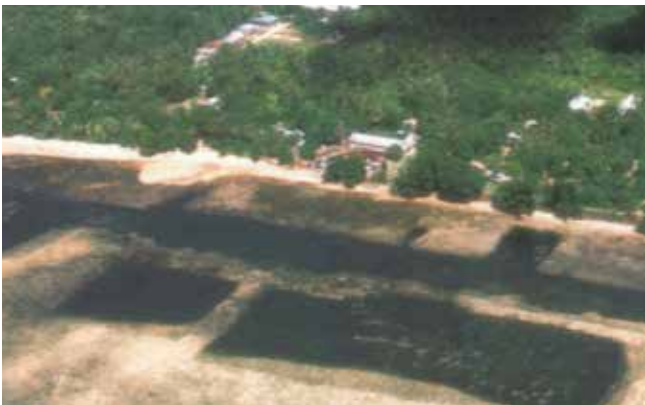
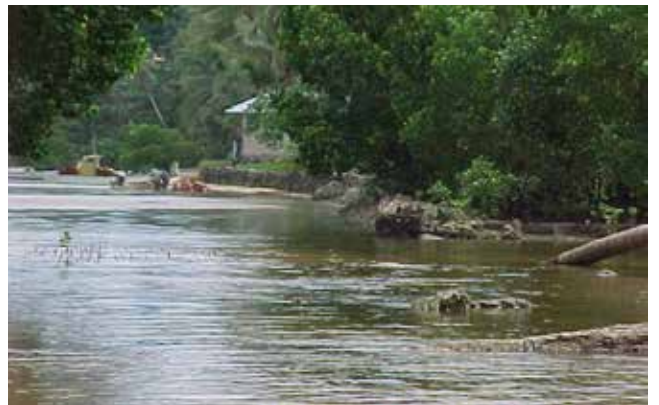
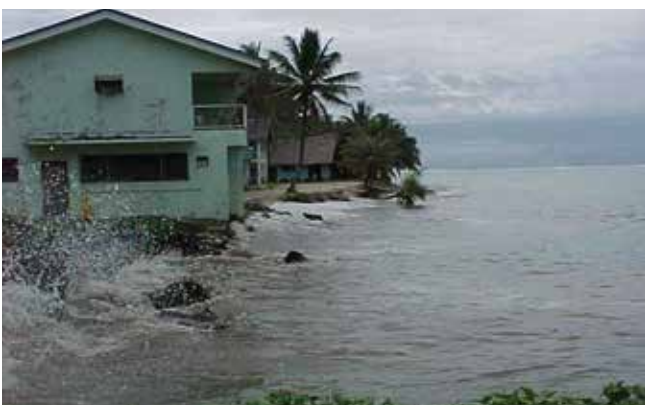
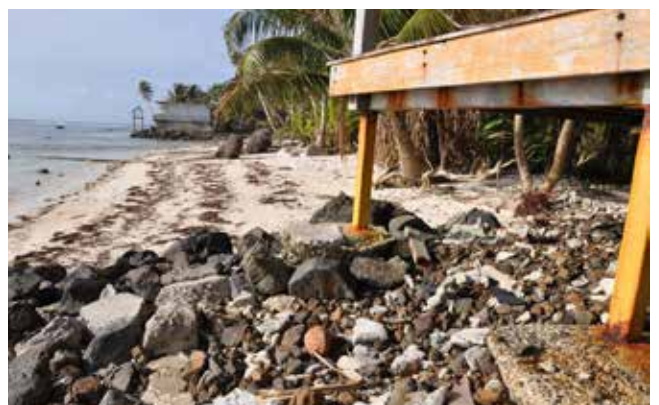
Figure 4: Examples of human impacts that have caused or exacerbated the potential for coastal erosion and inundation impacts on Kosrae. Top left: removal of coral rubble from the reef flat; Top right: Sand mining; Middle left: Dredge pits on the inner reef flat at Tafunsak; Middle right: Erosion at Walung caused by the cutting of a drainage channel at Leap; Bottom left: Erosion at the Sandy Beach Hotel caused by the seawall; Bottom right: Erosion and coastal change at Finkokoa caused by the reclamation at the old Pheonix Resort and recent house construction.

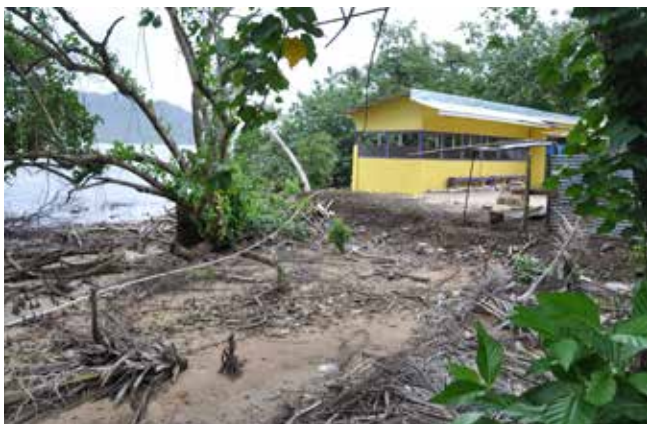
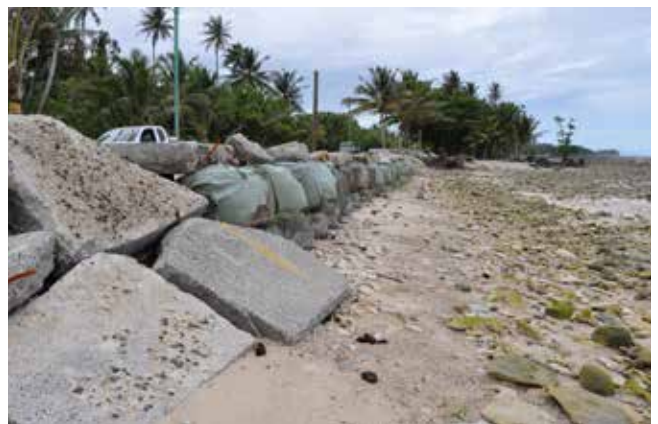
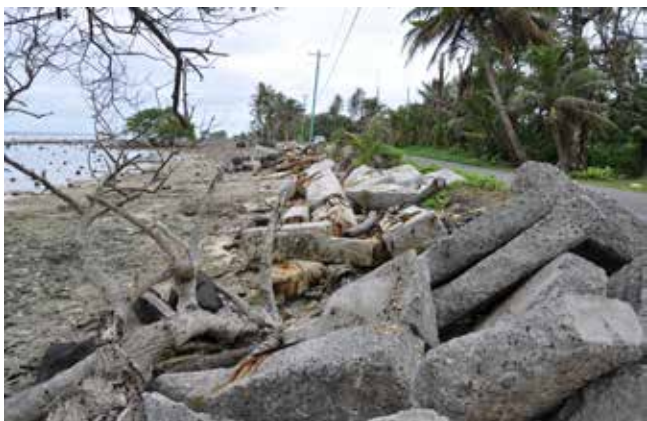
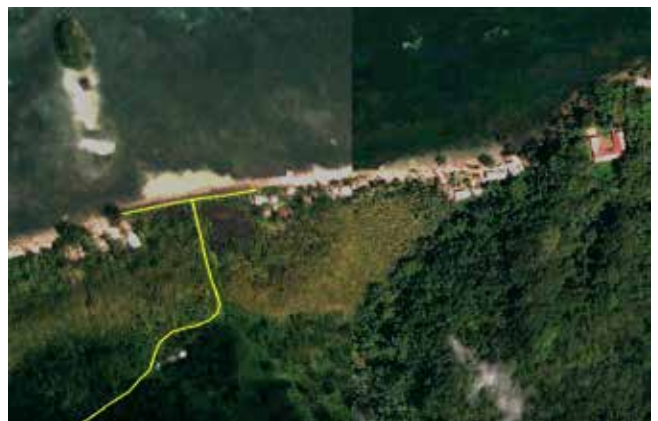
Figure 5: Recent examples of poor development activities that will lead to further coastal hazard-related problems and are not sustainable or effective in the long-term. Top left: Low-lying reclamation for a new laundromat at Tafuyat, Lelu Harbour; Top right: Concrete bag seawall to protect the road at Mosral, Malem; Bottom left: Dumped concrete rubble to attempt to protect the road at Pal, Malem; Bottom right: Access road construction through the mangrove and along the foreshore at Leap, Walung.

- The extension of the road across the wetland/mangrove area and along the shoreline at Leap in Walung (with the intention to continue the reclamation and road development to the church at Insiarf), rather than continuing it around the edge of the volcanic part of the island.

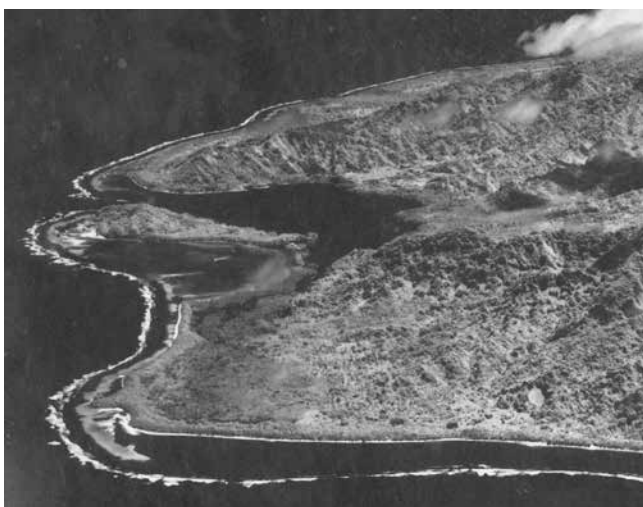
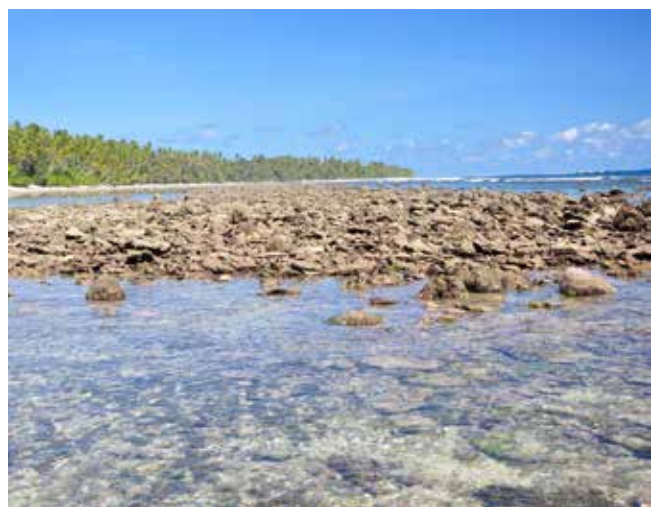
Figure 6: Aerial photograph of the north-east Kosrae coast in 1944 (left) and the remnants of the rubble ridge in 2013 at Putukte (right). The rubble ridge extending from Finaunpes all the way down the Pukushruk shoreline to Putukte can be clearly seen in 1944. The size of the ridge between Finaunpes and Finfokoa resulted in a build out of the shoreline in a bulge in the lee of the ridge. With the breakdown/removal of the rubble ridge, the sediment in this bulge in the shoreline has been redistributed along the adjacent coastline.

- **Lelu: Finfokoa and Pukushruk** – Large changes have occurred in the shoreline position at Finfokoa over the last half century and continued changes in shoreline position must be expected. However, it is expected the rate of change may be less in comparison with past change. Continued retreat of the coastline along the central section at Pukushruk will likely increase the exposure of the road to damage over time. Similarly the proximity of the road to the shoreline at Putukte suggests it will be susceptible to damage during large waves and high tides.

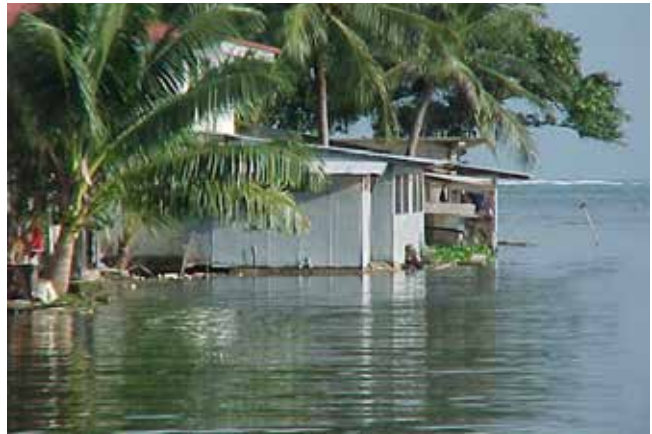
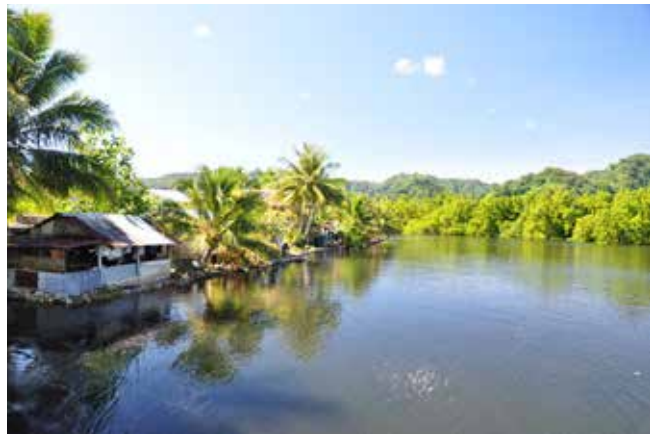
Figure 9: Low-lying reclaimed areas on Lelu Island (top) and Utwe village (bottom). Both Lelu and Utwe villages have been built on reclaimed land that is close to present day high spring tide levels. The frequency and severity of high-tide flooding will be an ever-increasing issue as sea-level rise continues. Constructing further seawalls will not prevent more frequently and severe inundation occurring in the future.

will result in increasingly more frequent damage to much of the infrastructure and property located along all parts of the coastal storm/beach berm and reclaimed areas (Figure 3). It will be increasingly difficult to maintain infrastructure and residential property located in these areas without substantial and continuous investment (for example raising reclaimed land levels in Lelu and Utwe villages).

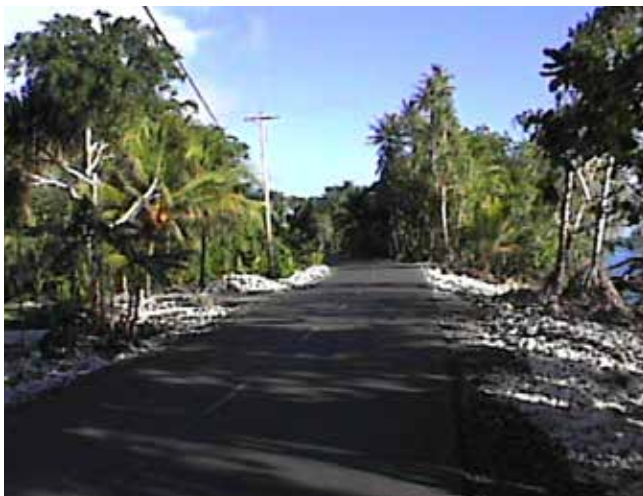
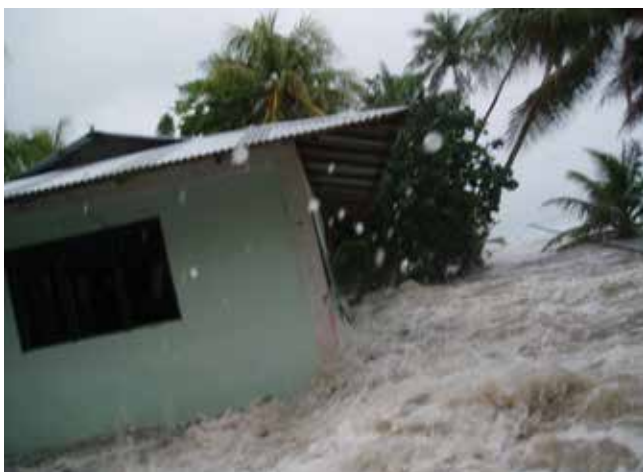
Figure 8: Overwashing of the road in South Malem during Tropical Storm 31W in December 2001 (top) and at Tafunsak during the December 2008 large swell event (bottom).

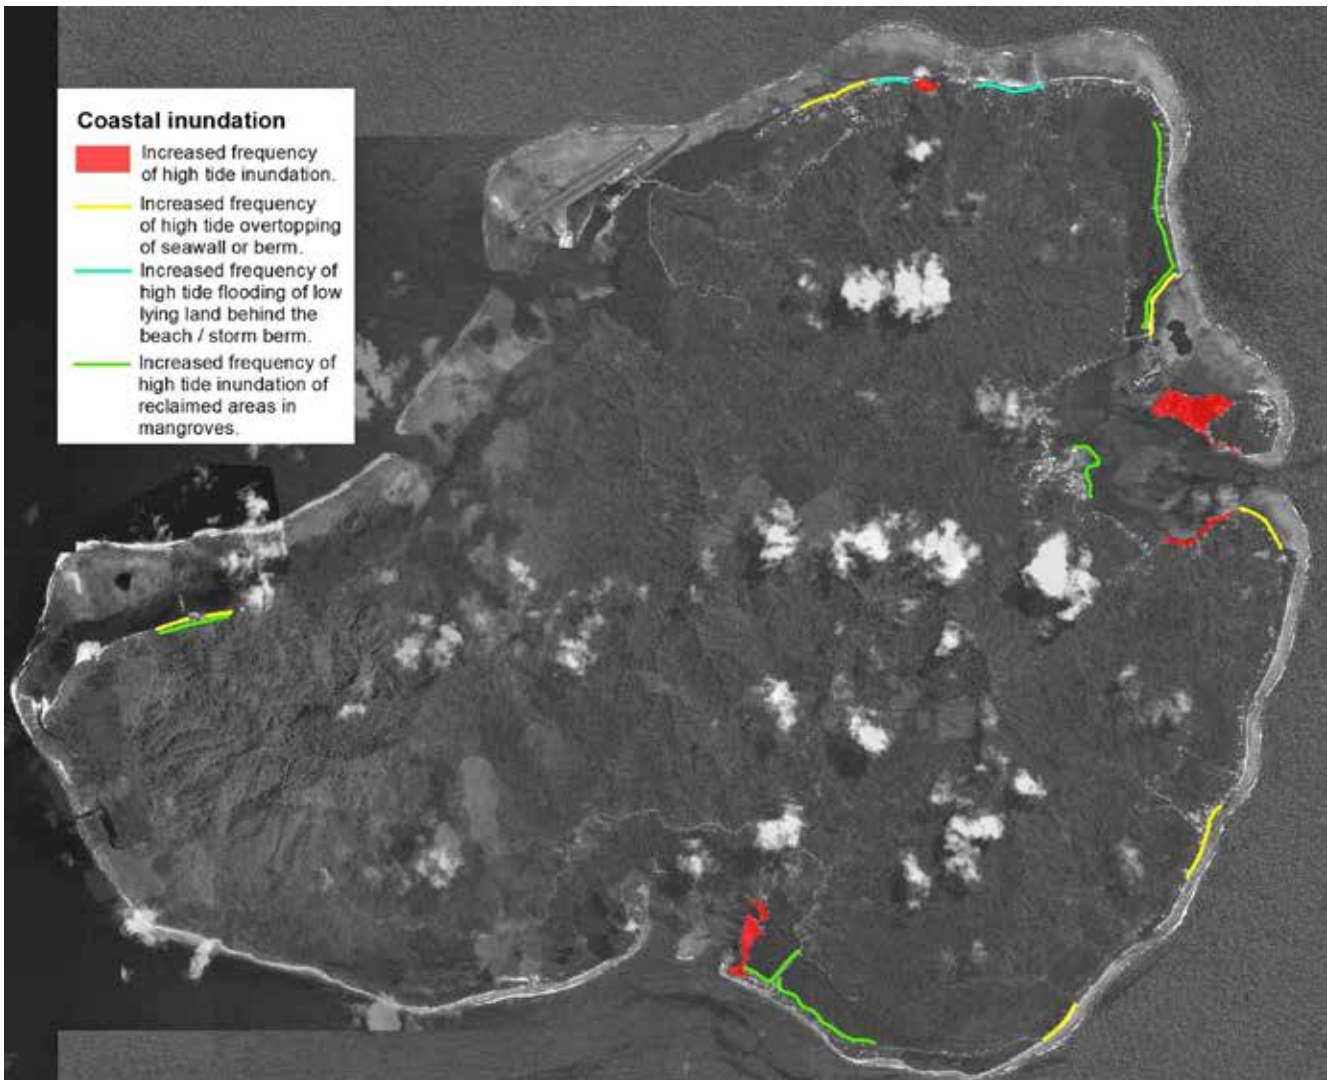
Figure 10: Summary of key locations where coastal inundation issues will increase on Kosrae over the next one to two generations.

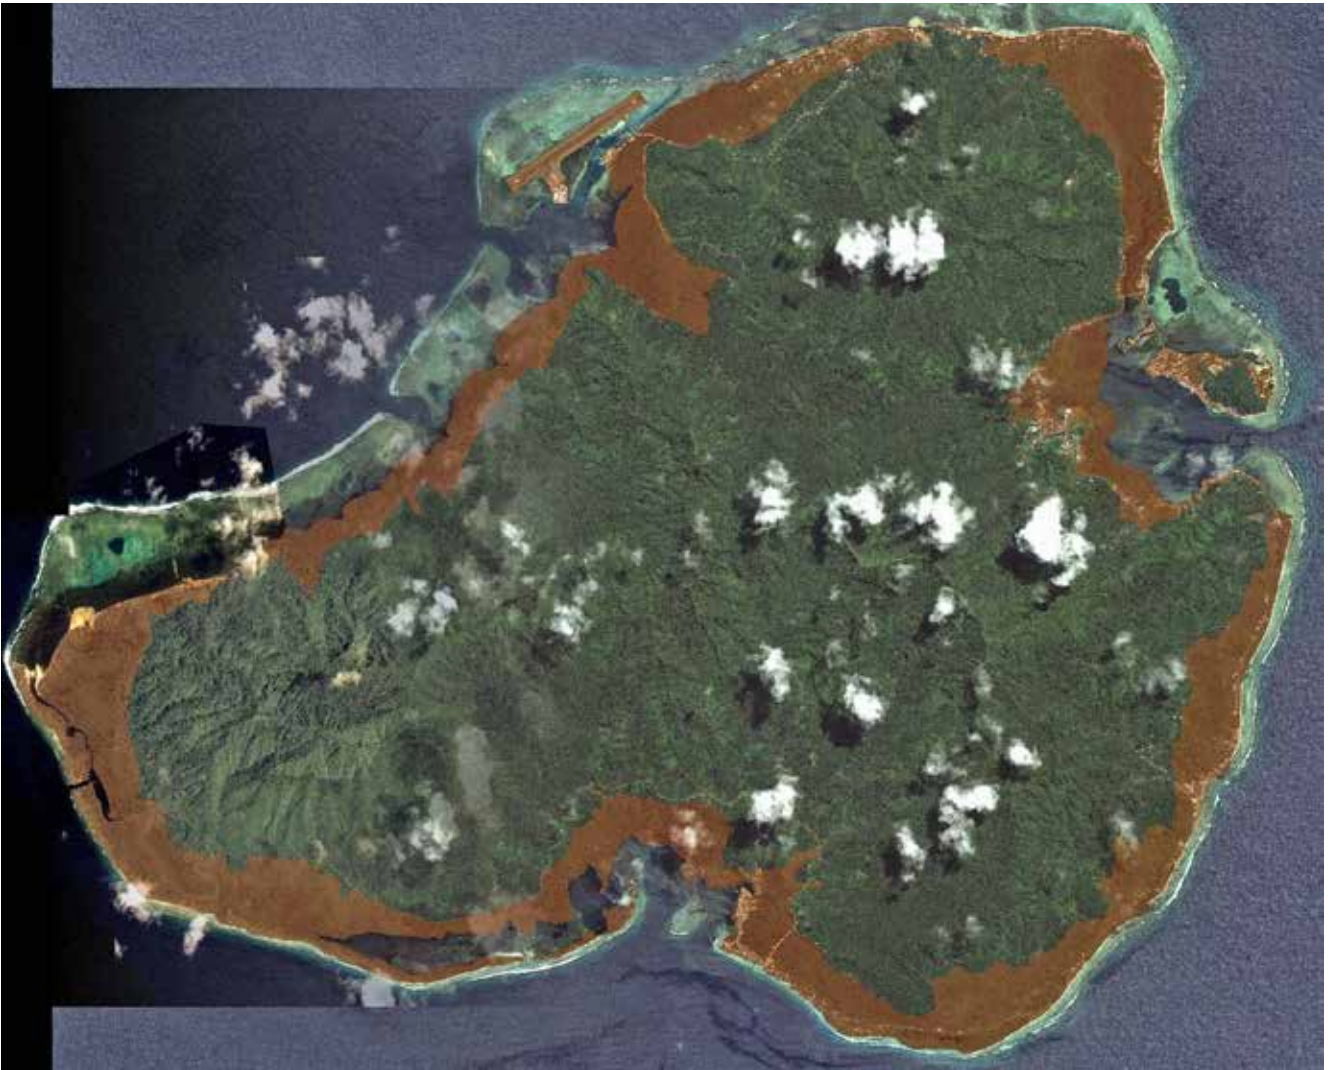
Figure 12: Low-lying coastal areas where restrictions on further development are required. The areas shown in red are largely below the 4 m MSL contour which is approximately 2 m above present day high spring tide level.

The area covered by the above development restrictions is shown in Figure 12.

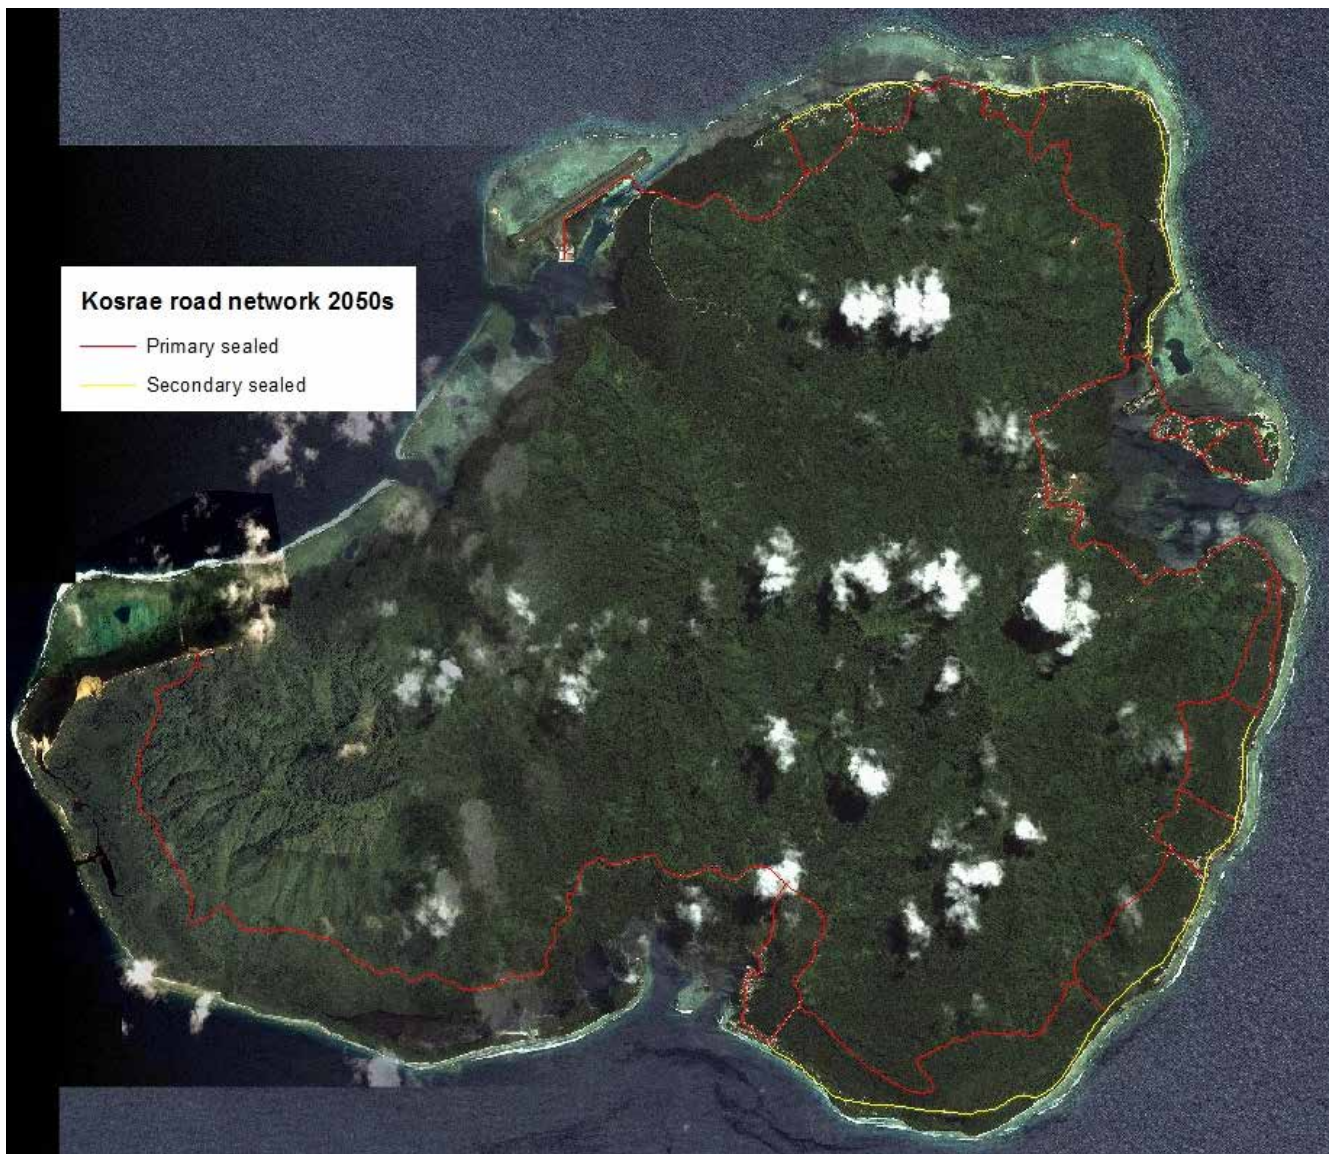
Figure 13: Potential primary and secondary sealed road network on Kosrae by the 2050s. Note: Parts of the secondary road network (current coastal road) may become impassable due to ongoing shoreline change and breaching.

By the 2050s (2 generations time) Kosrae needs to have made significant progress in implementing an adaptation strategy that repositions the majority of existing critical infrastructure and property away from the beach/storm berm areas, reclaimed areas of mangrove and low-lying wetland swamp to slightly higher ground around the base of the volcanic part of the island (Figure 13).

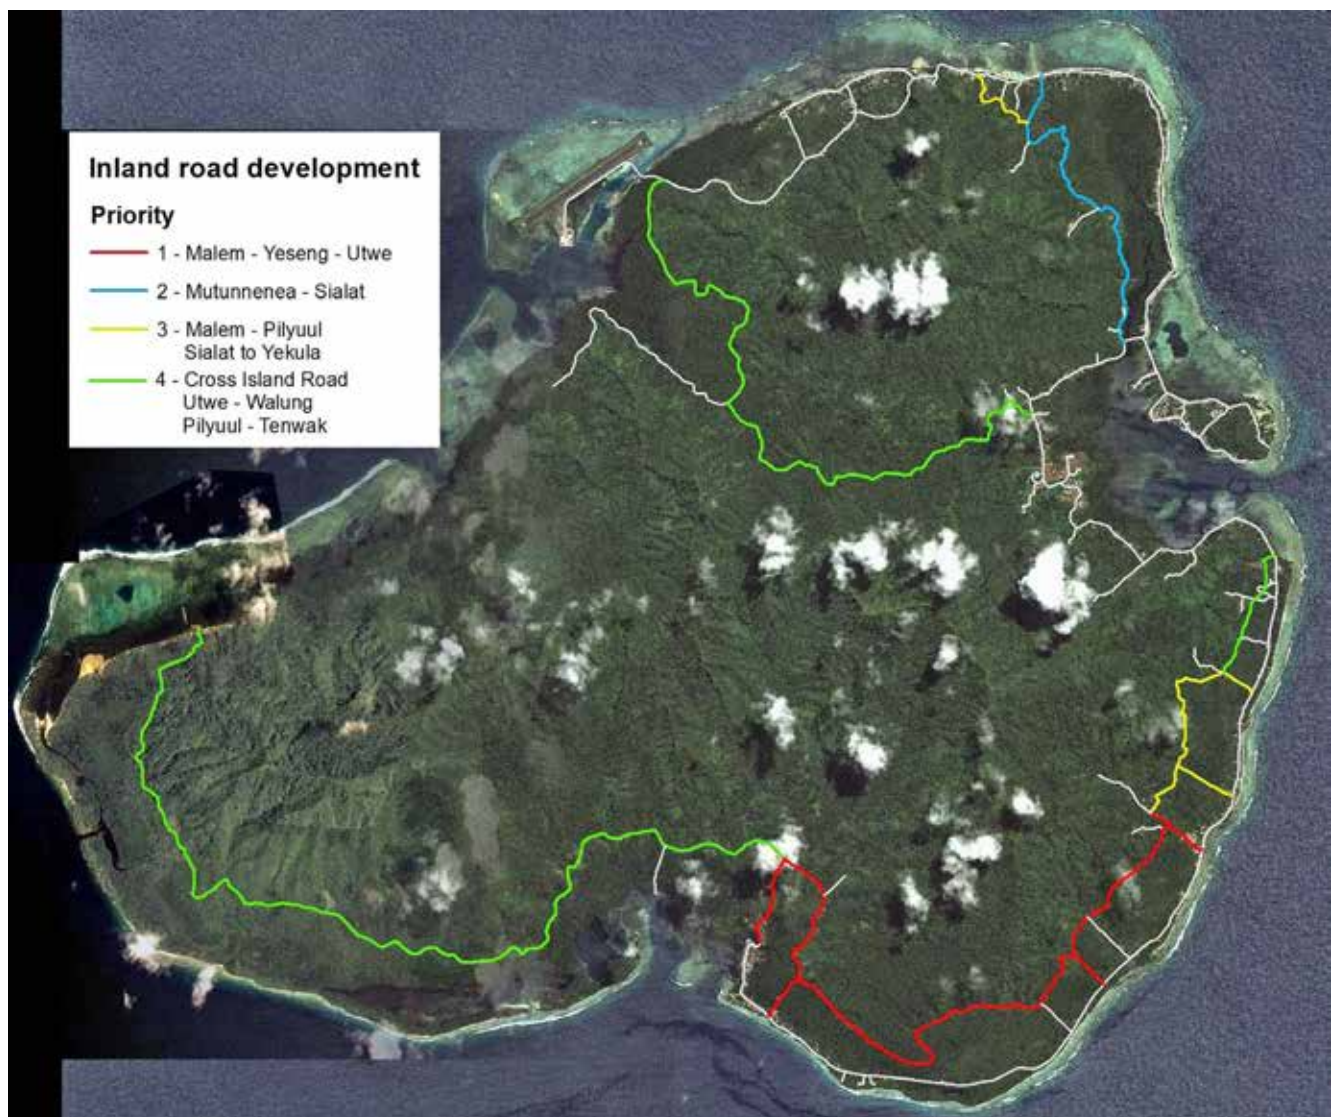
Figure 14: Priority section of the development of the inland road on Kosrae.

The prioritized redevelopment of the coastal road is summarized in Figure 14 and outlined below:

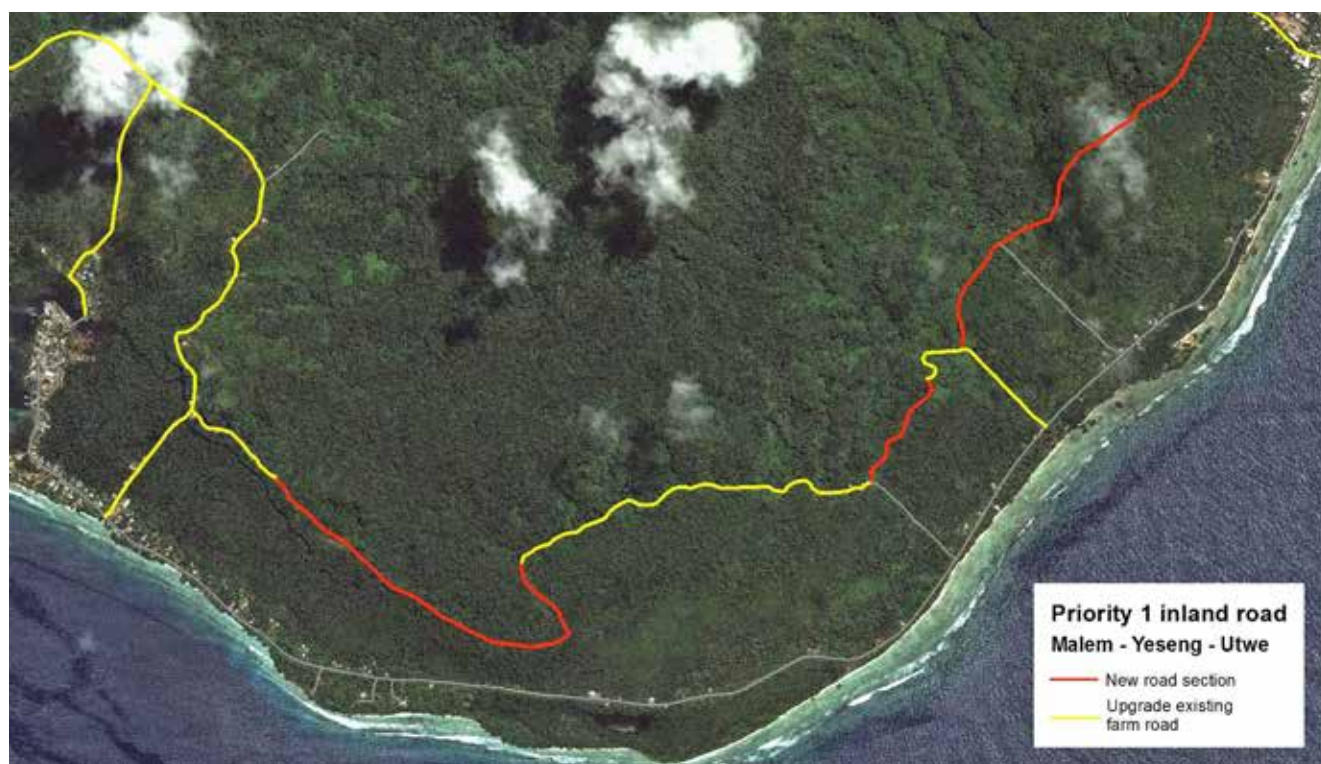
Figure 15: Indicative inland road between Utwe and Malem showing the requirements of new and upgraded sections of road.

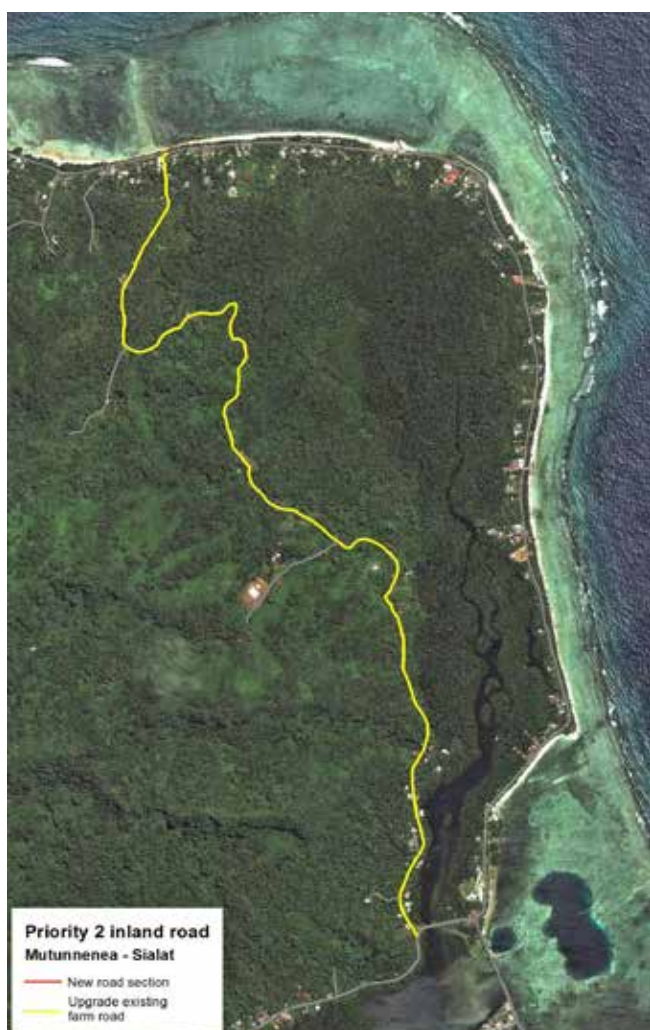
Figure 16: Inland road section between Mutunnenea and Sialat.

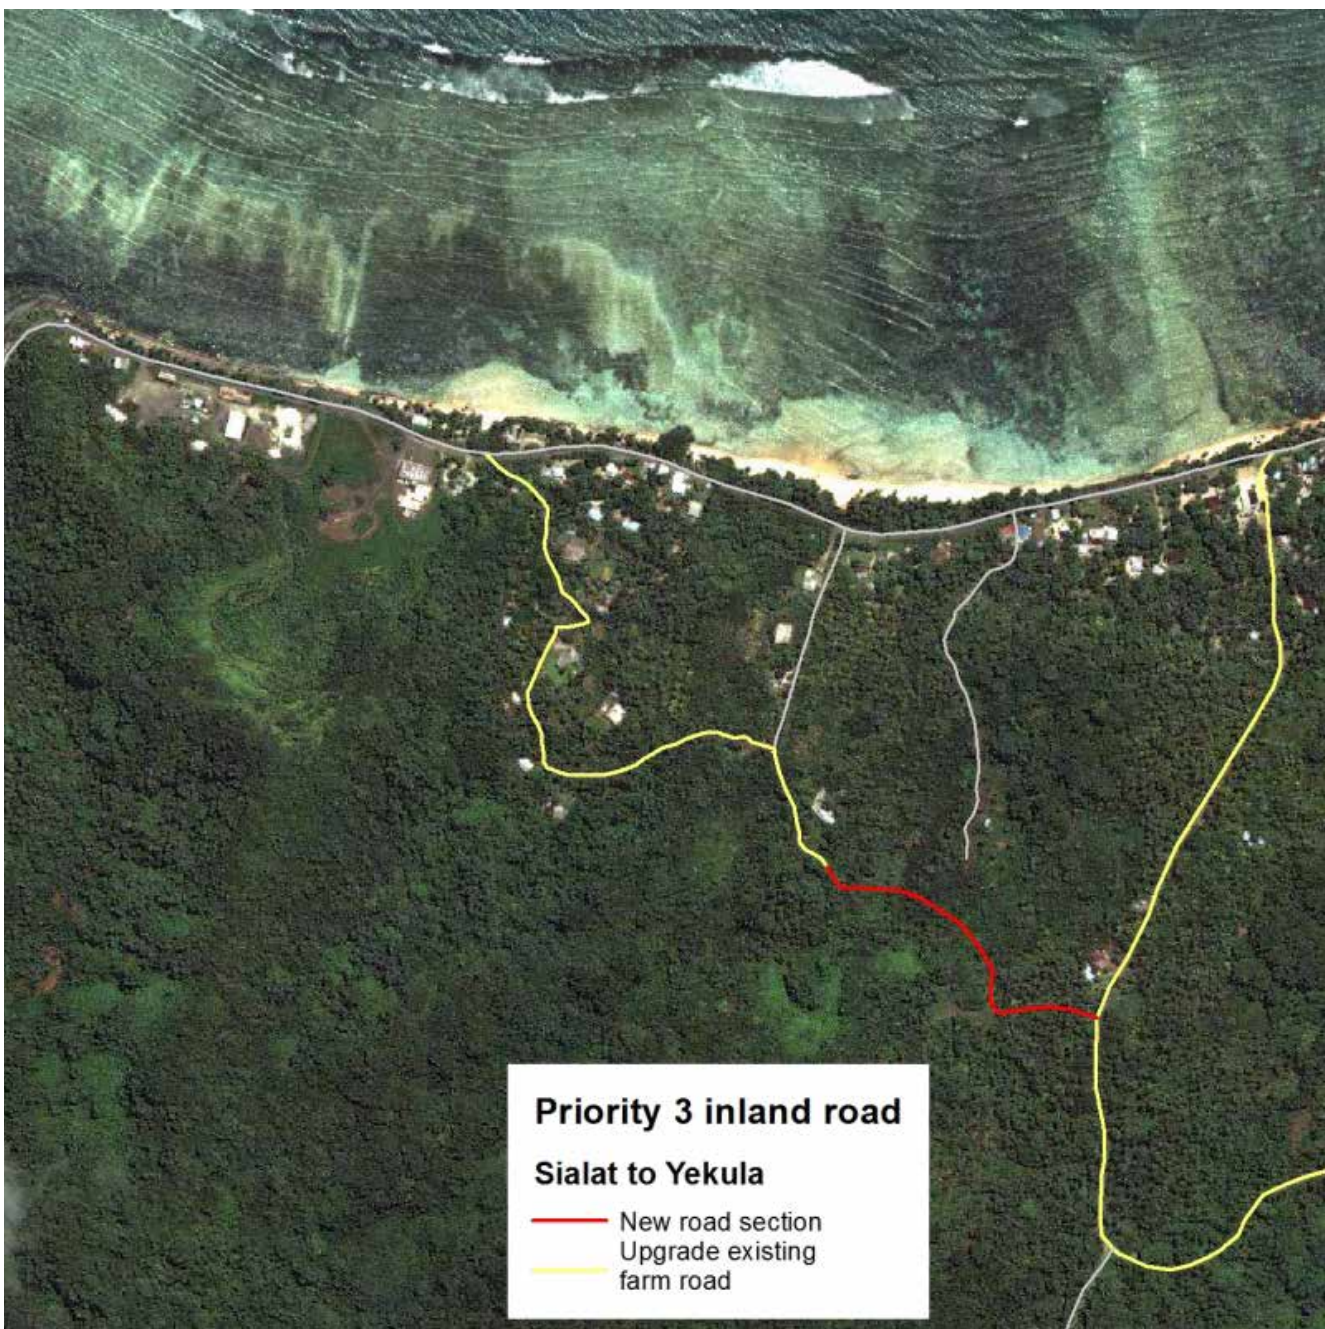
Figure 17: Inland road section between Sialat and Yekula.

The most exposed section between Sialat and Yekula, opposite the channel over the outer reef, was protected by a seawall in 1999. The wall was well constructed and succeeded in minimizing impacts on adjacent sections of the coast but had no crest protection resulting in the edge of the road remaining prone to damage due to wave overtopping. The potential for damage to the road along this protected section will increase over time unless some further crest protection is provided.

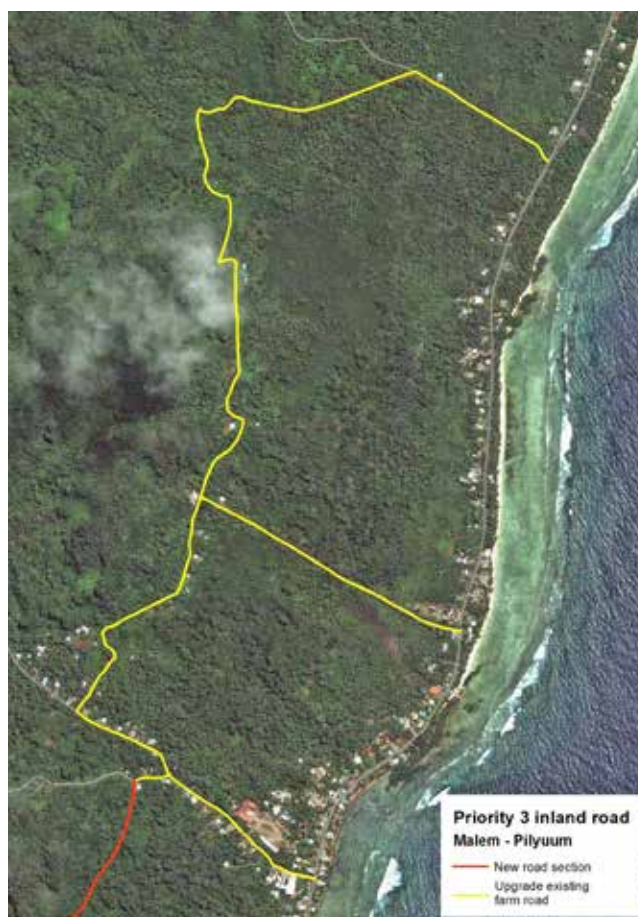
Figure 18: Inland road section between Malem and Pilyuul.

As on other sections of the exposed Malem and Lelu coastline, any coastal defences such as seawalls will tend to cause downdrift erosion on adjacent shoreline sections to the south and are not recommended.

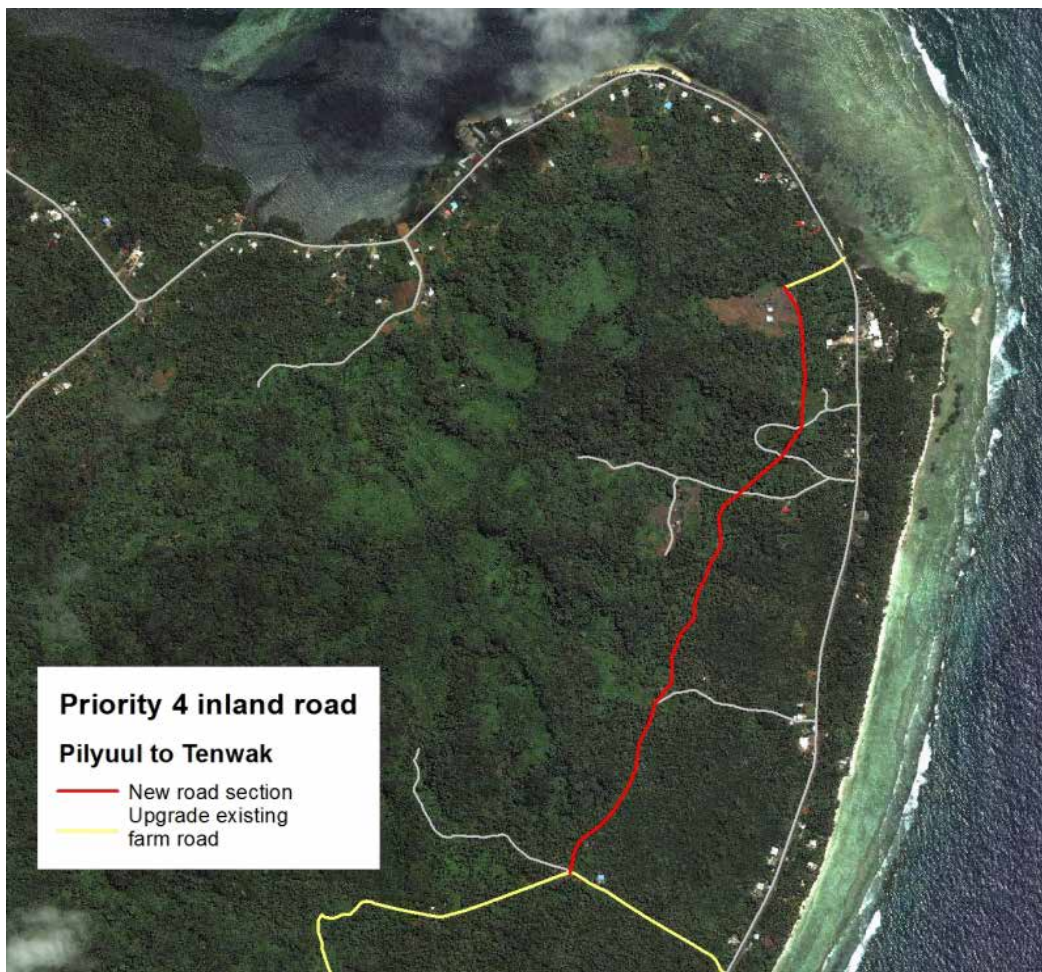
Figure 19: Inland road section between Pilyuul and Tenwak.

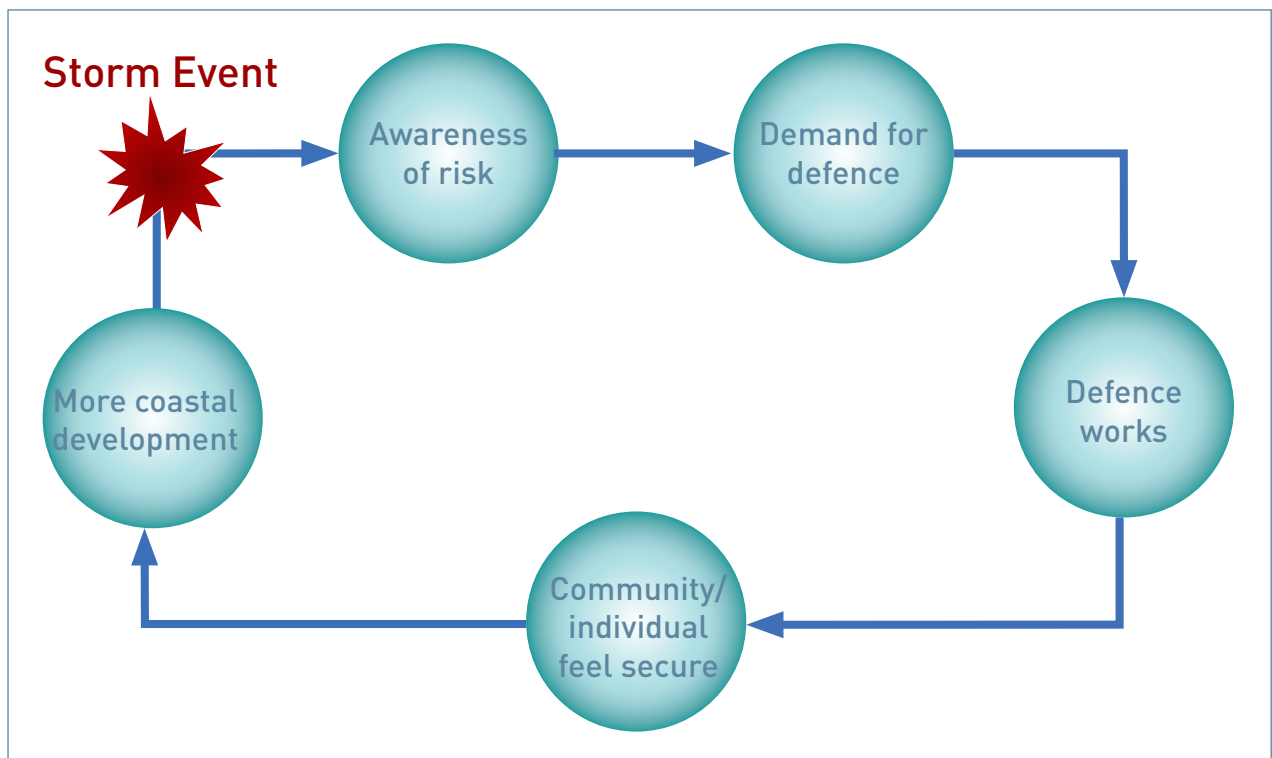
Figure 20: The develop-defend-develop cycle. Seawalls are often built in response to a storm event. This often then leads to a sense of security within the community that they are "protected" often leading to further development on land that is either too low lying or too close to the shoreline. When a further storm occurs, or the coastal defence breaks down and does not provide as much protection as anticipated there is a demand for bigger and better defences. This develop-defend-develop cycle that results typically causes the hazard problem to become more complex over time as the root cause of the problem is ignored, that is that people reside and infrastructure is developed on land that is at risk from coastal hazards.

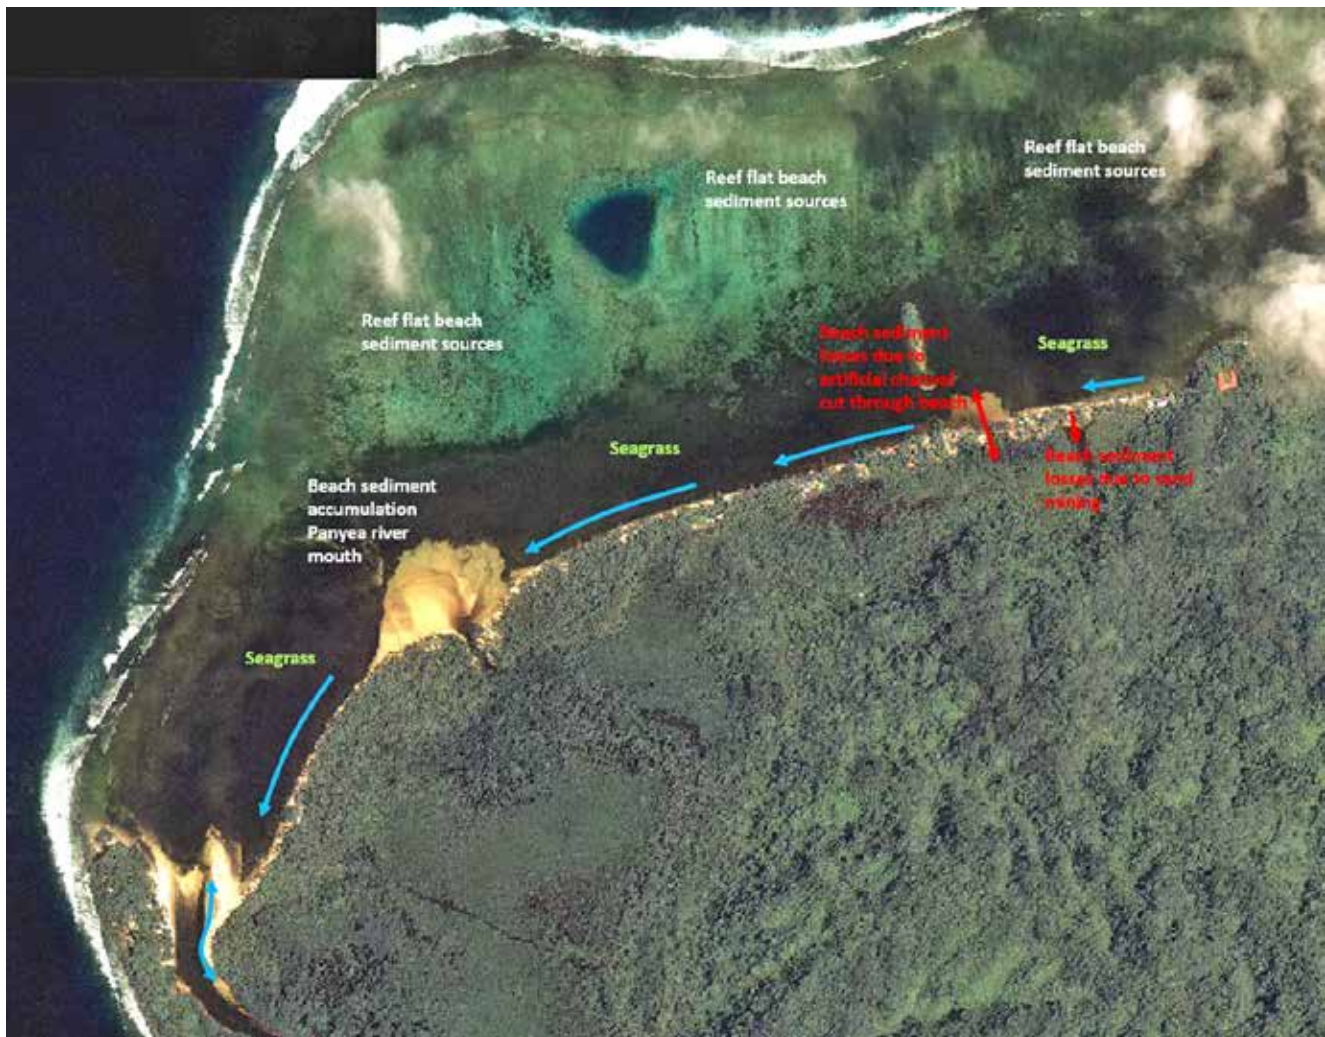
Figure B 4: Key sediment sources, longshore transport processes, and sediment losses along the Walung shoreline.

- The dredge pits at Tafunsak have been, and may well continue to be a sink of both beach and reef flat sediments.
- The net westerly longshore transport of beach sediment means that downdrift erosion problems (such as occurred at Sandy Beach and to a lesser extent at the western end of the Tafunsak seawall) are likely where poorly considered seawalls or reclamation is conducted.

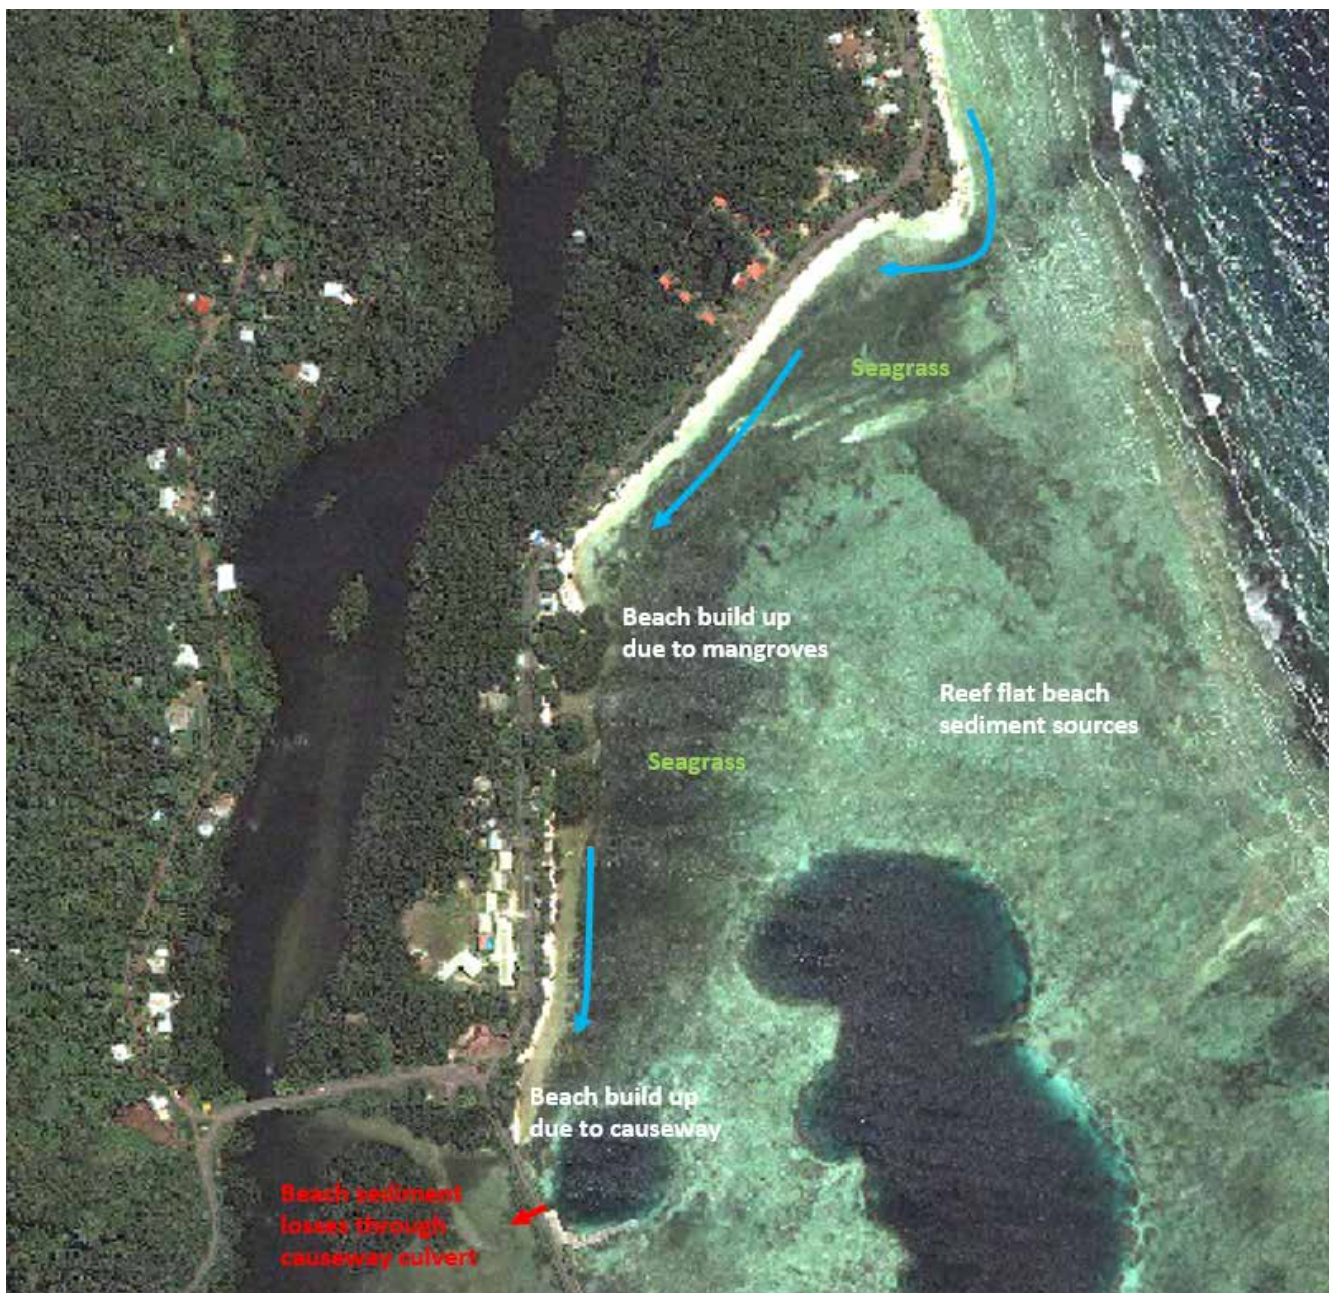
Figure B 5: Key sediment sources, longshore transport processes, and sediment losses along the Putukte to Finpukal shoreline.

- The net westerly longshore transport of beach sediment means that downdrift erosion problems are likely where poorly considered seawalls or reclamation is conducted. This occurred at Leap after the opening of the channel

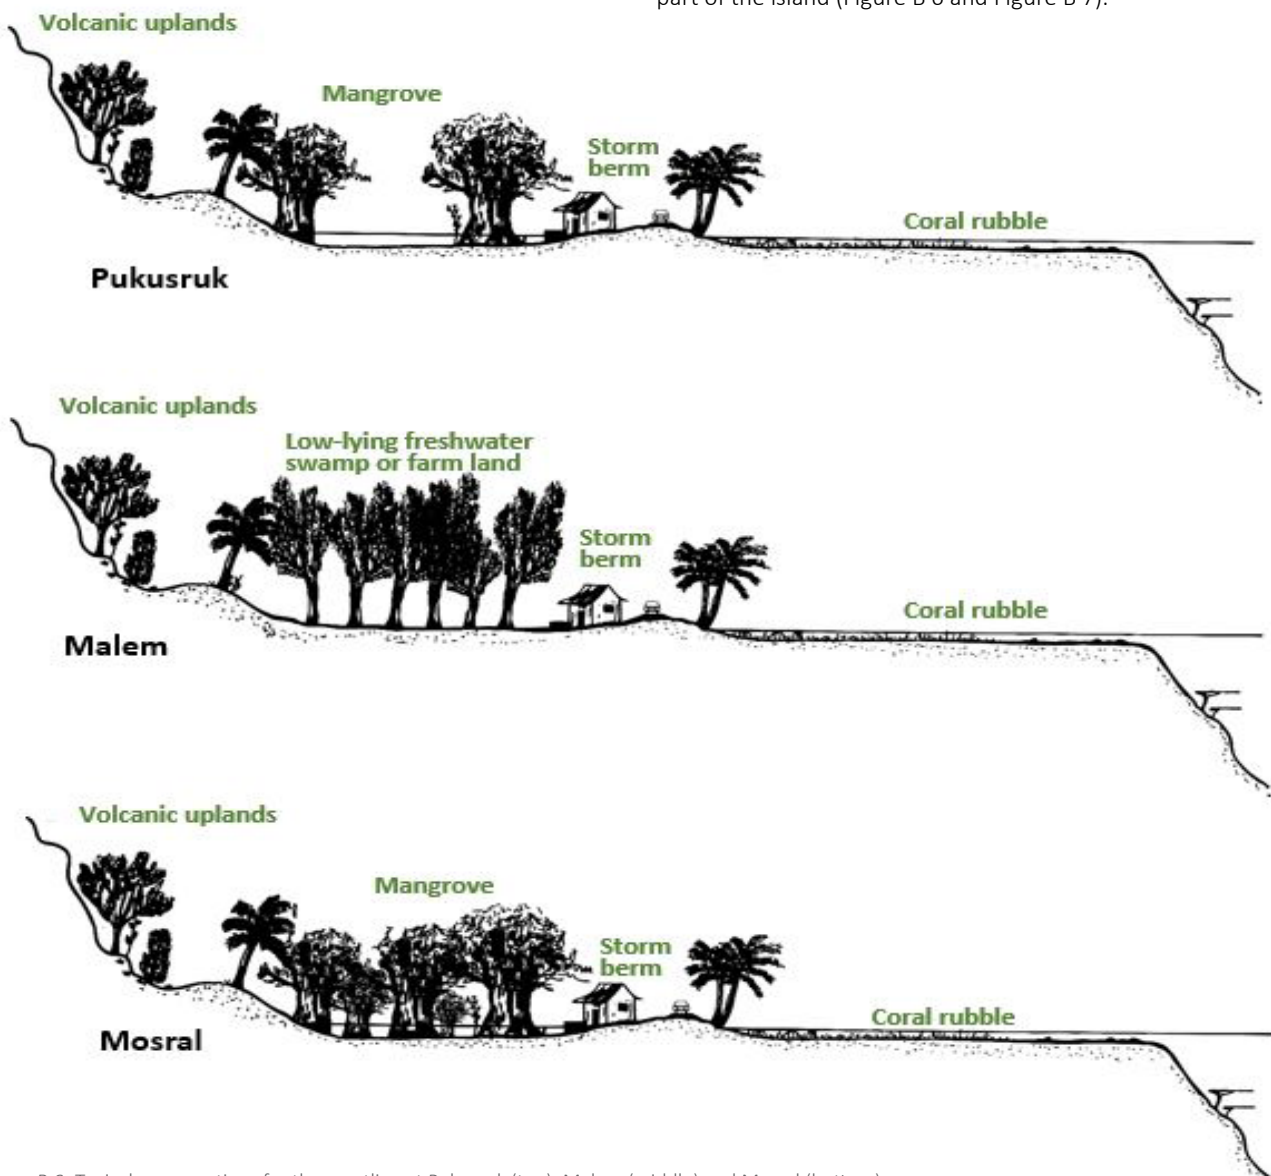
Figure B 6: Typical cross-sections for the coastline at Pukusruk (top), Malem (middle) and Mosral (bottom).

Much of the east and south coastline on Kosrae has been built by storm and typhoon events over many years. The east coast is characterised by relatively narrow fringing reef, a narrow storm berm upon which the coastal road and most development has occurred, with areas of low lying infill swamp, farmland or lagoon mangrove, behind the berm to the volcanic part of the island (Figure B 6 and Figure B 7).
