Kosrae Shoreline Management Plan

Repositioning for resilience

NIWA Client Report No: HAM2013-133
Report date: November 2013
NIWA Project: DGI13201

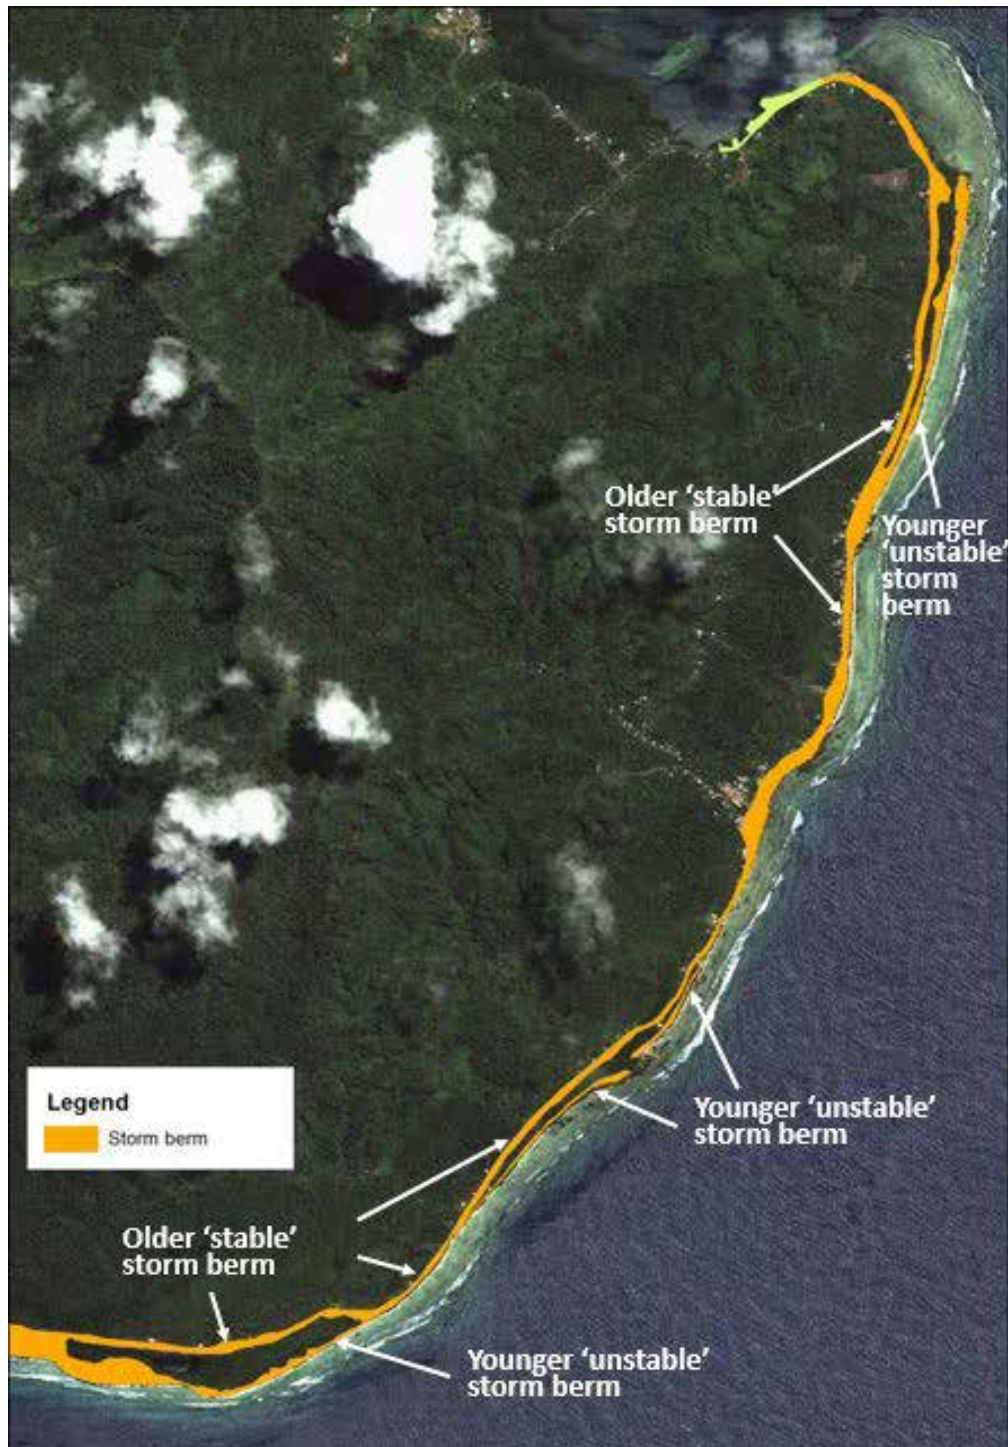
Figure B 7: Location of the storm berm along the Malem coast.

Much of the east and south coastline on Kosrae has been built by storm and typhoon events over many years. The east coast is characterised by relatively narrow fringing reef, a narrow storm berm upon which the coastal road and most development has occurred, with areas of low lying infill swamp, farmland or lagoon mangrove, behind the berm to the volcanic part of the island (Figure B 6 and Figure B 7).

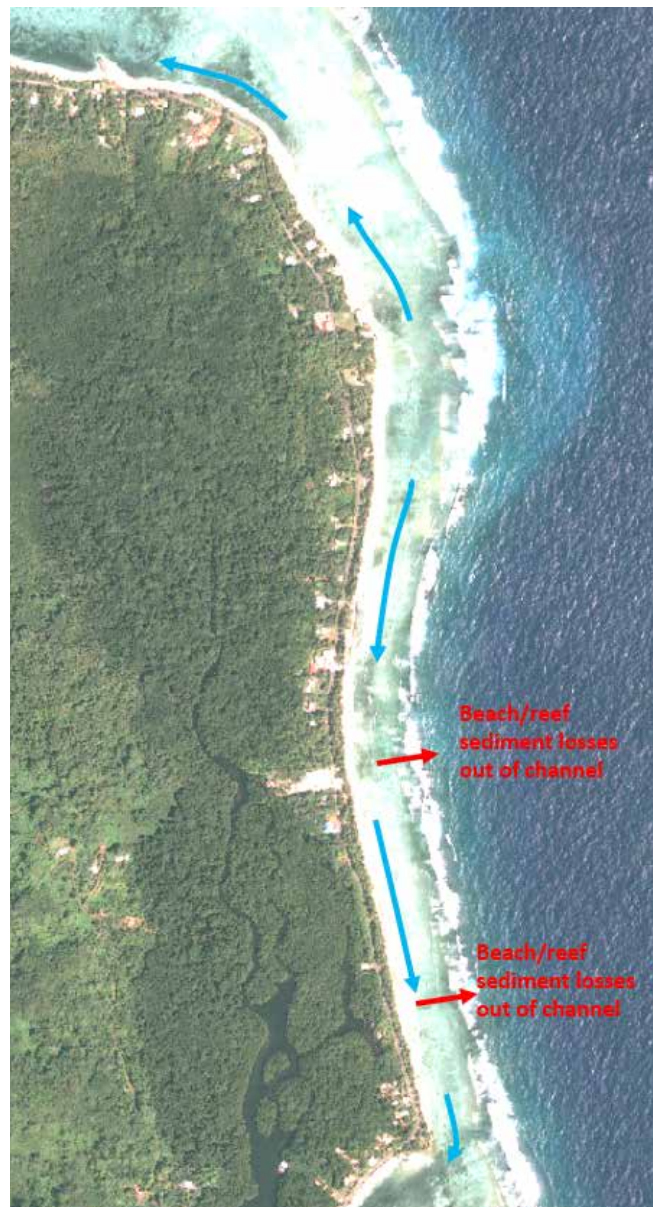
Figure B 10: Key sediment sources, longshore transport processes, and sediment losses along the Pukusruk shoreline.

- The net southerly longshore transport can be observed by the build-up of beach sediment to the north of the old Japanese blockhouse and subsequent downdrift erosion

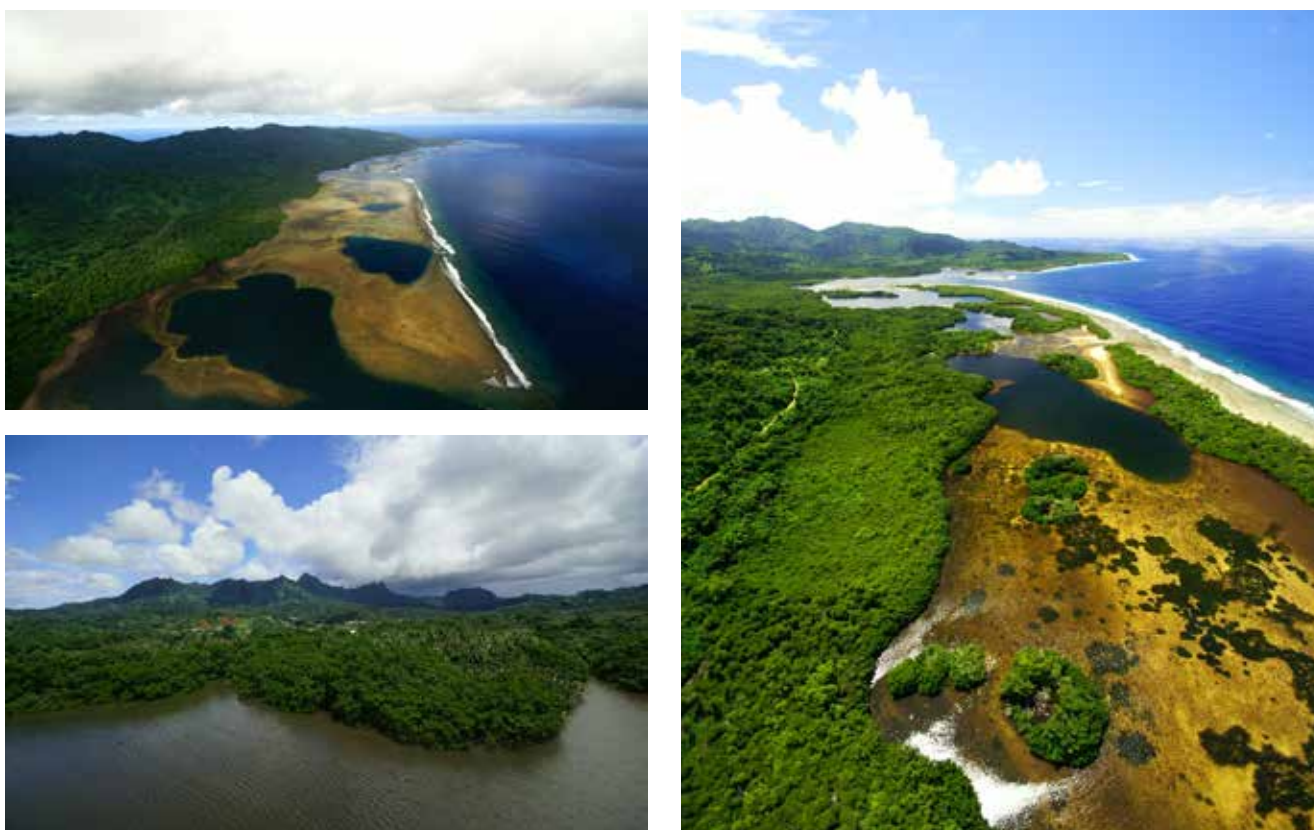
Figure B 12: Key mangrove settings on Kosrae. Top left: reef flat mangroves between Okat and Yela; Bottom left: Fringing harbour mangroves in Lelu Harbour at Tofol; Right: Back lagoon mangroves between Nefalil and Utwe Ma.

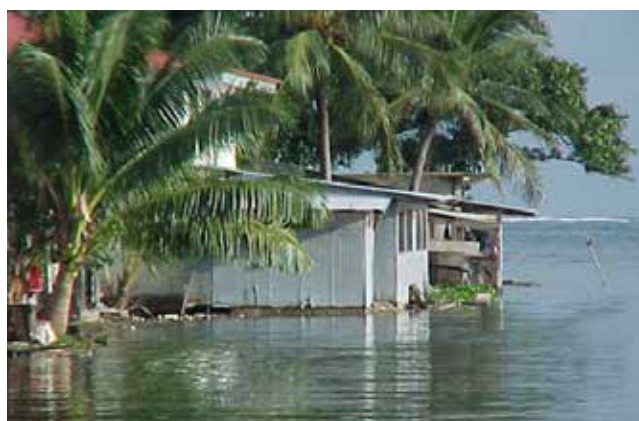
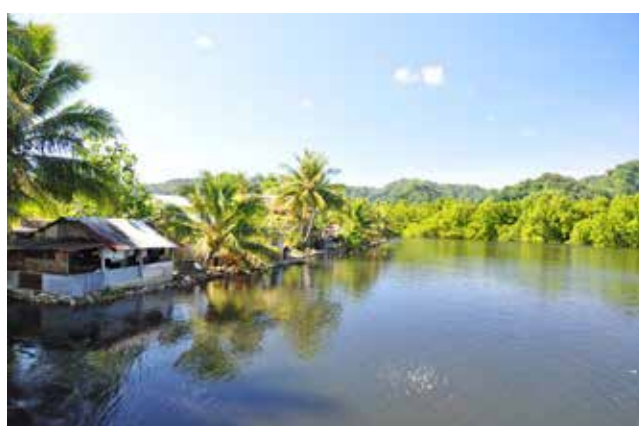
Figure C 1: High tide levels at Lelu during December 1999 (left) and Utwe during December 2010 (right).

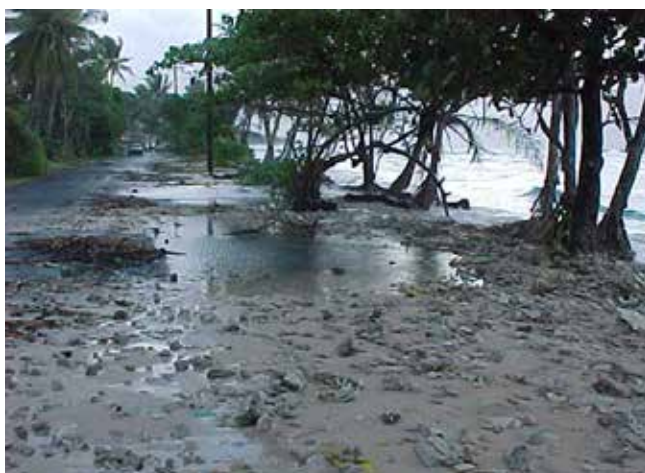
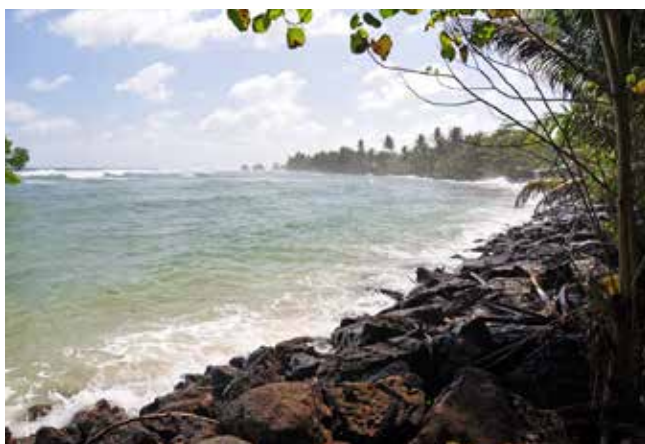
Figure C 2: Wave overwashing at Fukrin in Malem during February 2000 (left) and high tide wave overtopping of the seawall at Malem village during December 2010).

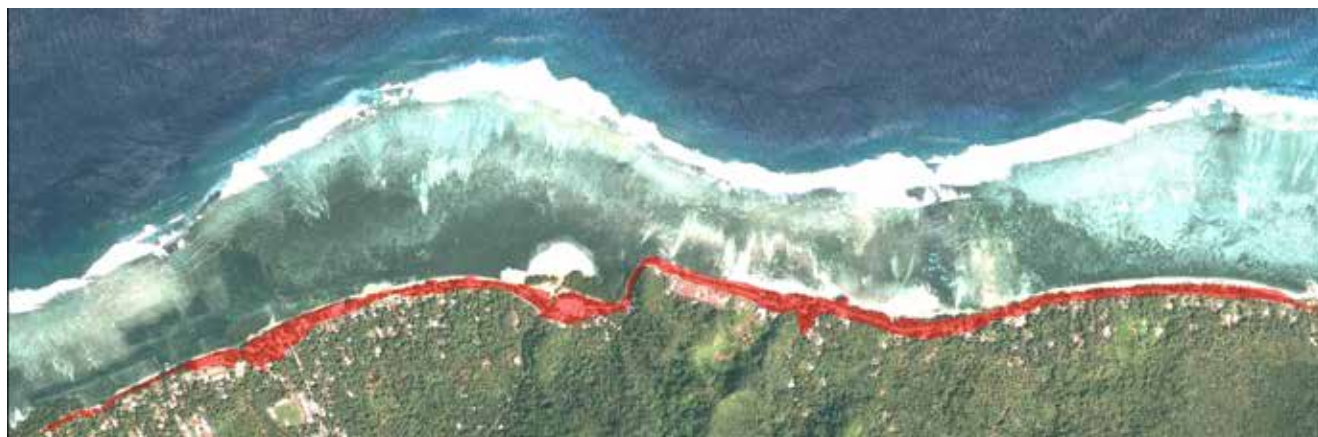
Figure C 4: Extent of inundation along the Tafunsak coastline during the swell event of 8-9 December 2008. Inundation extent information courtesy of KIRMA.

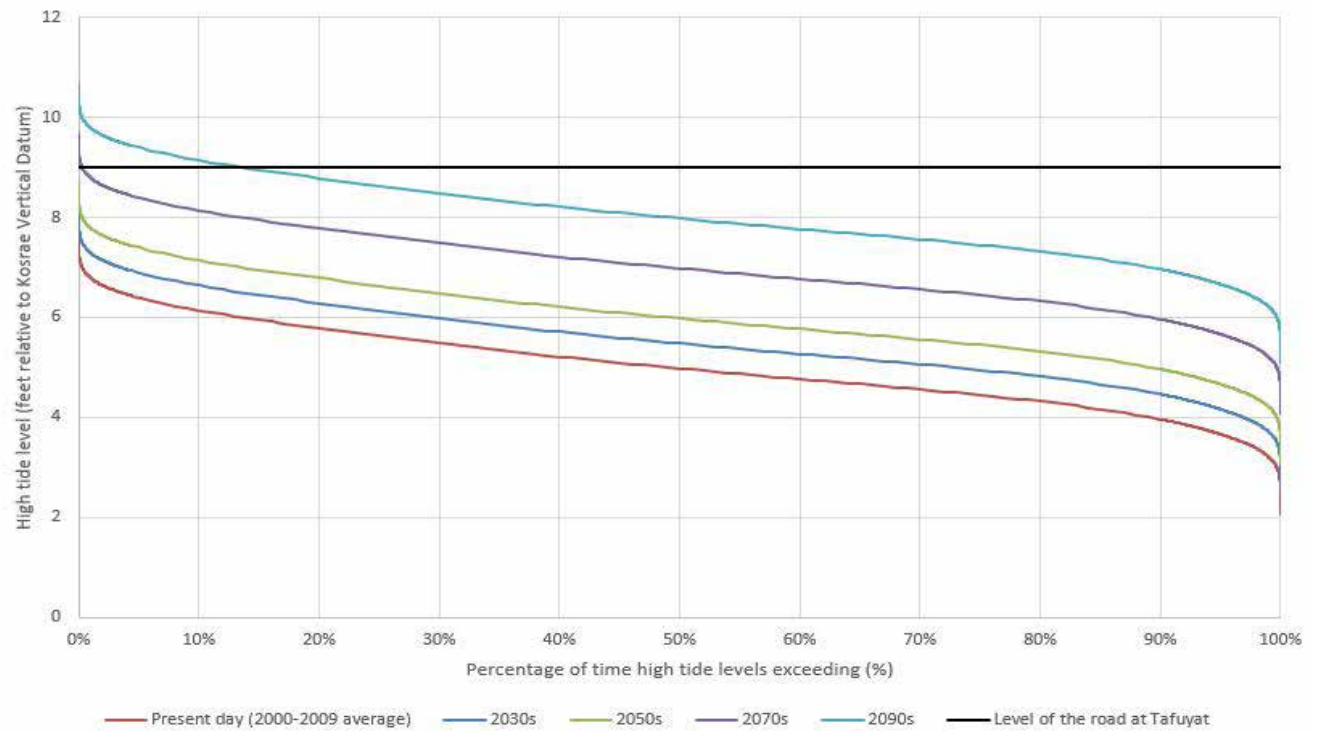
Figure D 7: High tide exceedence curves for the present day and for the 2030s, 2050s, 2070s and 2090s relative to the level of the road at Tafuyat.
