*Archaeological Survey and Inventory of  
Submerged Cultural Resources in the Lagoon  
of Kwajalein Atoll:*

SITES ON THE SOUTH AND EASTERN SIDES OF KWAJALEIN ATOLL

Matthew B. Holly

HPO Report 2000/02

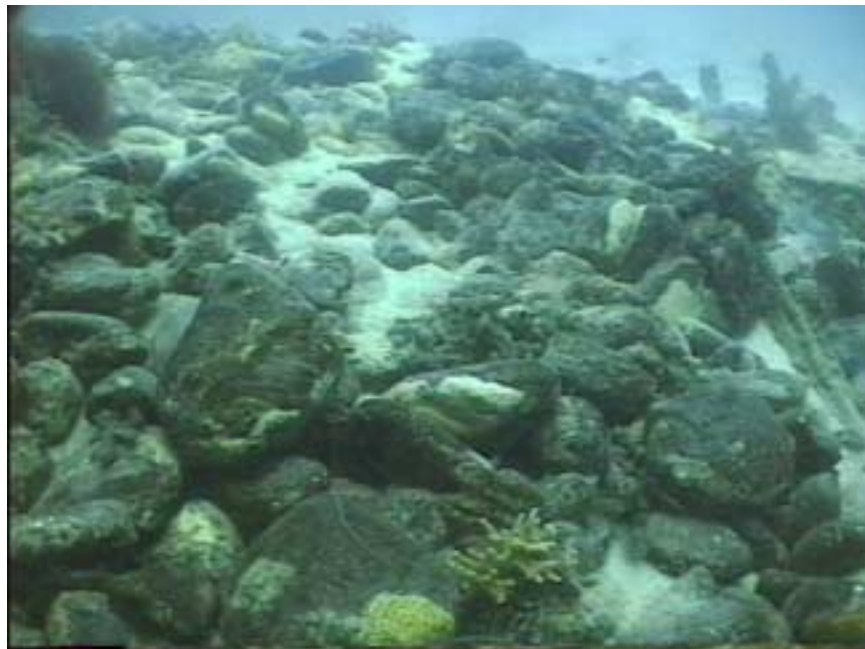
Photo KS2-3 shows the ballast stones in the forward hull section.

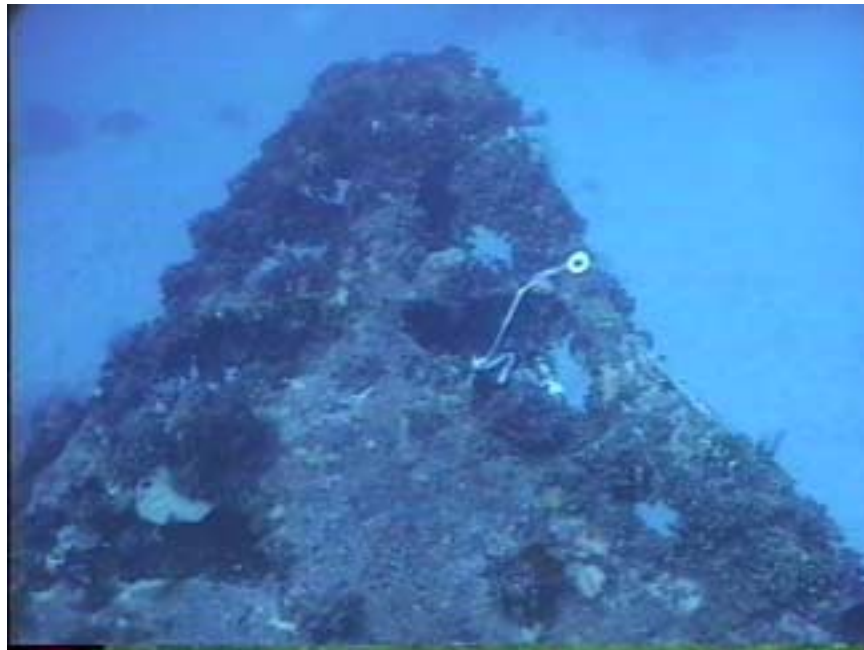
Photo KS3-1 Bow of Shell Island Wreck

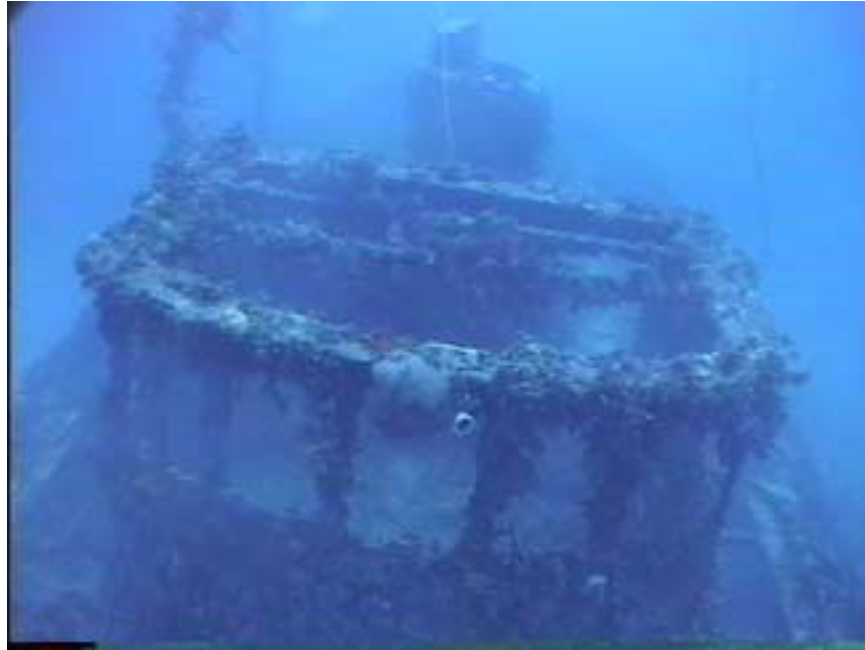
Photo KS3-4 Wheelhouse of Shell Island Wreck with funnel in background.

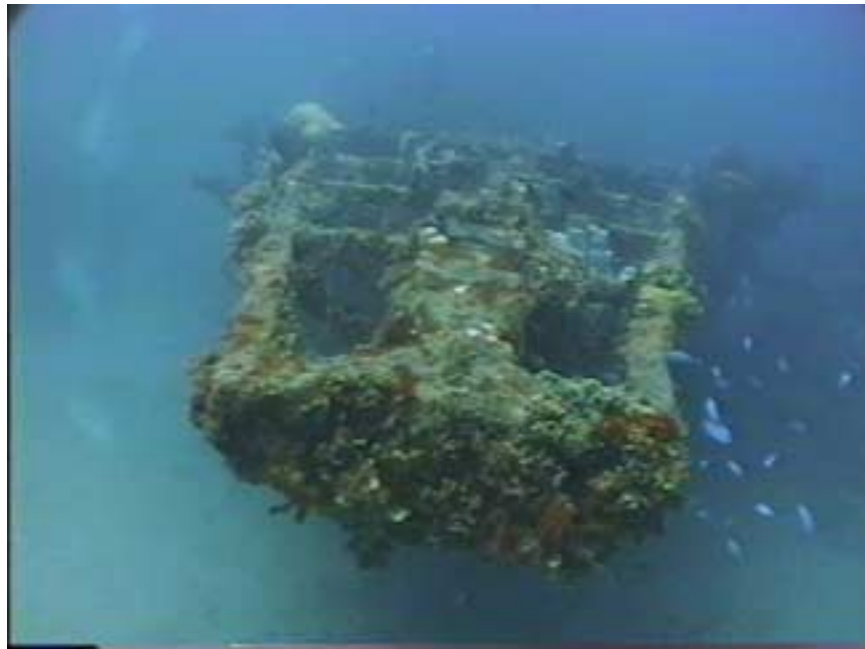
Photo KS4-1 Bow of North Loi wreck, showing extended fishing vessel style bow. Object hanging on starboard side is the remains of steel reinforcing on the deck to support anchor and chain, and not an anchor. Coral head is visible on the right side of the vessel.

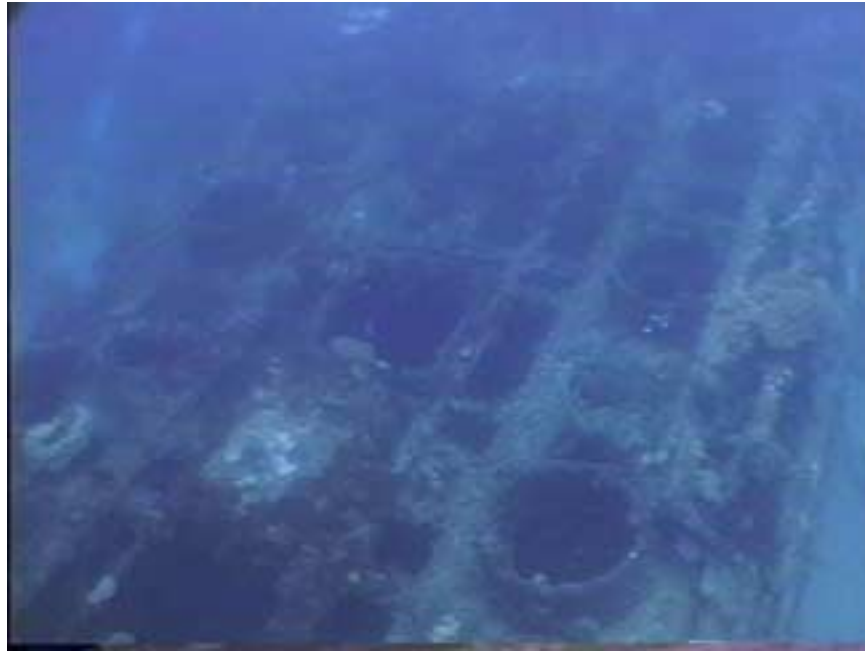
Photo KS4-2 Main deck of the North Loi Wreck.

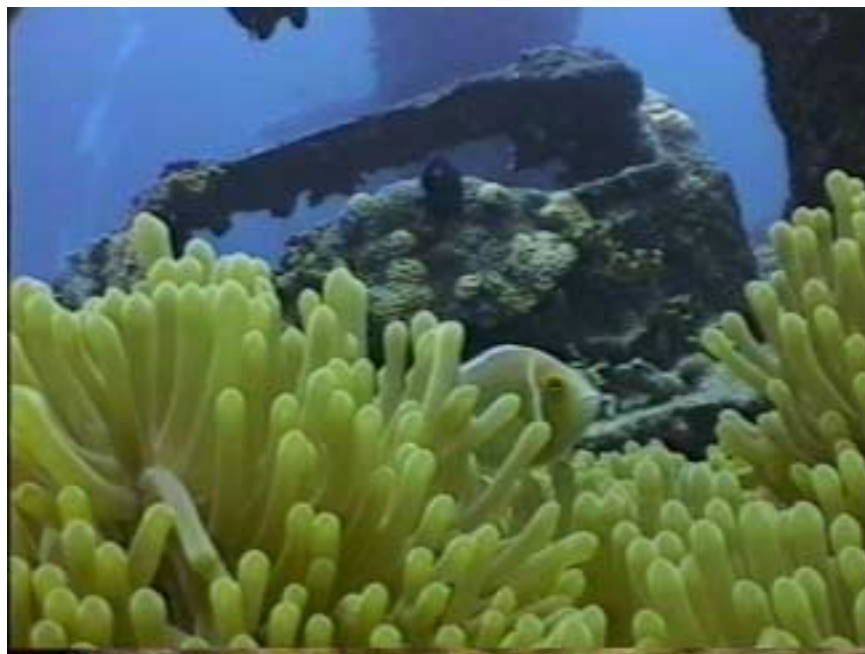
The vessel, even well worn and stripped, housed a variety of marine life. The vessel was a great dive primarily from this marine life, which added some beauty to the site (Photo KS4-11).

PhotoKS4-11 Marine life near engine room skylight.

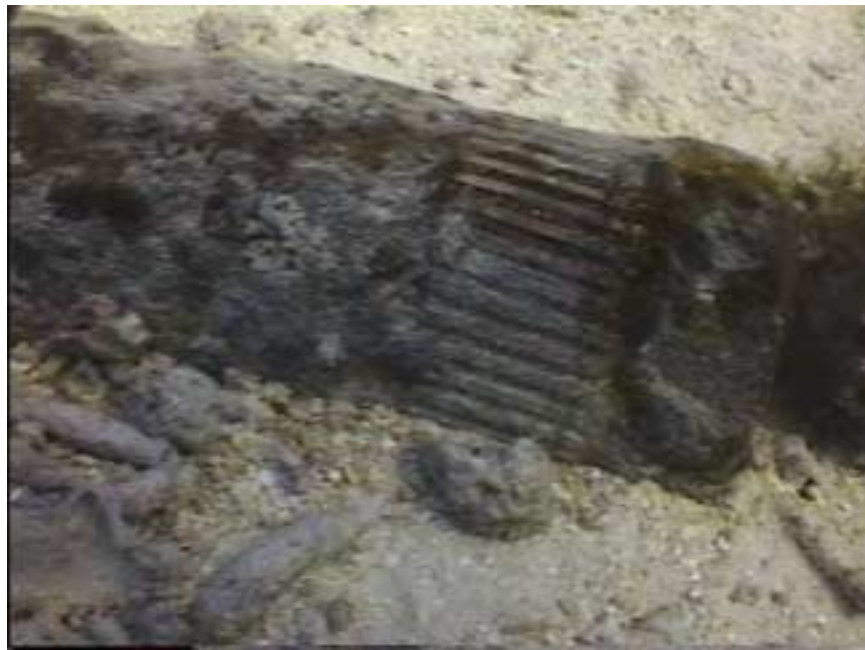
Photo KS6-3 The brass rifling on the artillery round.

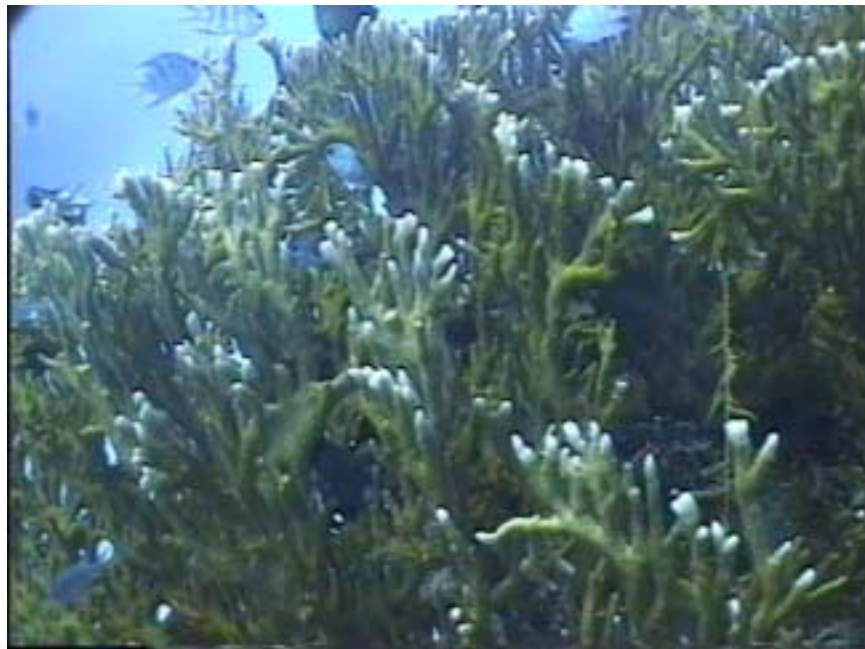
Photo KS7-9 Shows more coral growth on the Flying-Boat remains.

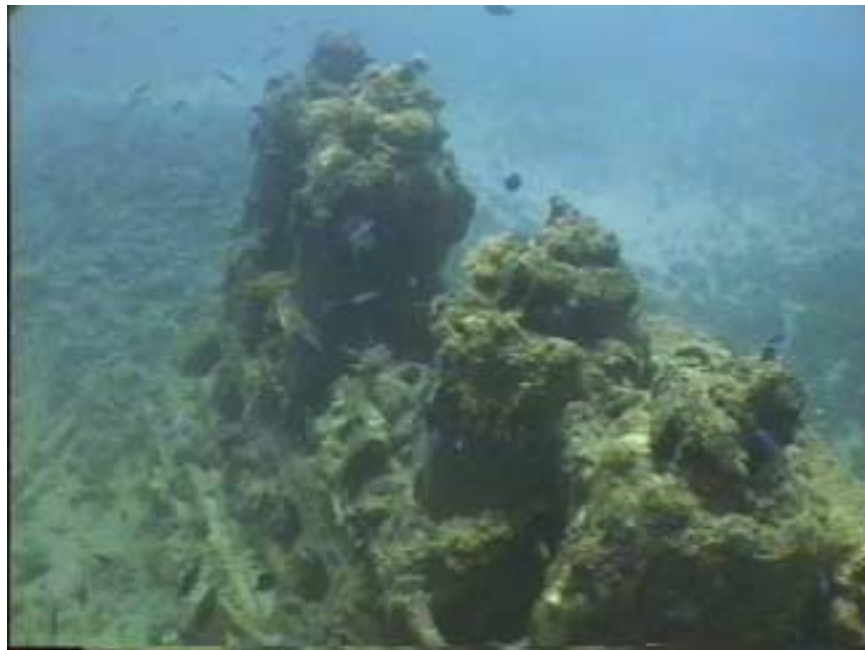
Photo KS11-2 Main engine of Ski Area Wreck no. 1.

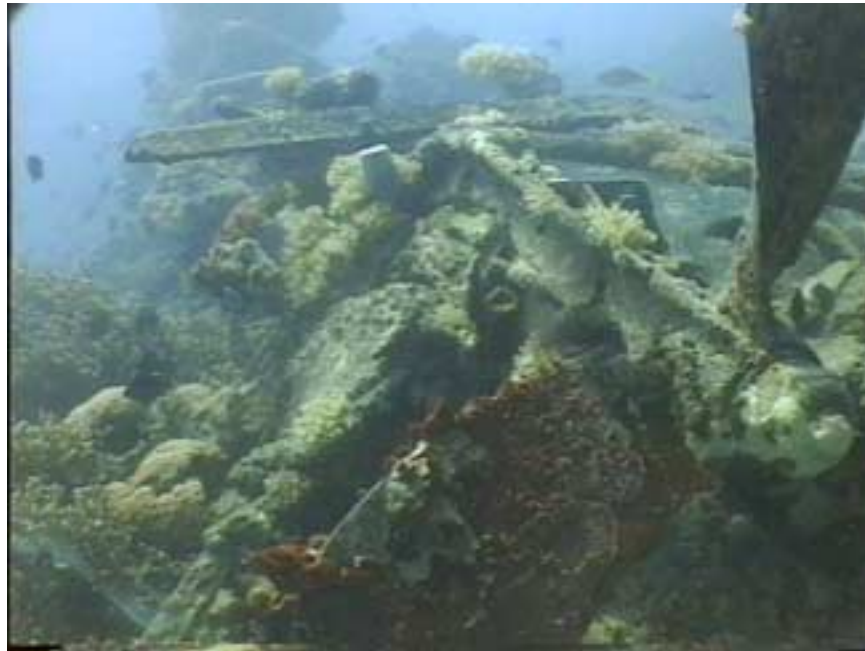
Photo KS11-3 Propeller of Ski Area Wreck No. 1.

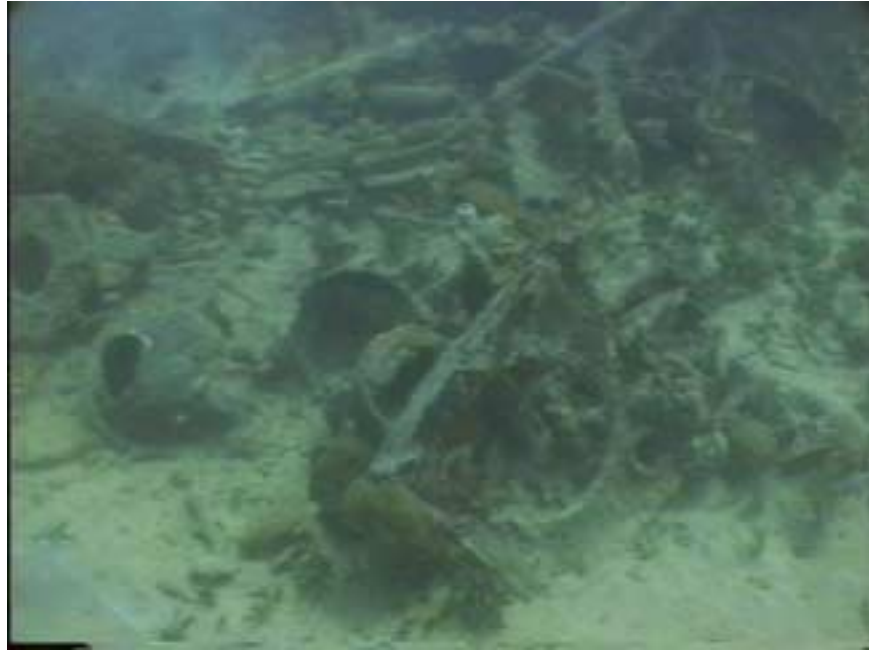
Photo KS11-5 Stern Debris of Ski Area Wreck No. 1.

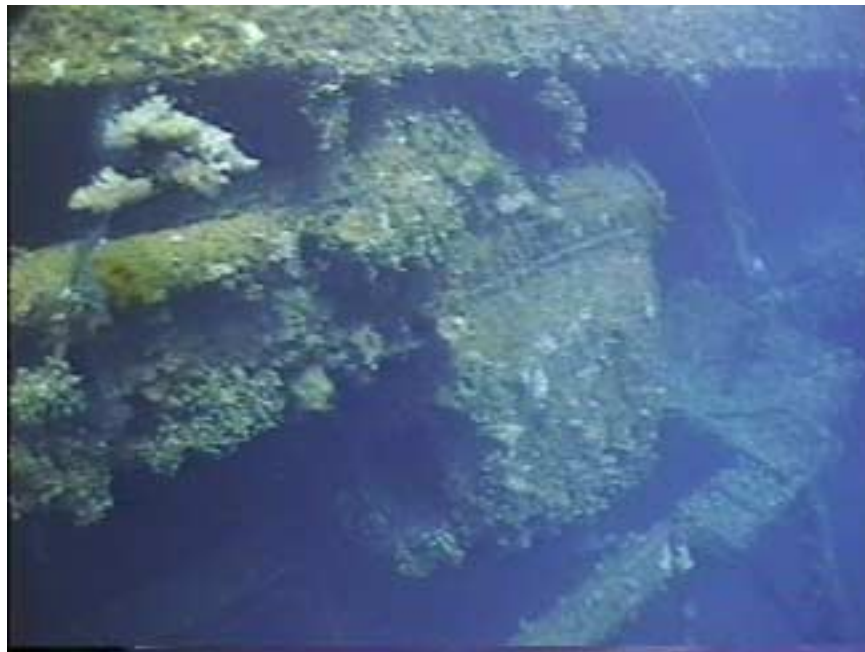
Photo KS13-8 Triple 21 inch torpedo launcher forward on port side.

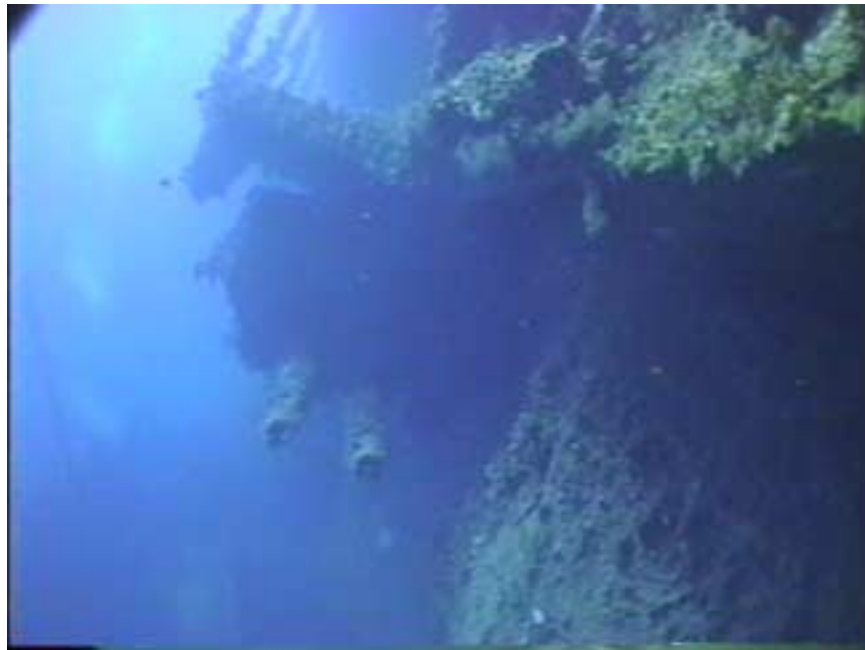
Photo KS13-10 Twin 88 Gun mount on Prinz Eugen.

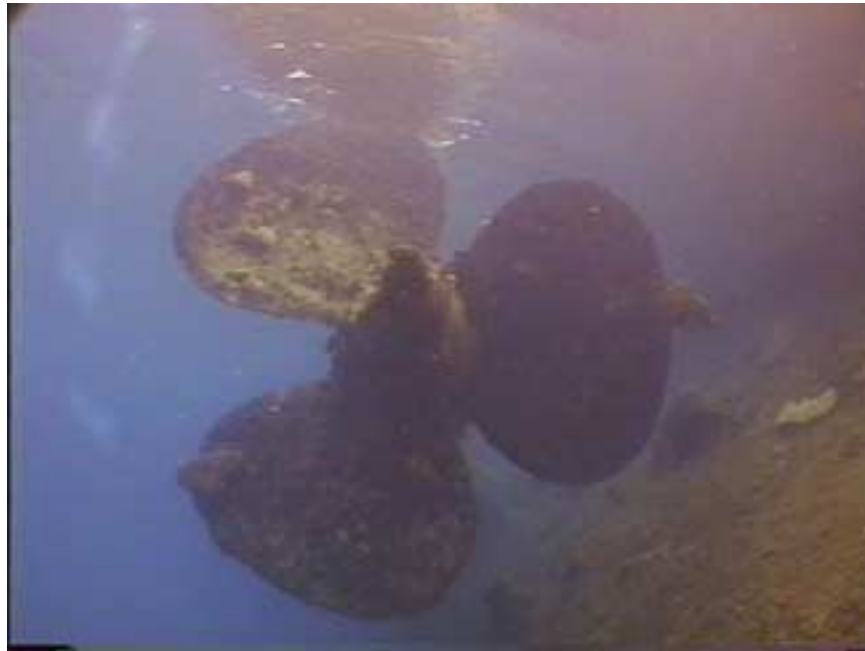
Photo KS13-13 Starboard side propeller of the Prinz Eugen.
