*Archaeological Survey and Inventory of Submerged
Cultural Resources in the Lagoon of Wotje Atoll*

Matthew B. Holly

HPO Report 2000/03

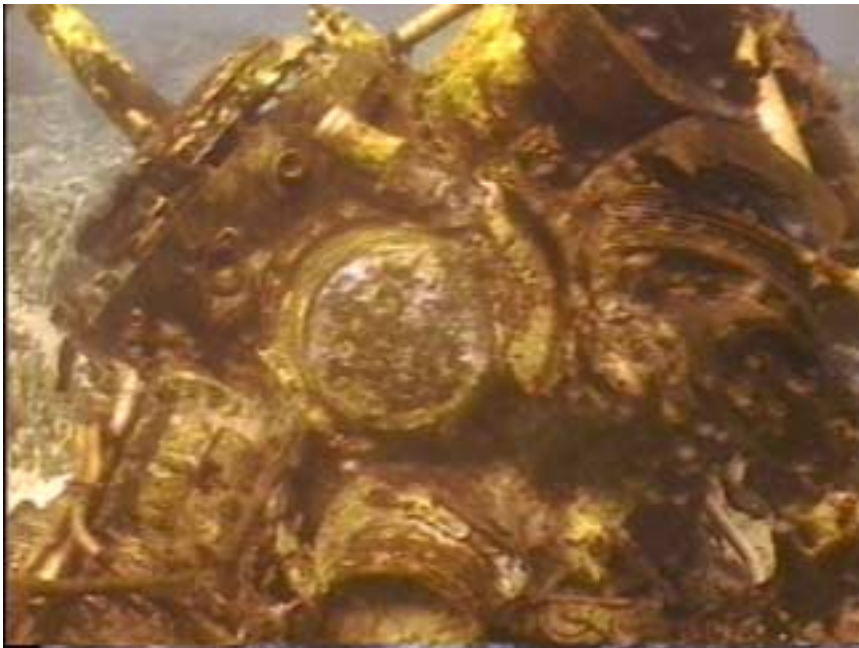
Photo WT1-6. Close-up of Wright Cyclone R 2600 engine of a SB2C "Helldiver".

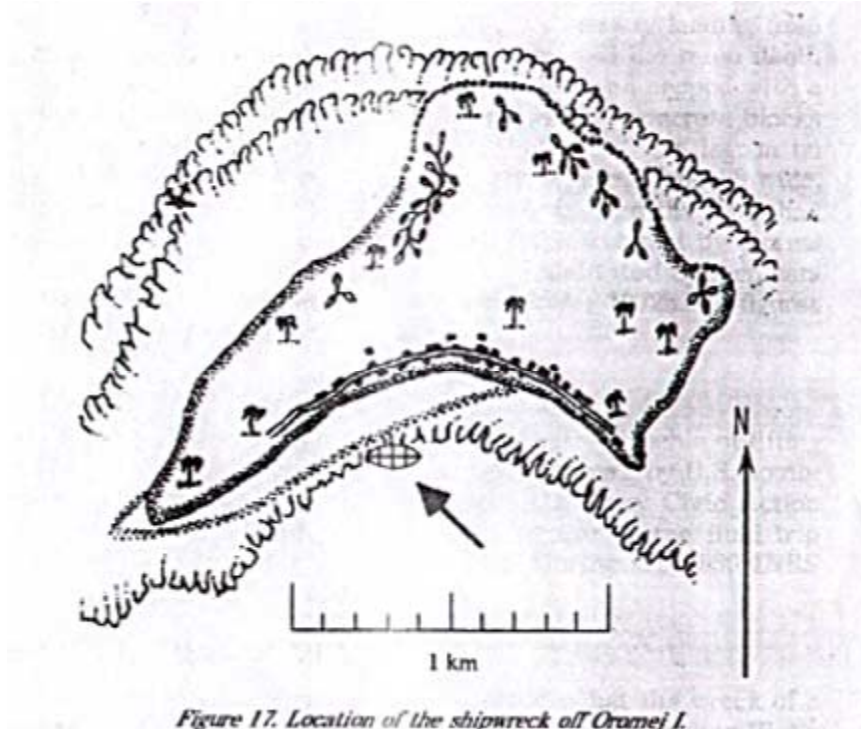
I presume this Wotje Site Number 3 was incorrectly identified from the 1978 aerial survey and the *Spennemann* report, and was perpetuated incorrectly in following reports, as it was never physically inspected or identified. It shows that mistakes are made, repeated, and hopefully corrected as history rolls on. Sometimes it's easy.

Photo WT3-1. Scanned map from *Spennemann, 1991/7:27* Arrow points to exact position of the lagoonside coral heads formed like a vessel. Also note there is no coral reef line along the shoreline, as Ormed has a sandy bottom and beach along its' entire length.

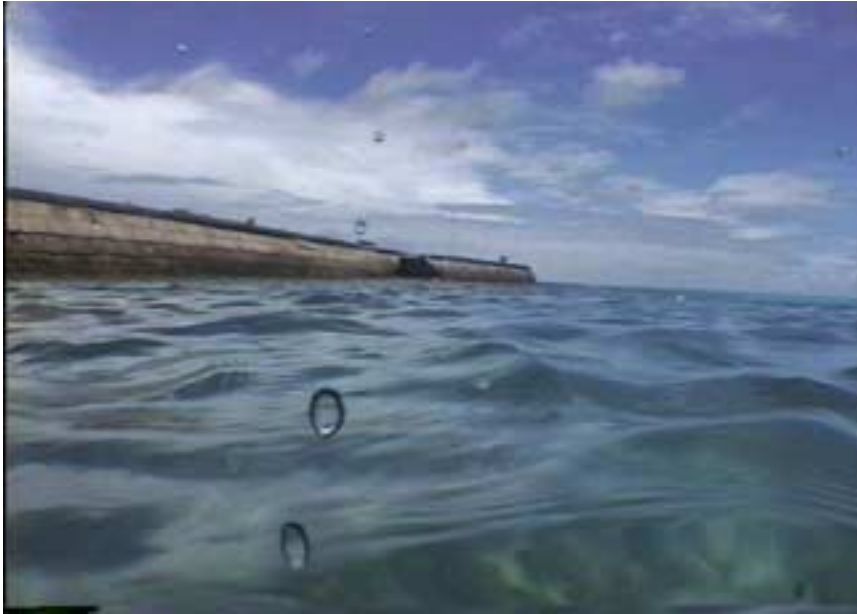
Photo WT4-1. North side of the Japanese Seaplane Ramp from in the water.

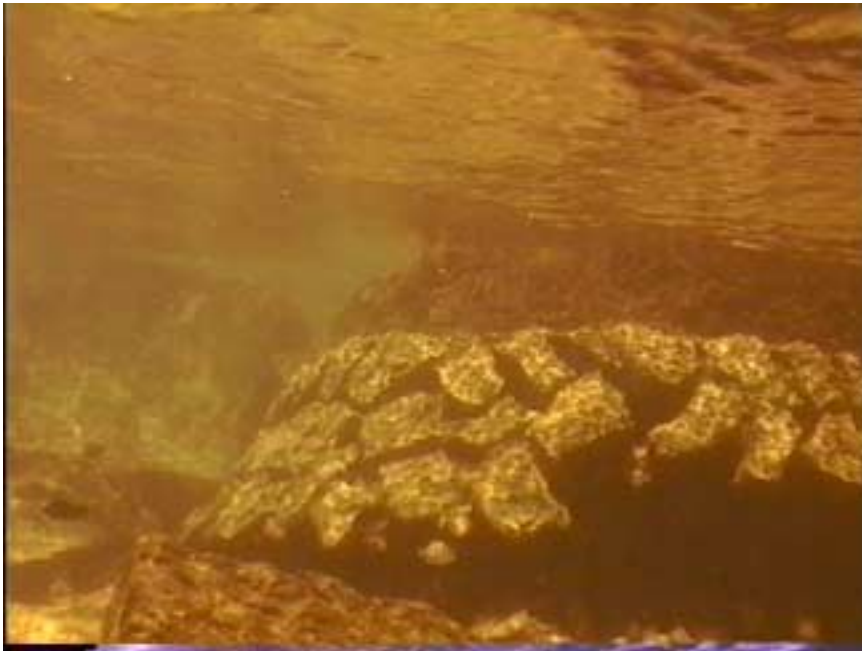
Photo WT4-6. Anti-aircraft site blown into the water off the Seaplane Ramp.

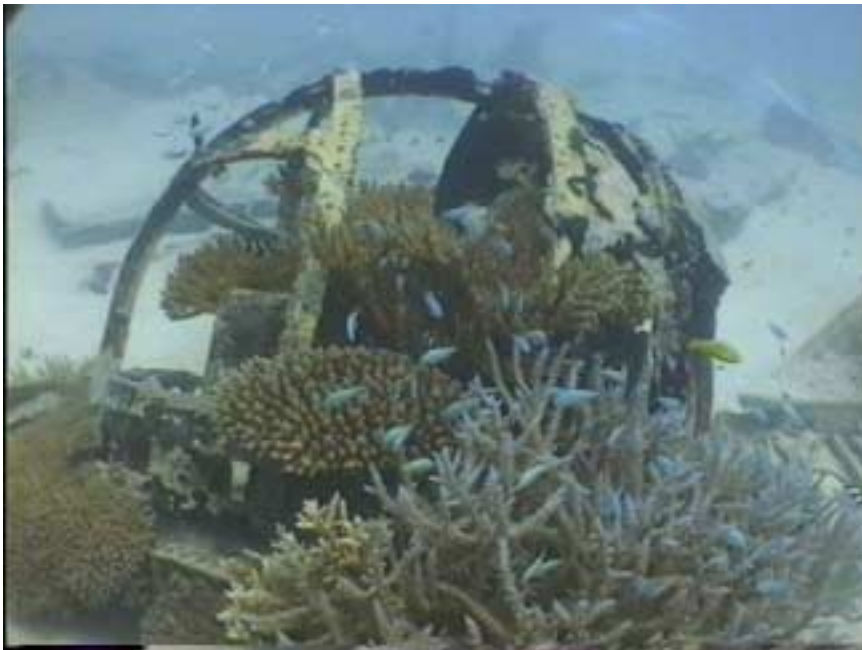
Photo WT5-7. The top turret of the aircraft with the 20mm cannon removed.

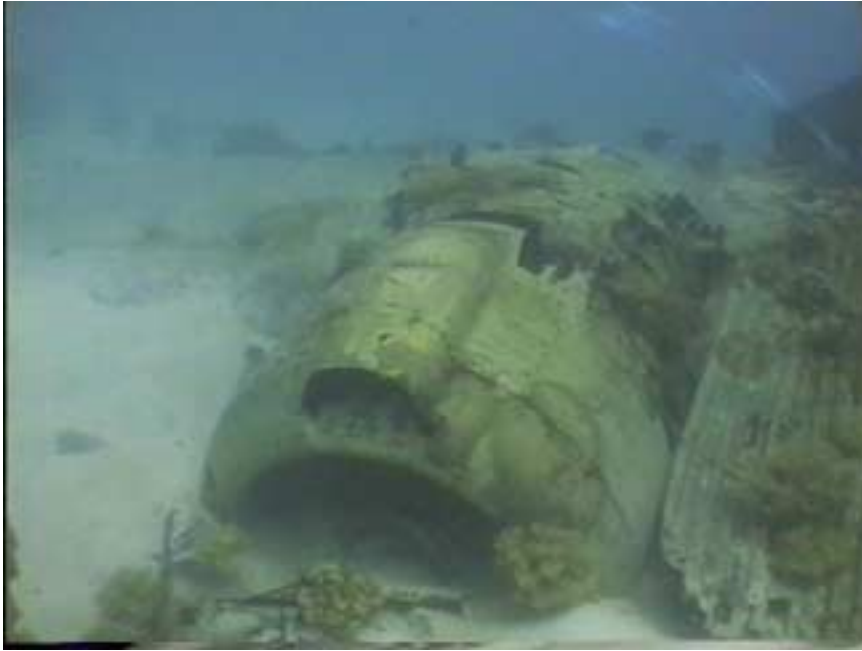
Photo WT5-10. Number 4 engine of the Kawanishi H8K aircraft.

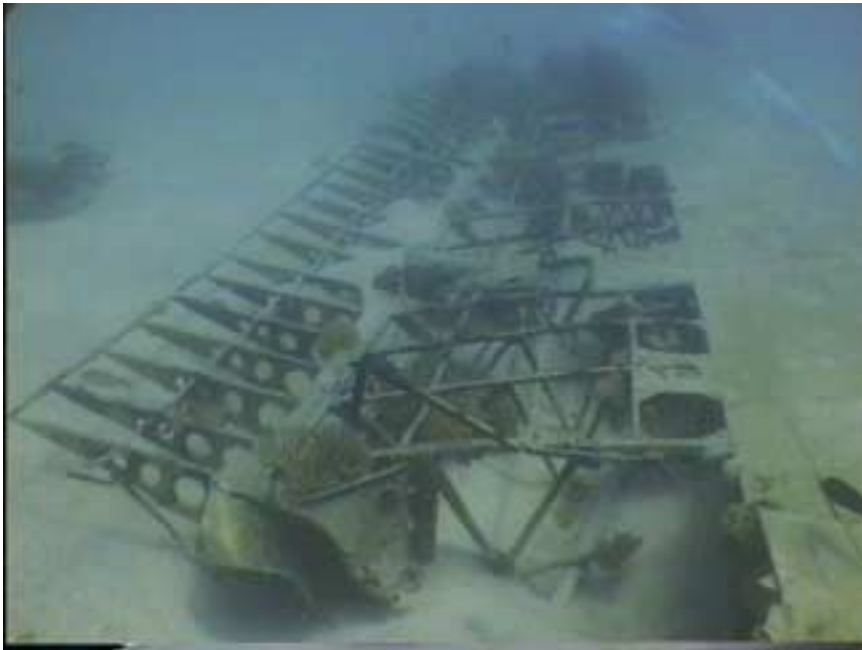
Photo WT5-11. Metal skeleton of the fabric covered wing control surfaces.

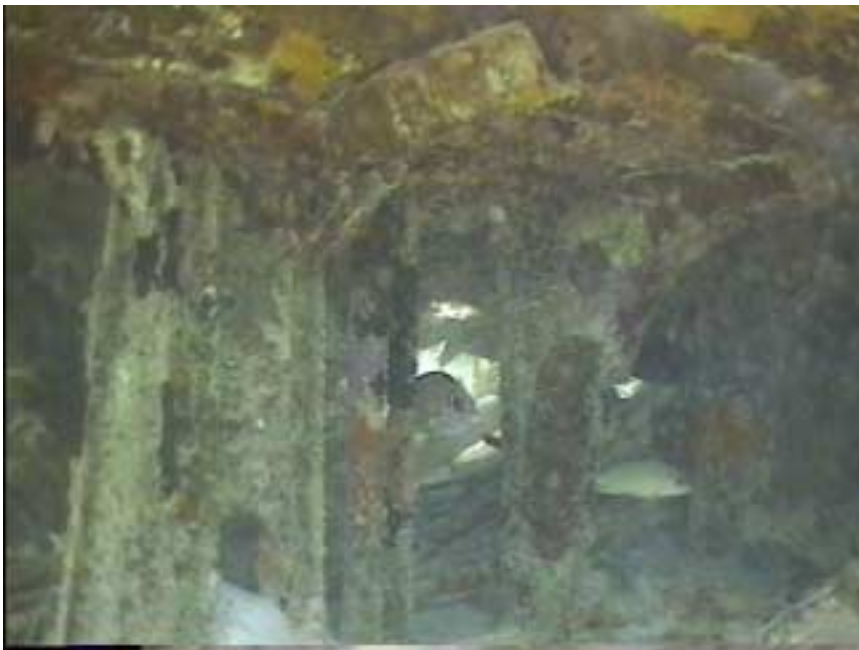
Photo WT5-13. Marine life within the wing of the aircraft.

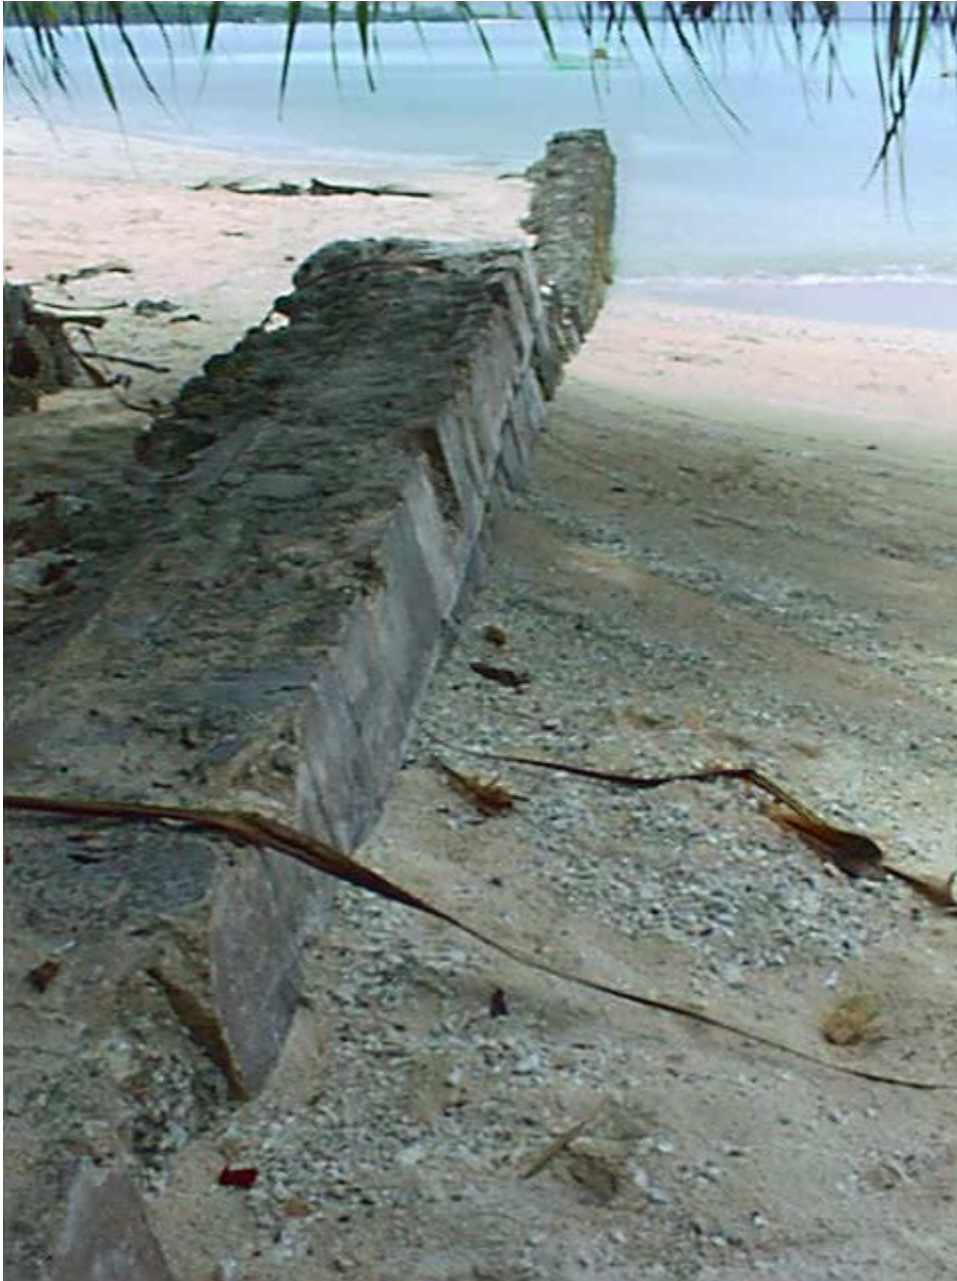
Photo WT6-8. Remains of Wotje Small Service Dock.

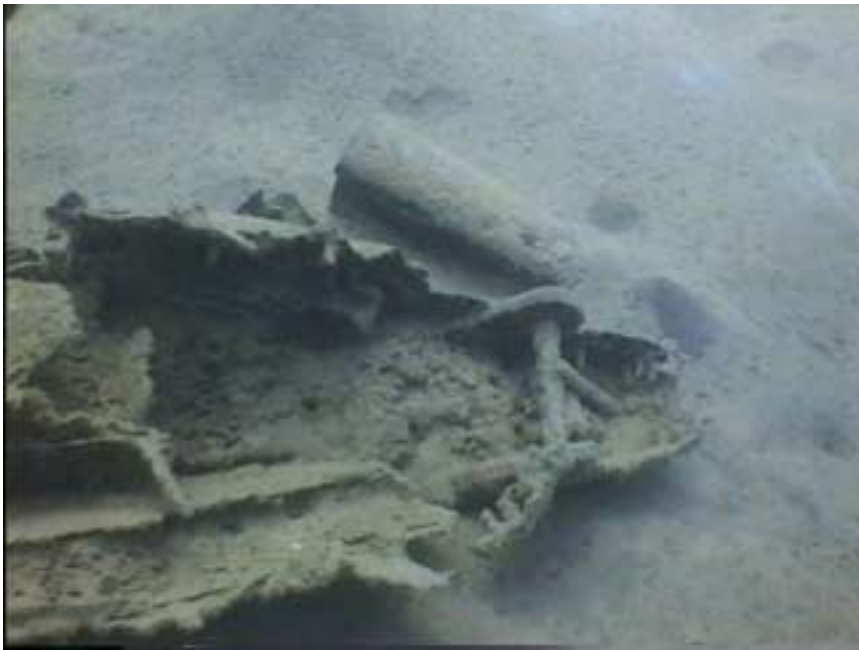
The bow of the vessel had a bow spirit, decayed away in Photo WT7-1. The bow and most of the vessel had concrete poured between the frames, generally a repair technique for older boats not worthy or far away from repair areas. This concrete is visible, as is the base of the bow spirit in Photo WT7-2 .

Photo WT7-1 Bow of Central Vessel Wreckage, with decayed bow spirit.

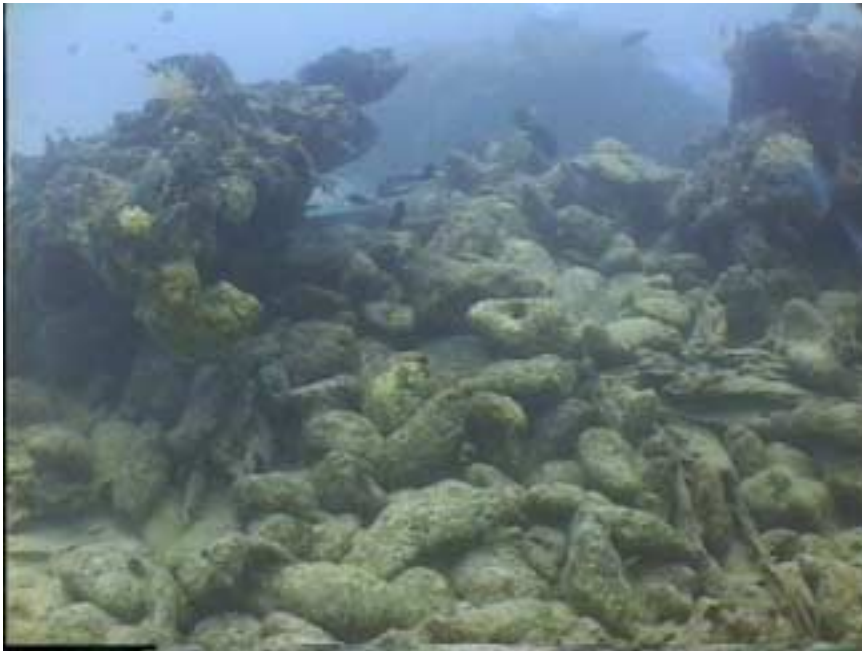
Photo WT7-4. Ballast Stones behind Niigata Main engine.

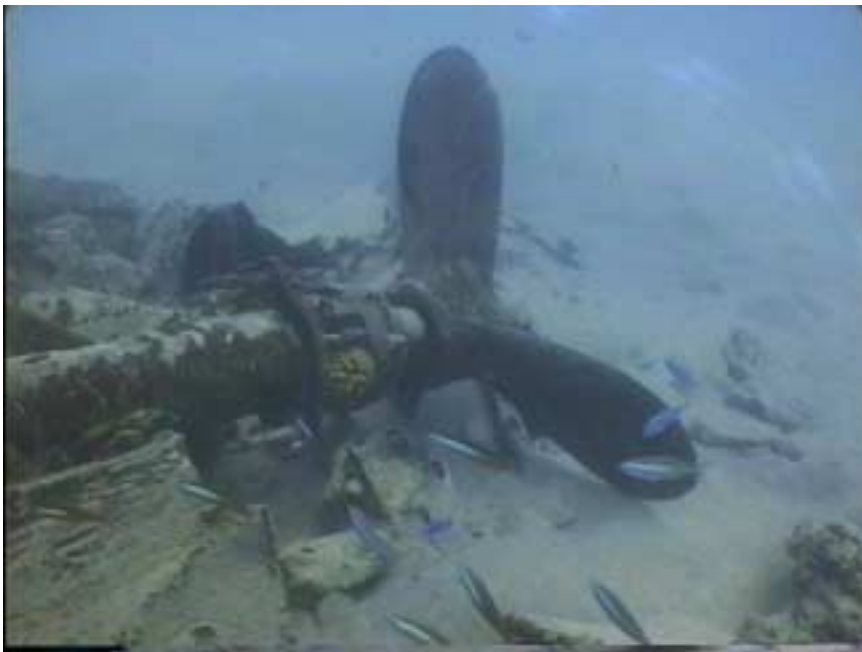
Photo WT7-5. Propeller and shaft of Central Vessel Wreckage.

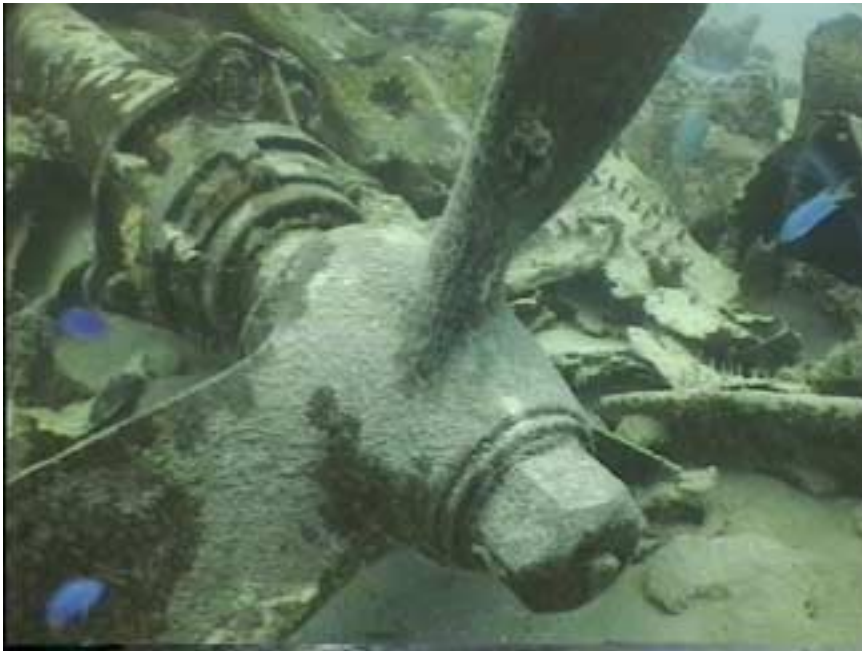
Photo WT7-6. Close-up view of propeller of Central Vessel Wreckage.

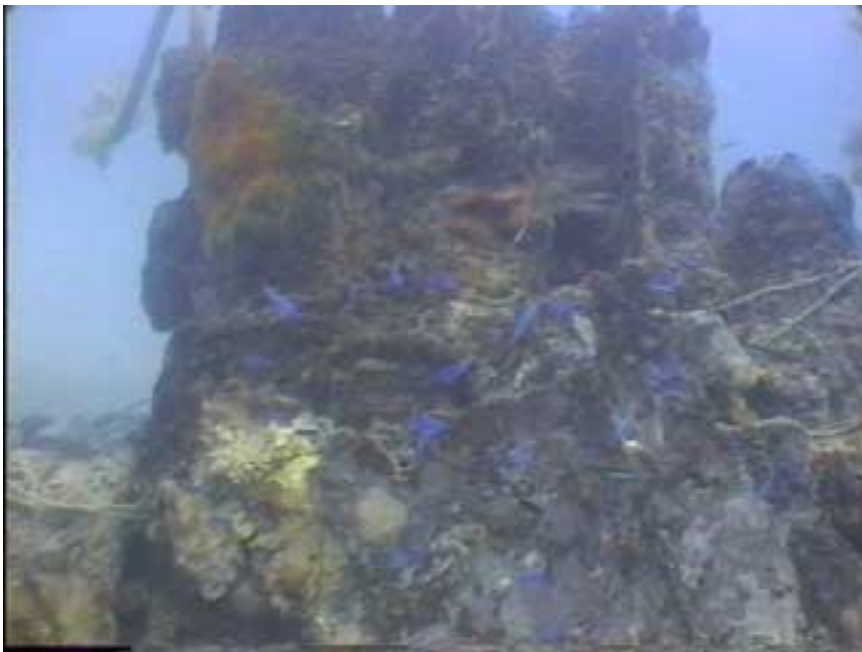
Photo WT7-7. Robust 3 cylinder Niigata Main engine.

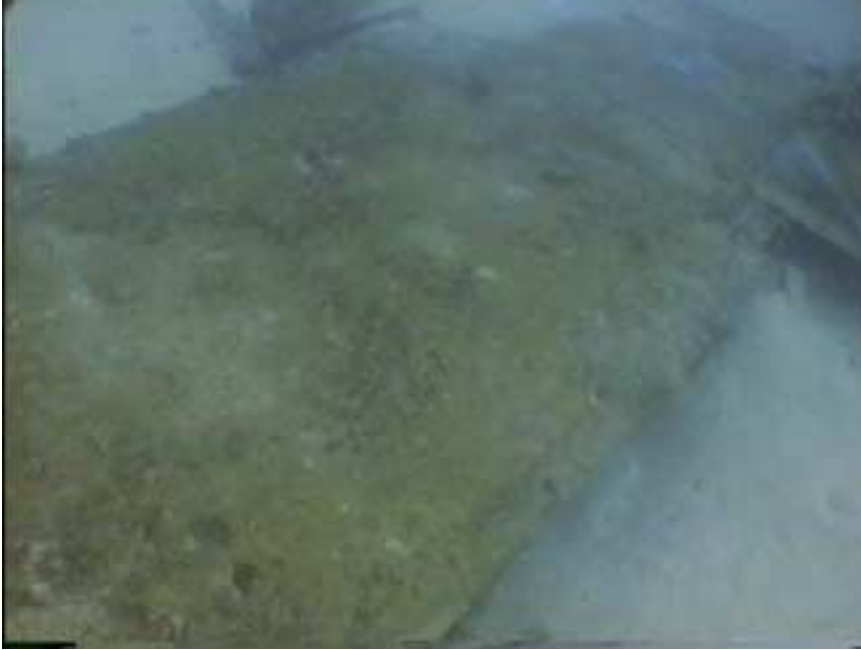
Photo WT8-1. A large aircraft wing section at Site 8.

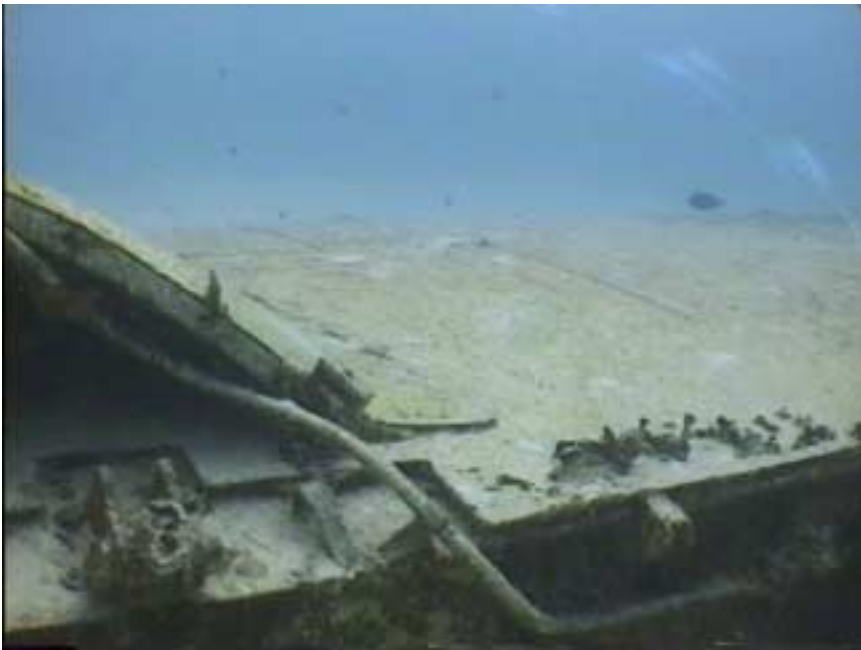
Photo WT8-2. Front edge of a wing section, with an engine mounting area on the left edge of the photo.

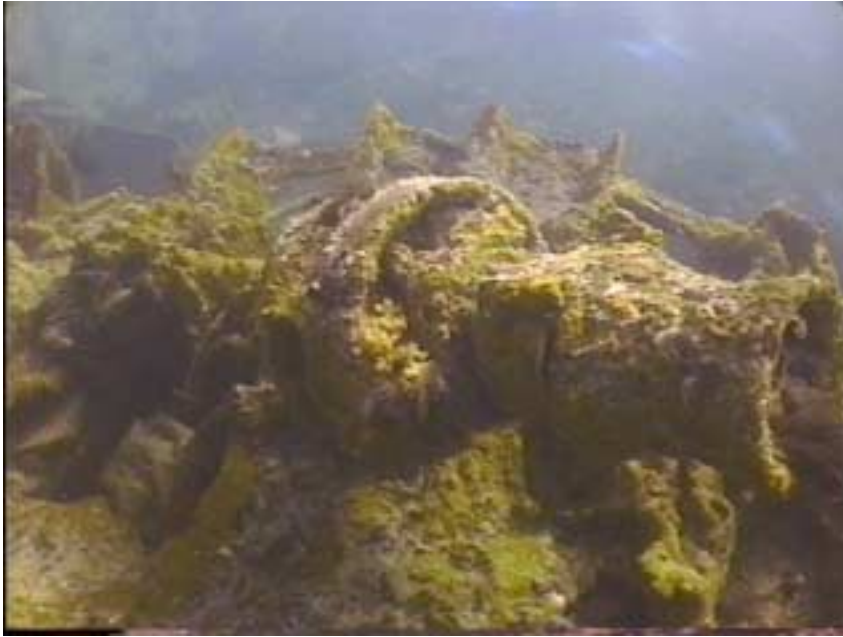
The bow is shown in Photo WT9-2, with 2 anchor tubes. The vessel had an attached bilge keel, with the port side shown in Photo WT9-3. The vessels windlass is in Photo WT9-4, and a steel mast post base in Photo WT9-5. If an original photo of each of the Wotje vessels could be found, it could more easily identified.

Photo WT9-4. Windlass from bow of demolished steel vessel.

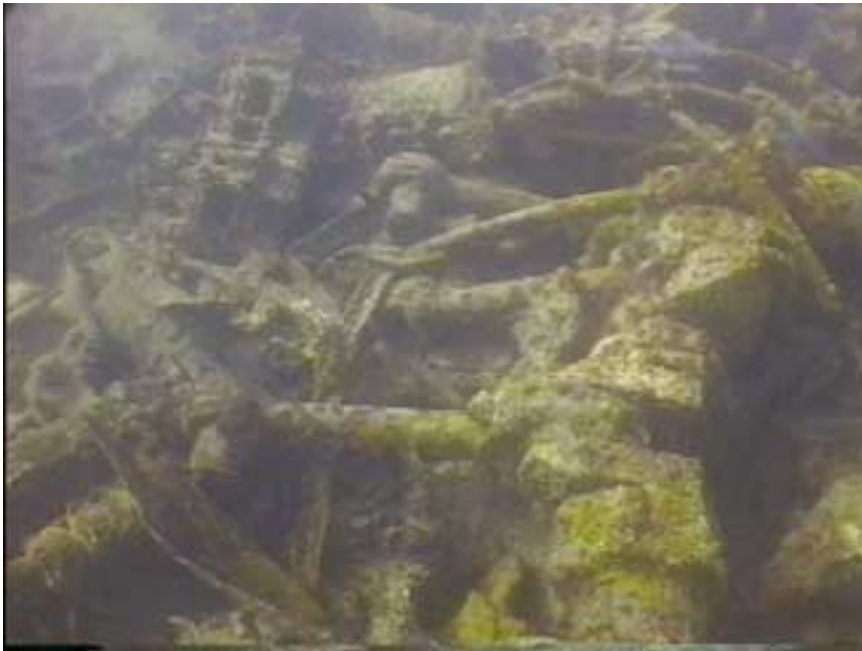
The main engine, a large robust older diesel model is in Photo WT9-6. The vessels air tank for starting the main engine is in Photo WT9-7, the diesel tank shown in Photo WT9-8., and the generator with flywheel is in Photo WT9-9. A brass bomb detonator was found for Photo WT9-10, and the coral and steel debris from the bottom in Photo WT9-11. The only marine life found was 2 tiger cowries in some steel debris in Photo WT-12.

Photo WT9-6. Remains of vessels main engine.

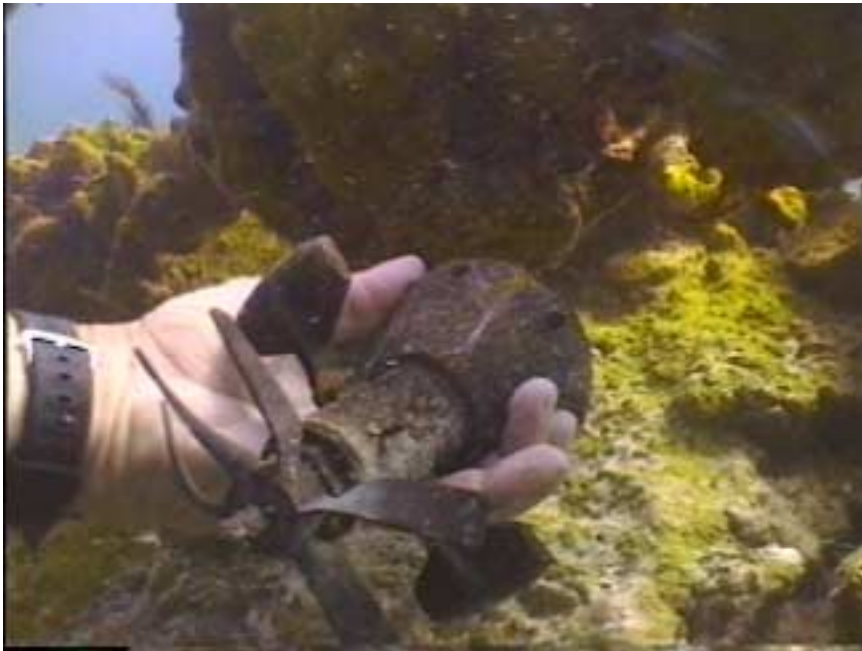
Photo WT9-9. Flywheel from ship service generator.

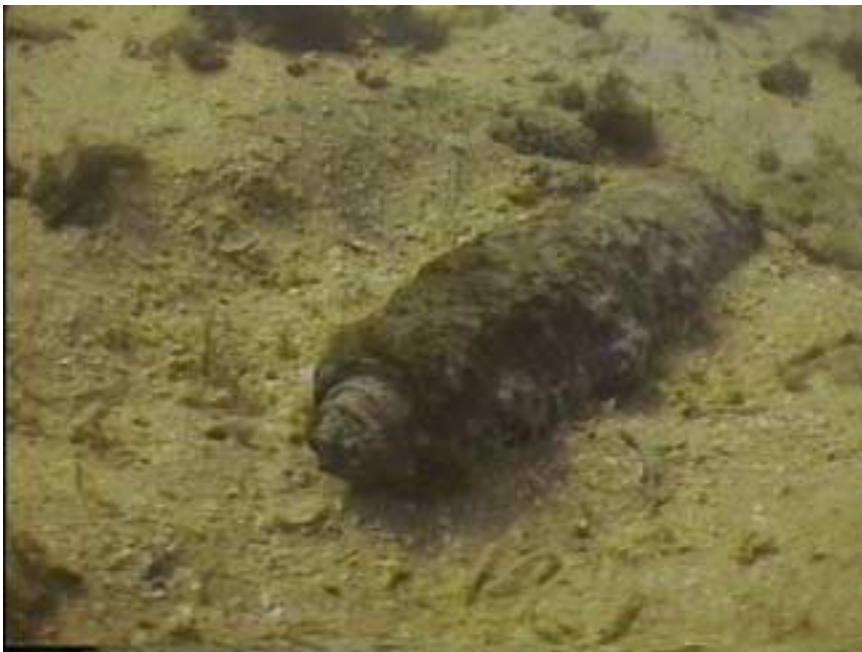
Photo WT9-12. Two tiger cowries in the steel vessel remains.

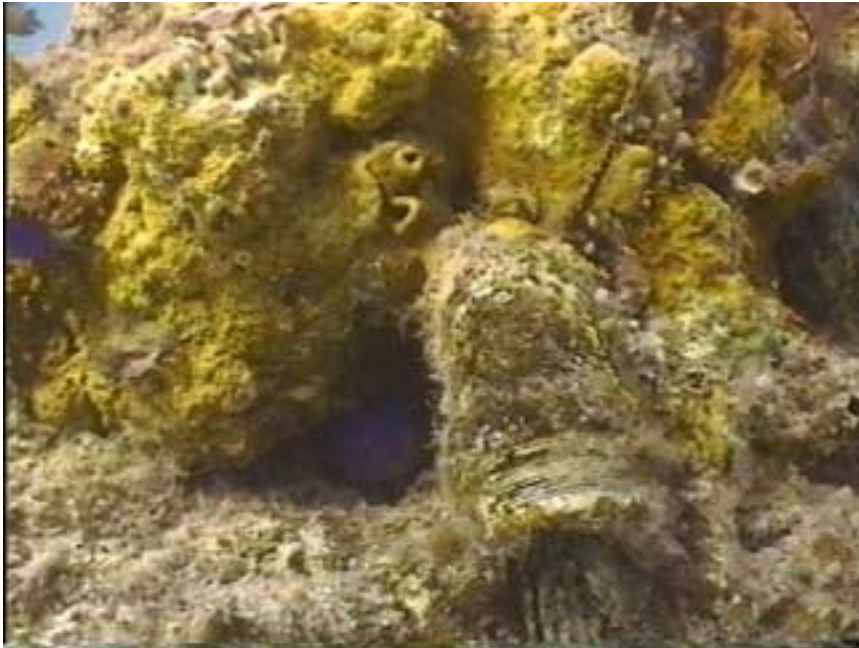
The engine is hardly recognizable from some angles, being overgrown with coral (Photo WT10-1) One cylinder head was missing, allowing the measurement of the cylinder bore, 140mm diameter, in Photo WT10-2. This measurement is typical of a smaller engine, such as belonging in a fighter, rather than engines in Japanese bombers or flying-boats. The rear of the engine is seen in Photo WT10-3, and a close up of the secondary gears, possibly used for timing the machine guns firing through the propeller of a fighter aircraft, is shown in Photo WT10-4.

Photo WT10-1. Aircraft engine heavily coral encrusted.

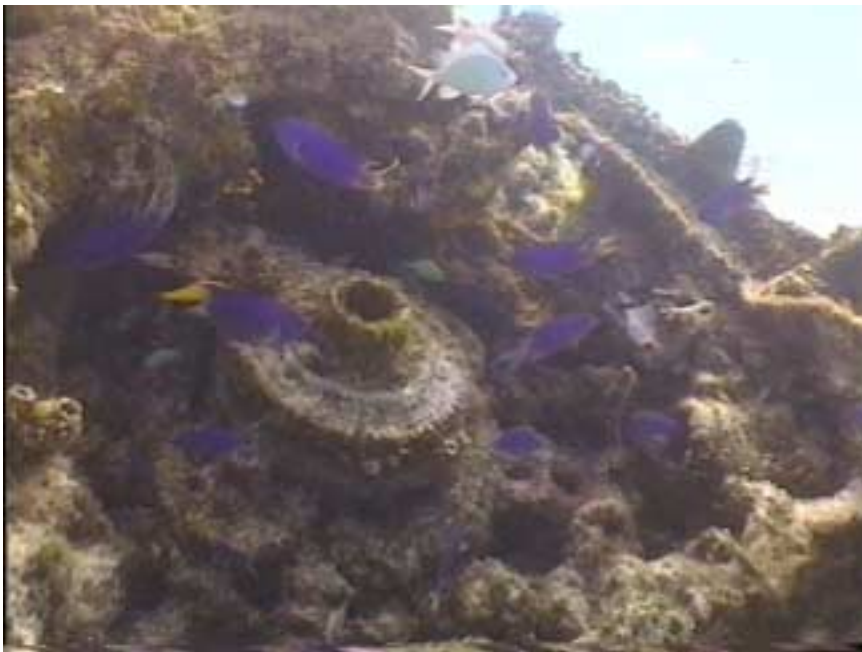
Photo WT10-3. Rear of engine.

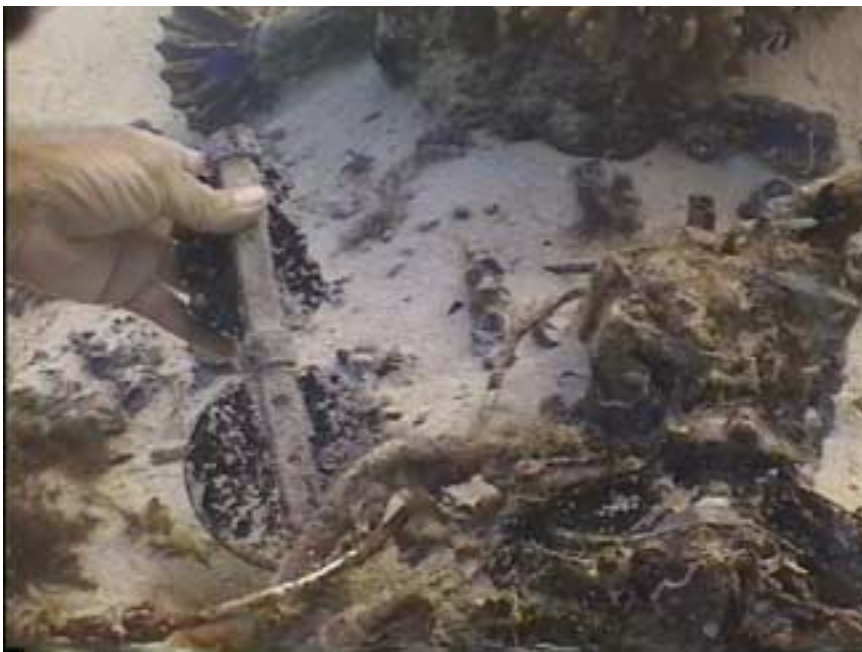
Photo WT10-5. Carburetor butterfly valve among engine debris.

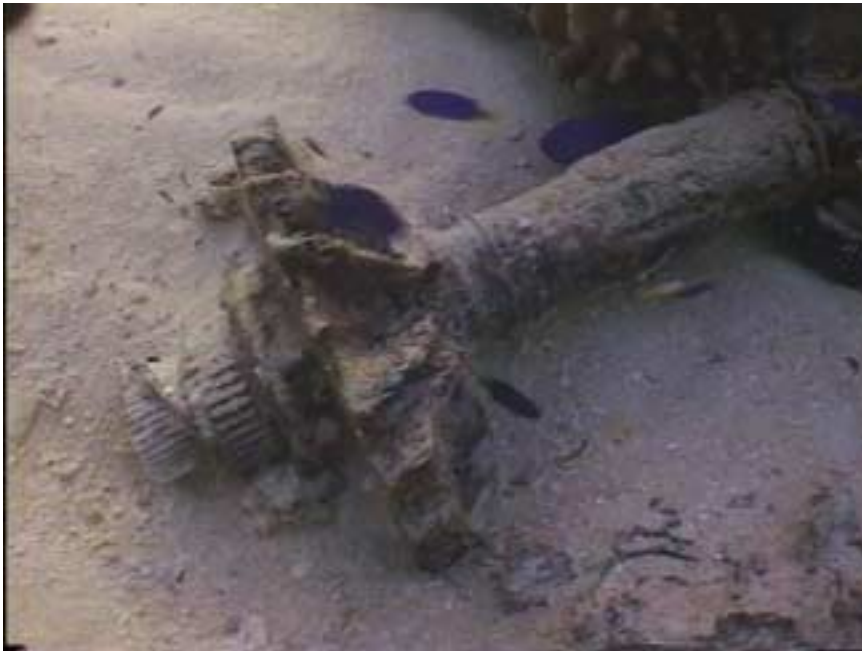
Photo WT10-6. Engine supercharger drive shaft with blower blades.

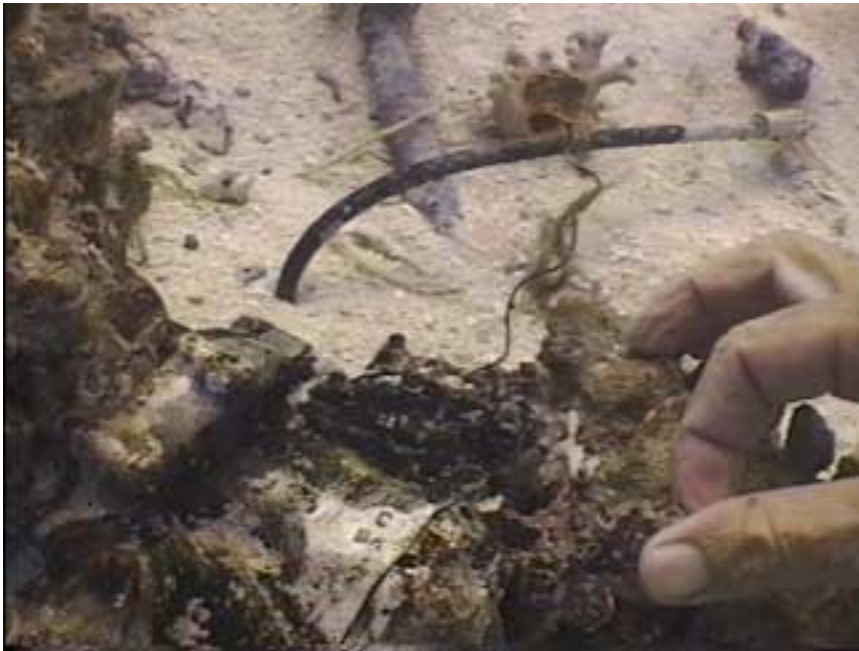
Photo WT10-8. Carburetor governor, unknown type, with letters.

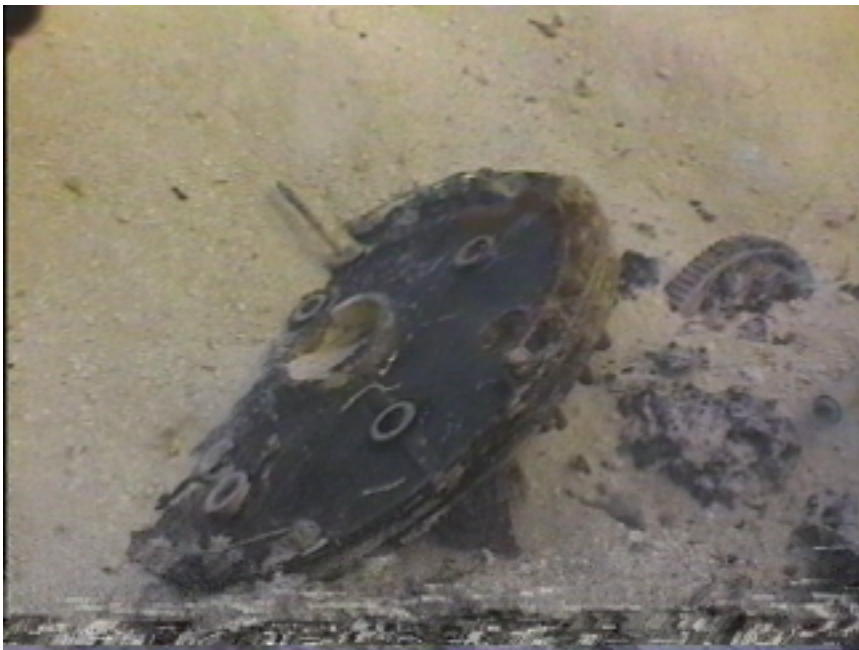
Photo WT10-9. Aluminum part from gear box or supercharger housing.

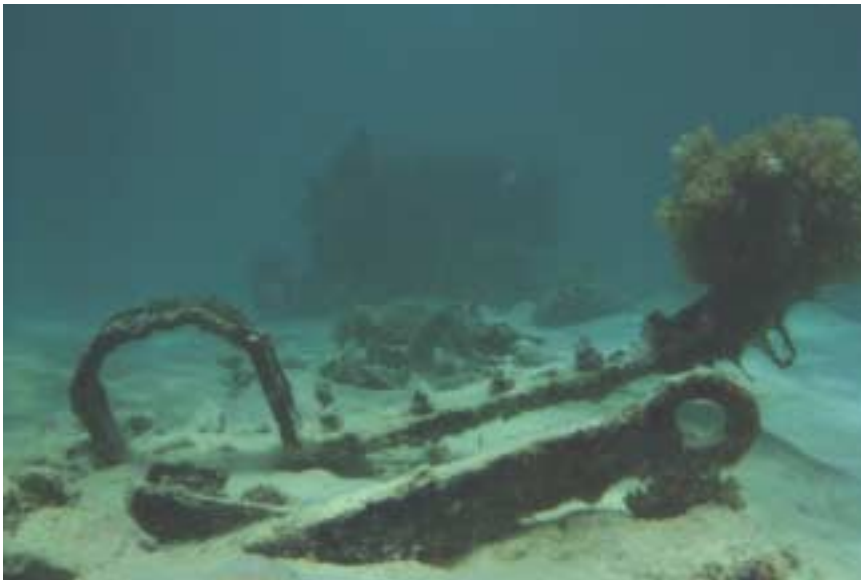
Photo WT11-1. Bow spirit remains on Southern Vessel Wreckage.

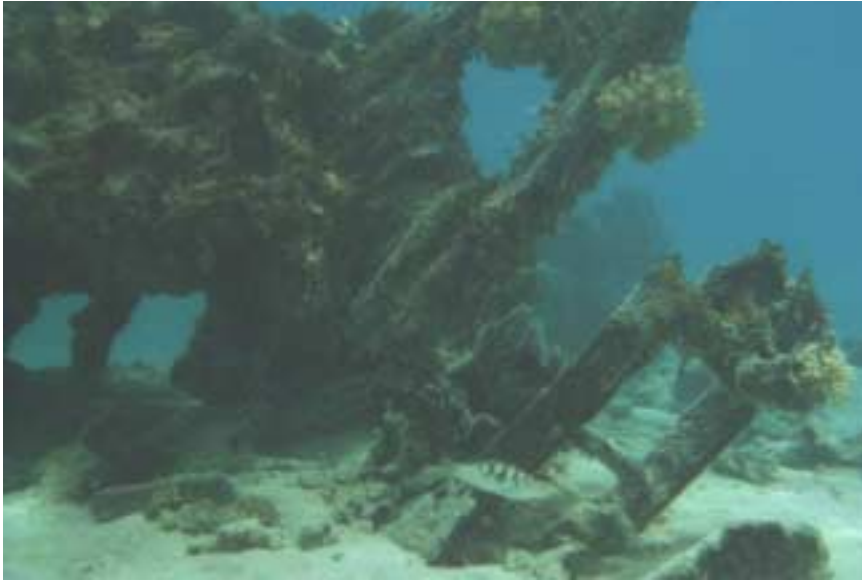
Photo WT11-2. Remains of starboard side of the bow.

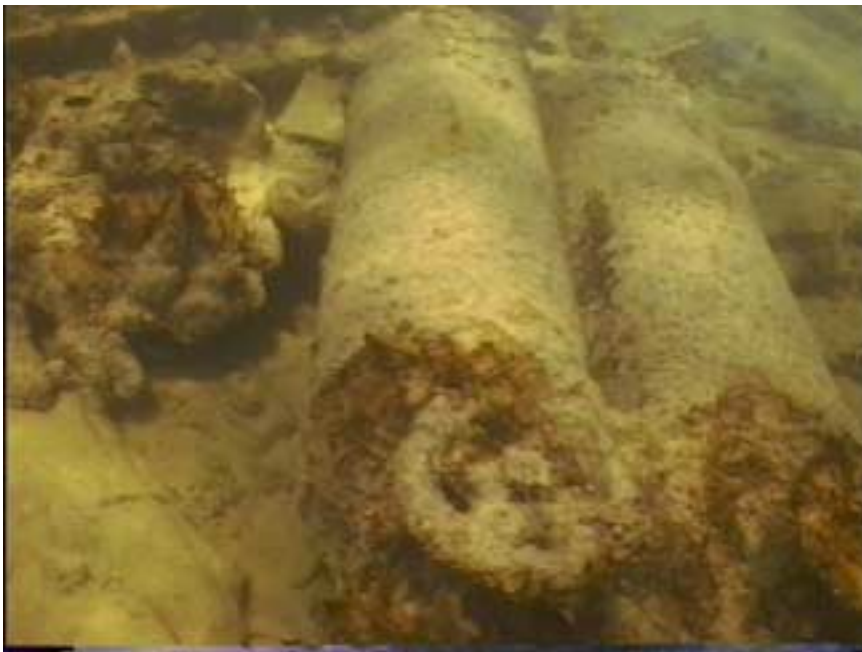
The main engine was a typical 6 cylinder unit, but was more modern than other units surveyed (Photo WT11-4). The engine and generator were air started, and air storage bottles were found near the main engine (Photo WT11-5). The gearbox and main shaft were attached to the main engine, but the propeller had already been removed. The stern items remaining were the kitchen stove nearby (Photo WT11-6), and the fuel tanks and steering gear. Small broken shards of dishes and bottles were also found in the area. A spare anchor, probably stowed on the stern, also rested on the bottom at the stern of the vessel (WT11-7).

Photo WT11-5. Air tanks to start main engine and/or generators.

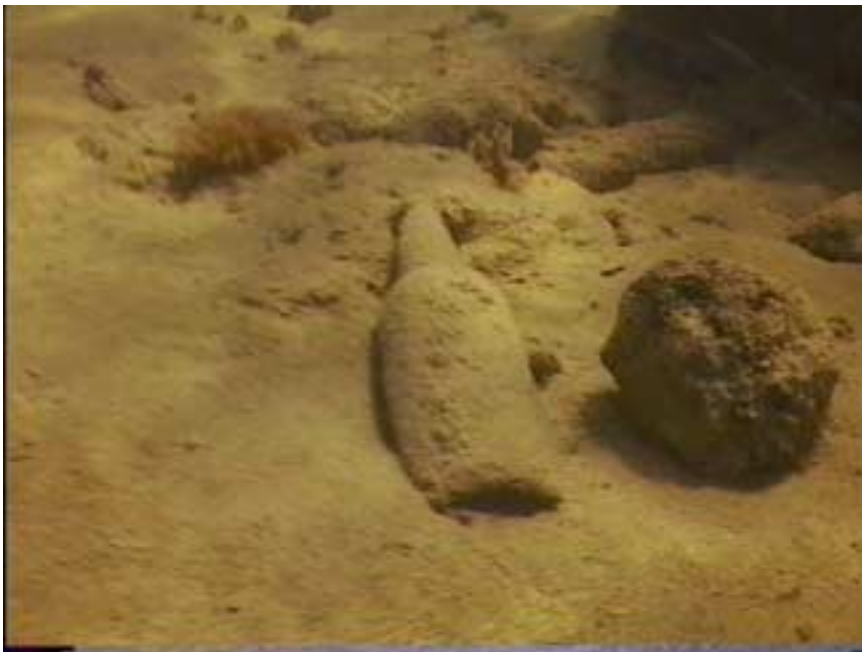
Photo WT11-11. Bottle in sand near vessel.

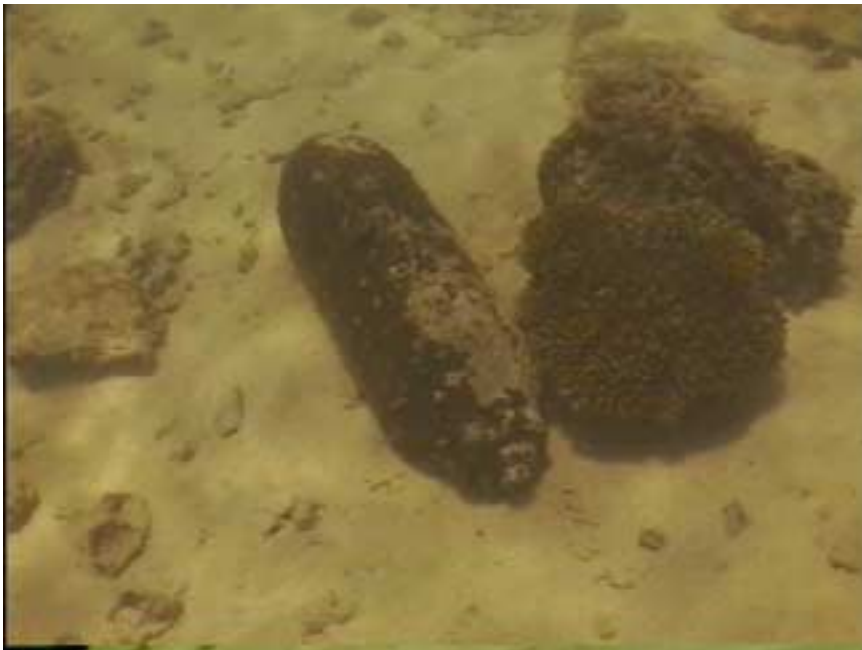
Photo WT11-13. This large, probably 250 pound US bomb lies un-exploded nearby.

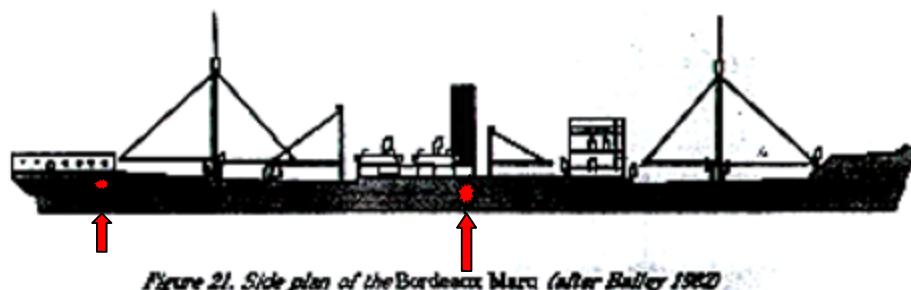
Figure 21. Side plan of the Borudou Maru (after Bailey 1982)

Photo WT12-1. Scanned drawing of the Borudou Maru from *Bailey, 1982*. Red arrows and red explosion marks show location of two holes in the starboard side of the vessel. These holes are shown on Photos WT12-12 and WT12-17, later in photo section.

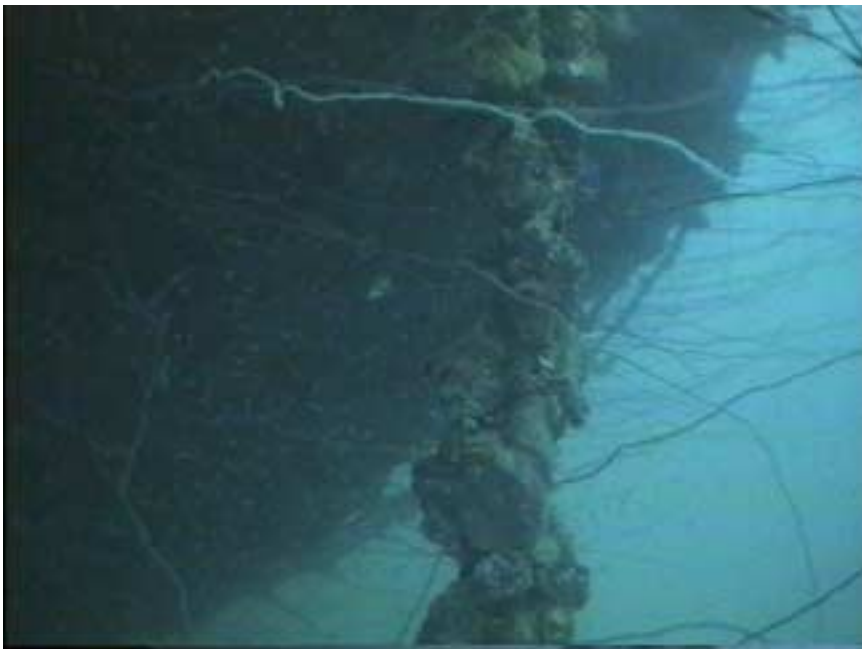
Photo WT12-3. Massive anchor chain is completely encrusted with coral and marine growth.

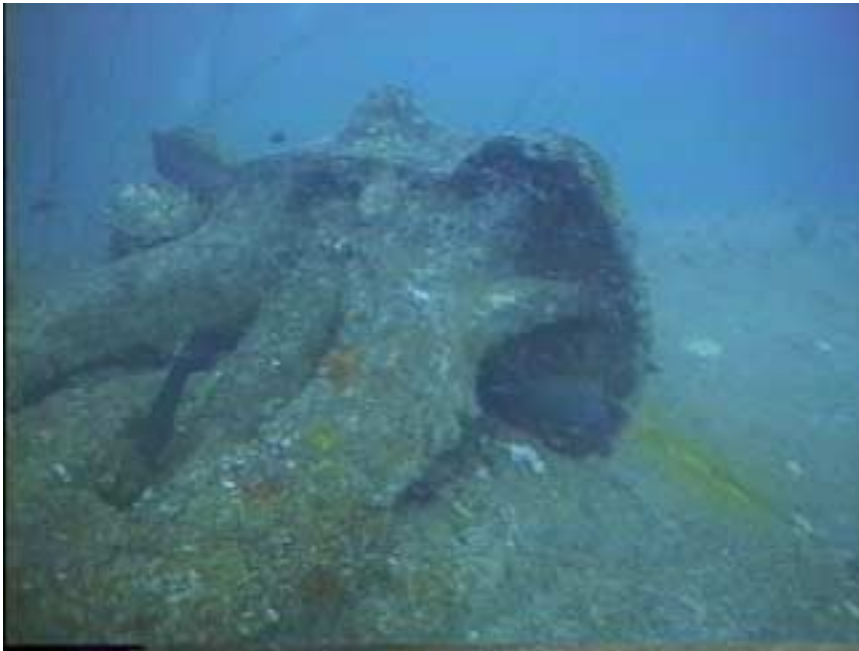
Photo WT12-4. Vessels starboard anchor is still in place.

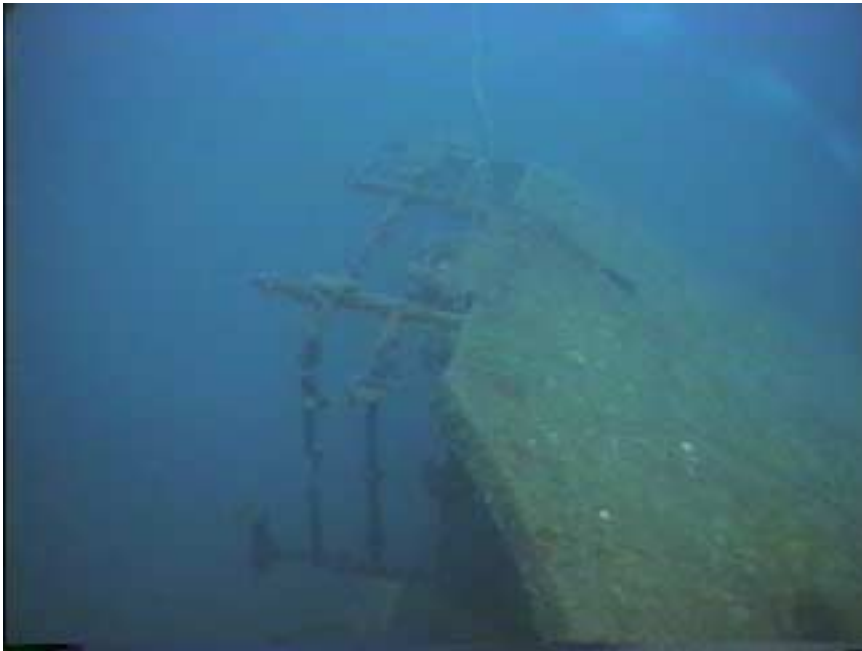
Photo WT12-6. Facing towards the bow on the starboard side of the vessel.

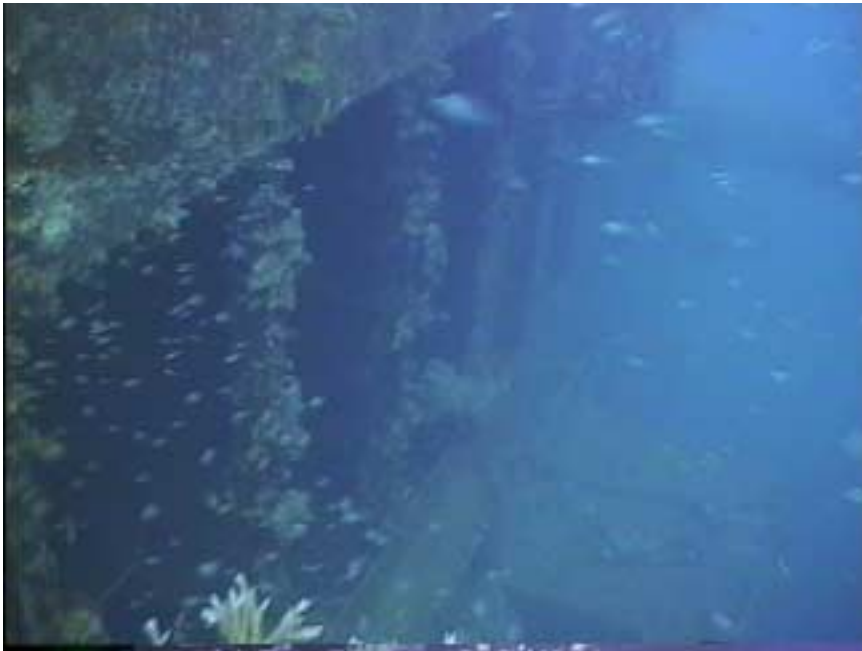
Photo WT12-8. The number 1 hold.

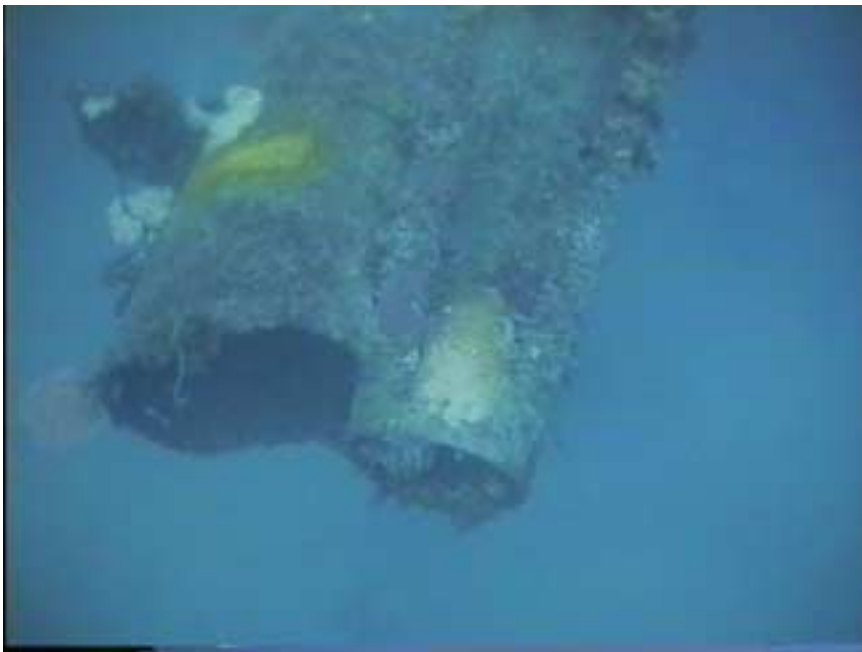
Photo WT12-9. The crows nest atop the number 1 mast.

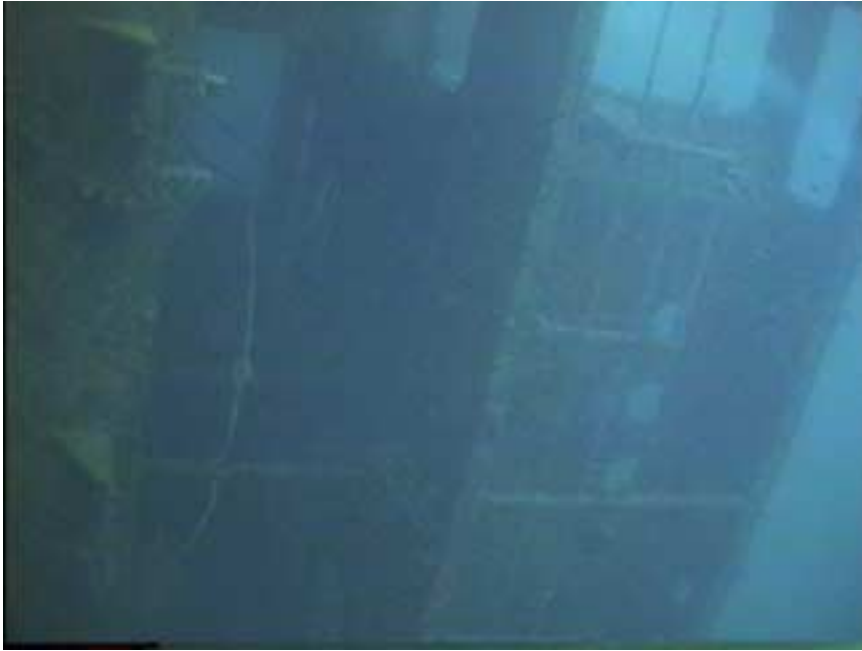
The bridge area is intact, but being made primarily with wood, has decayed away. Photo WT12-10 shows the bridge area, with portholes, and the overhanging walkways. The bridge area was completely decayed and stripped, with only the binnacle for the wheel left hanging by its ' base (Photo WT12-11). A few ceramic items were found here, as the vessel had ceramic light reflectors and sockets for the ships deck lighting.

Photo WT12-10. The ships bridge area behind the portholes.
