*Archaeological Survey and Inventory of Submerged
Cultural Resources in the Lagoon of Wotje Atoll*

Matthew B. Holly

HPO Report 2000/03

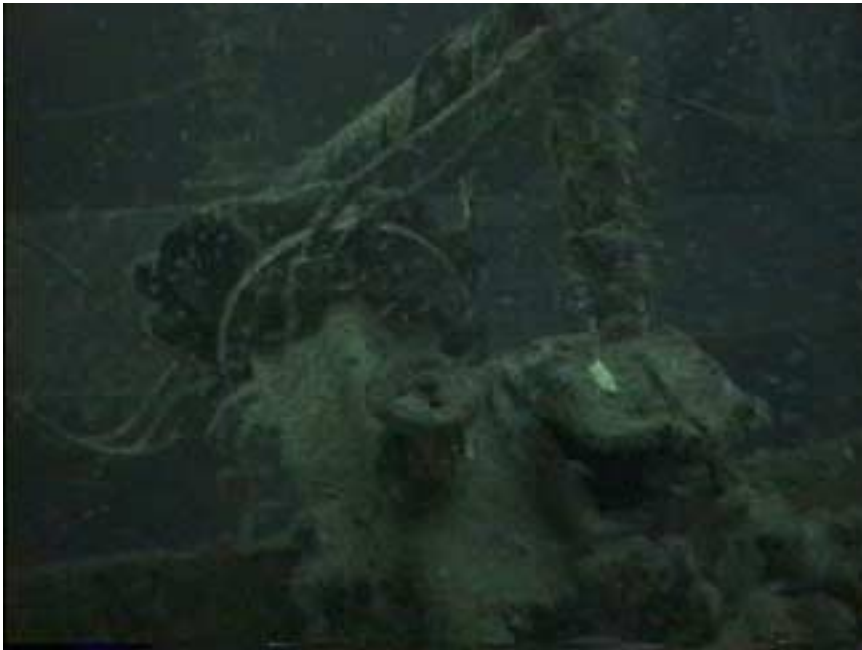
Photo WT12-11. The base of the binnacle, missing the ships wheel, hanging off the steering cables and plumbing.

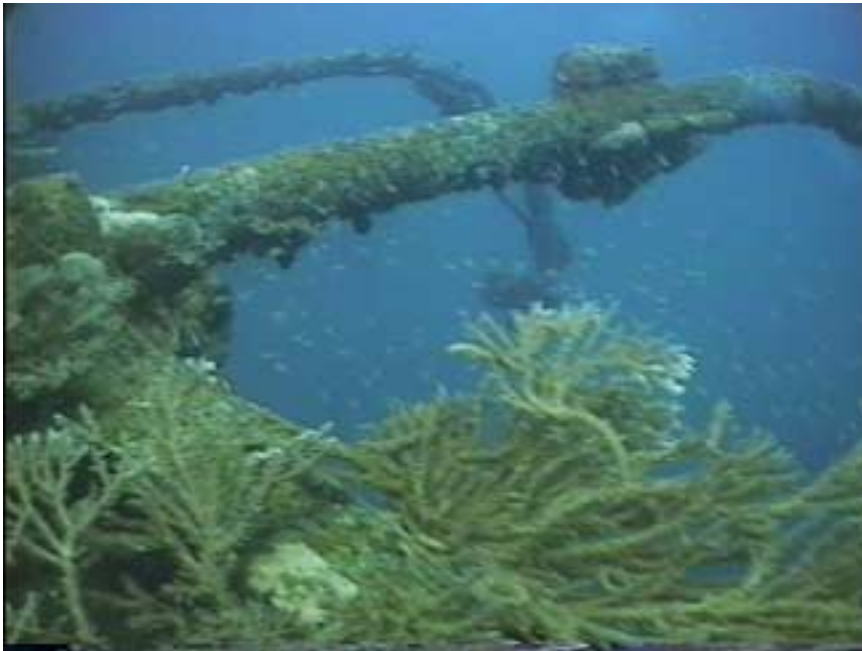
Photo WT12-14. Empty life-raft davits with coral growth.

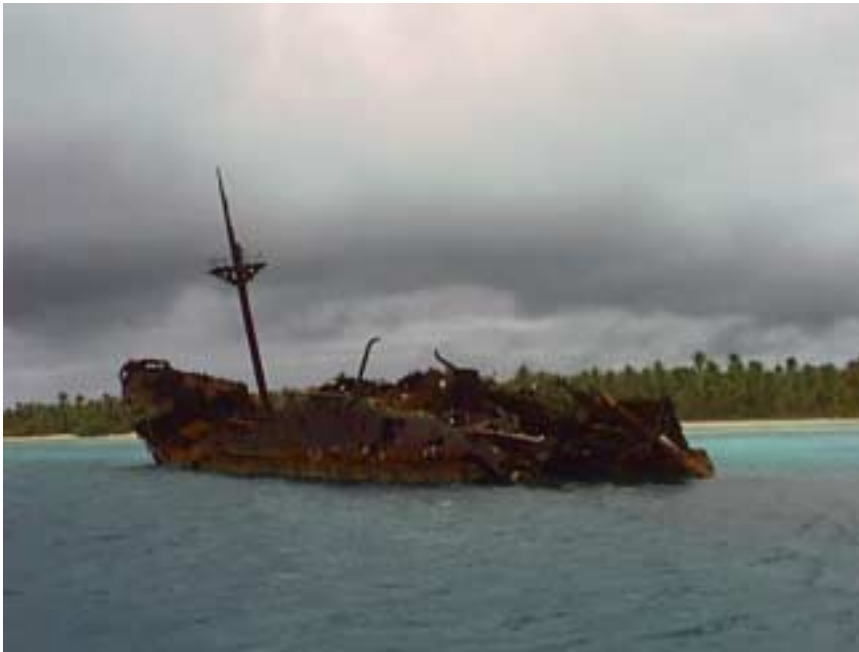
The repeated bombing, and 50 years of salt water and weather, have caused the ship to seriously decay. This damage has also weakened the bow, now collapsing dangerously under its ' own weight. Artifacts, such as bottles and ships equipment, lay in the holds in this area, as seen in Photo WT13-8. Care must be taken diving in this area.

Photo WT13-2. Surface photo of the wreckage of the Toyotsu Maru.

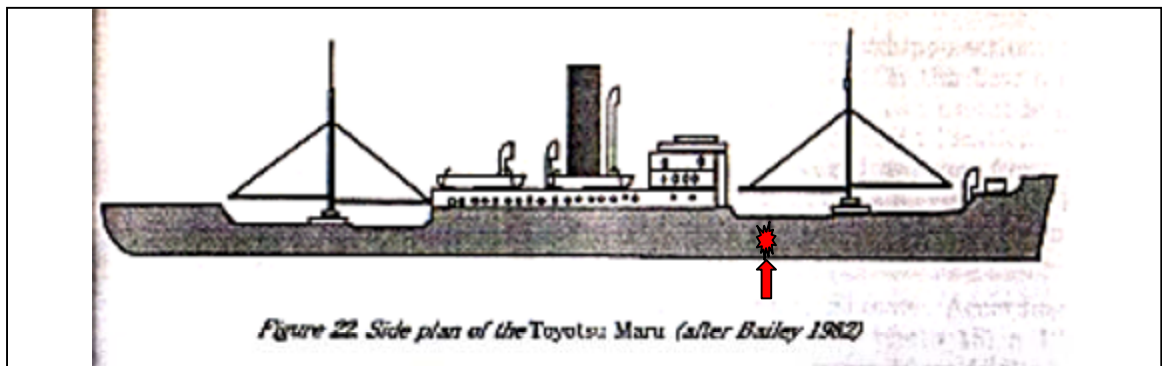
WT13-3 Drawing of the Toyotsu Maru scanned from *Bailey, 1982*. Red arrow points to red explosion mark indicating the site of the hole from an artillery round, also seen on Photo WT13-x.

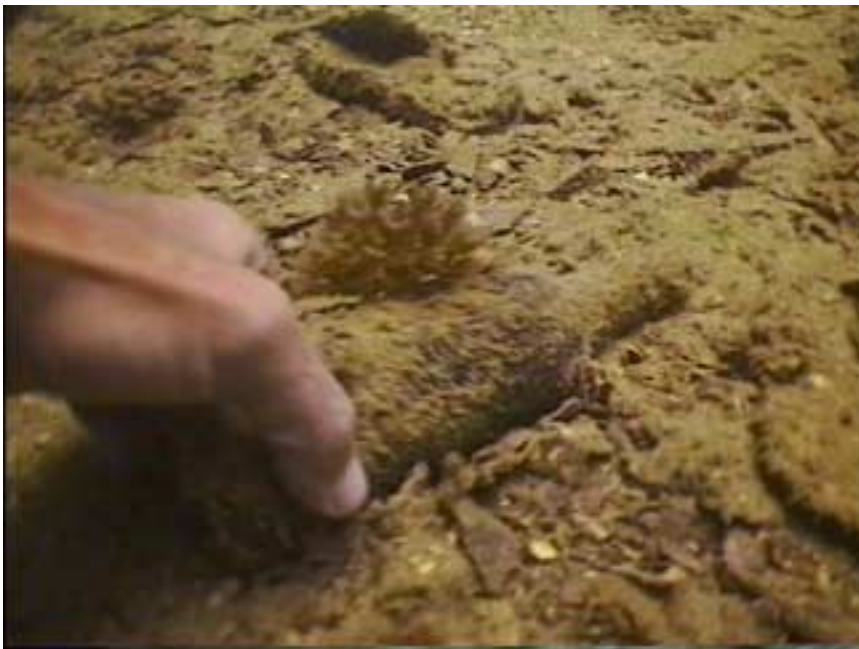
Photo WT13-8. Bottle buried in the bottom of the number 2 hold.

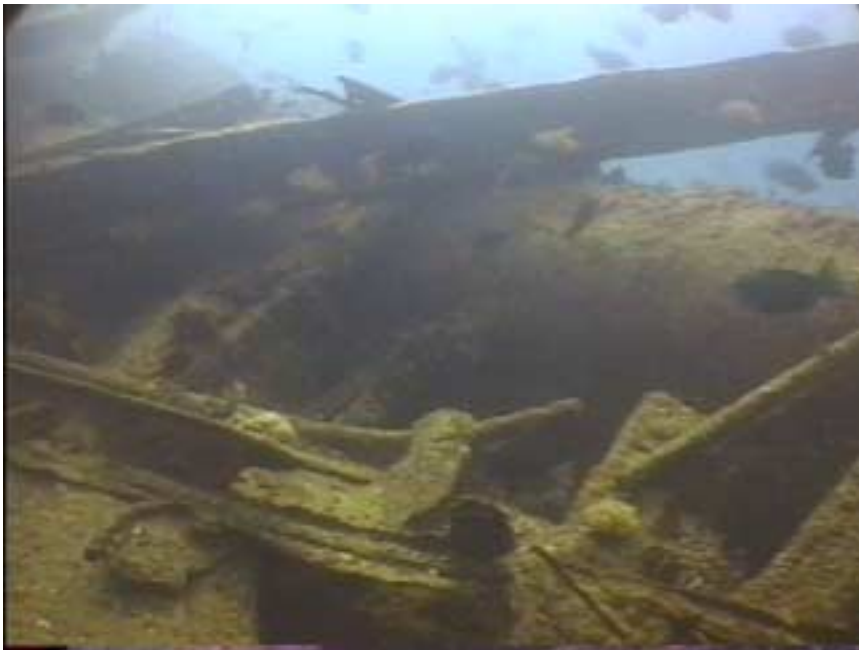
Unfortunately, the vessel was probably struck at this site in the stern by large bomb(s), as from behind the engine room, including the last 2 holds, is a pile of steel debris. Repeated and/or large bomb blasts have shredded the vessel to its keel. Photos WT13-9 and Photos WT13-10 show this damage. The final portion of the vessel has a segment of hull still attached from the keel to the underside of the stern, supporting the rudder, which is still attached, and actually a danger to passing boats.

Photo WT13-10. Stern debris.

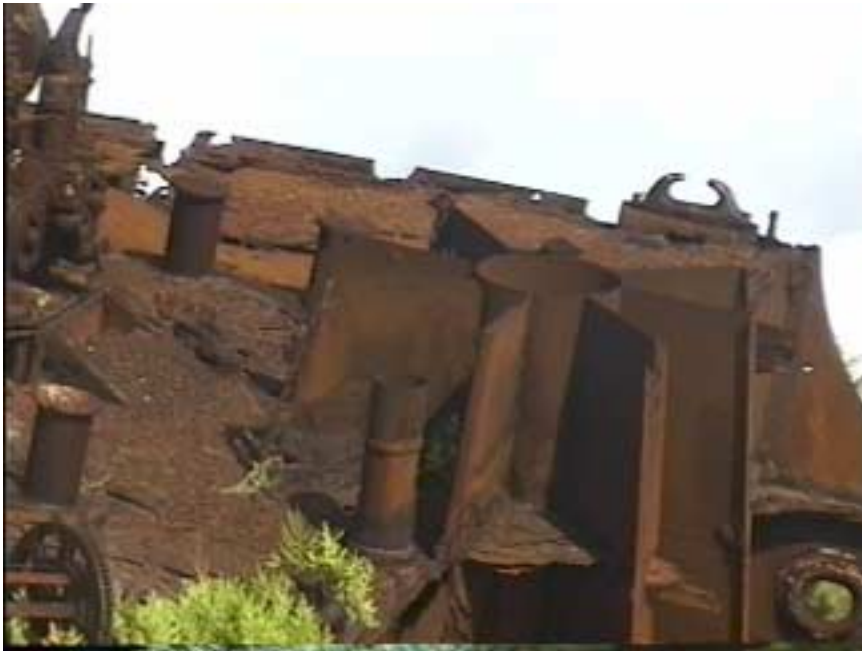
Photo WT13-13. Empty bow gun position on beached vessel Toyotsu Maru.
